Ewa Łuzyniecka*

Architectural examinations of the parish church in Dobrzyki

The team working on the subject headed by Professor Ewa Łuzyniecka consisted of students of The Faculty of Architecture of Wrocław University of Technology: Katarzyna Dorosz, Karolina Cichoń, Natalia Jagielska and Agnieszka Rabęda (Polish acronym ZWAPWr).

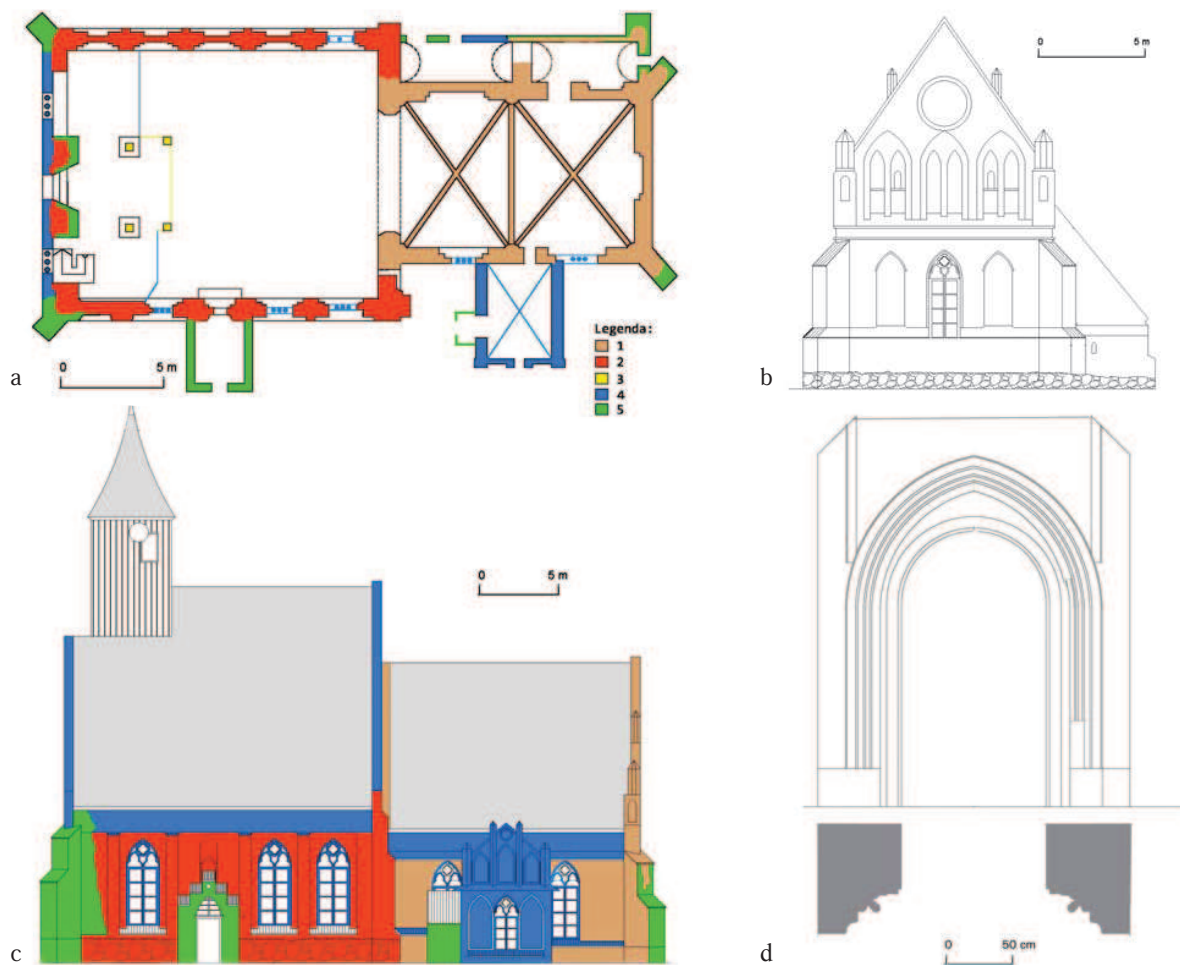
The church in Dobrzyki is now a building 29.90 m long, which consists of the chancel with the dimensions 11.90 × 7.0 m and by the name with the projection dimensions 18.0 m × 13.70 m. An additional element of the building is its northern extension as well as the porch built in the south and the sacristy. The church is not built homogeneously and formal and technological differences of particular parts of the construction allowed us to distinguish five main building phases (Fig. 2).

Fig. 2. Dating suggestions and measurements of the particular parts of the church: a) projection; b) eastern façade; c) southern façade; d) southern portal; 1. beginning of the 14th century; 2. first part of the 14th century; 3. circa 1776; 4. circa 1864; 5. circa 1910 (by ZWAPWr)

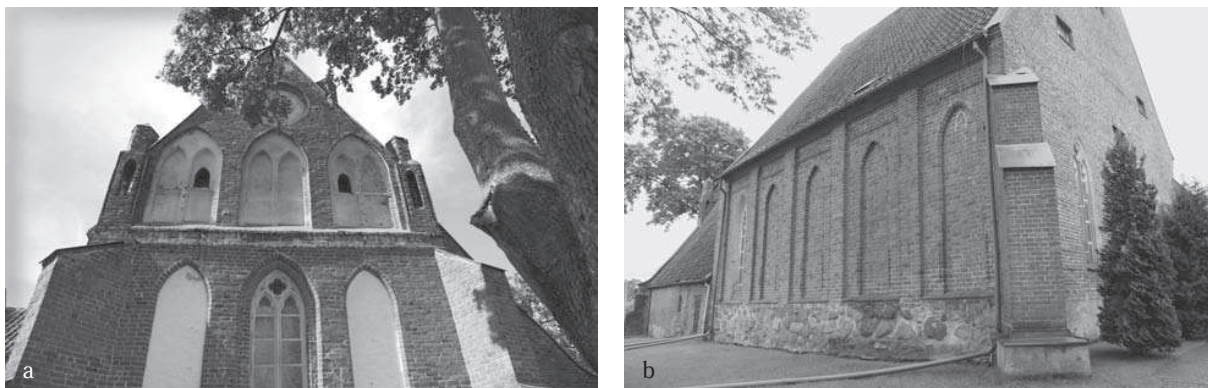
Fig. 3. Church façades: a) eastern of the presbytery; b) northern of the nave (photo: E. Łuzyniecka, 2010)

while in the northern façade there are arcade blind windows of the same size. Façades were additionally segmented – between gothic arches vertical ledges (German: *lisene*) were placed and along with cornices they form a frame system (Fig. 3b)

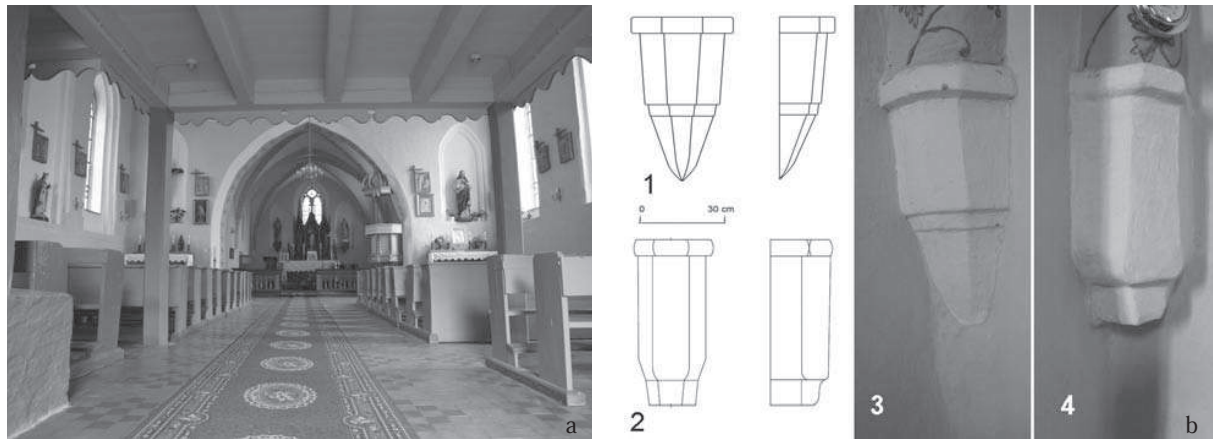
Fig. 4. Church interior: a) nave and presbytery; b) cantilevers in the presbytery: 1, 3 north-east; 2, 4 north-west (photo: E. Łużyniecka, 2010)

The nave interior was covered by the ceiling from the beginning but we are not sure whether the present ceiling, which is painted from the bottom, is also original. We do not know whether the present form of the rood arch is authentic and if it was not changed during further repair works (Fig. 4).

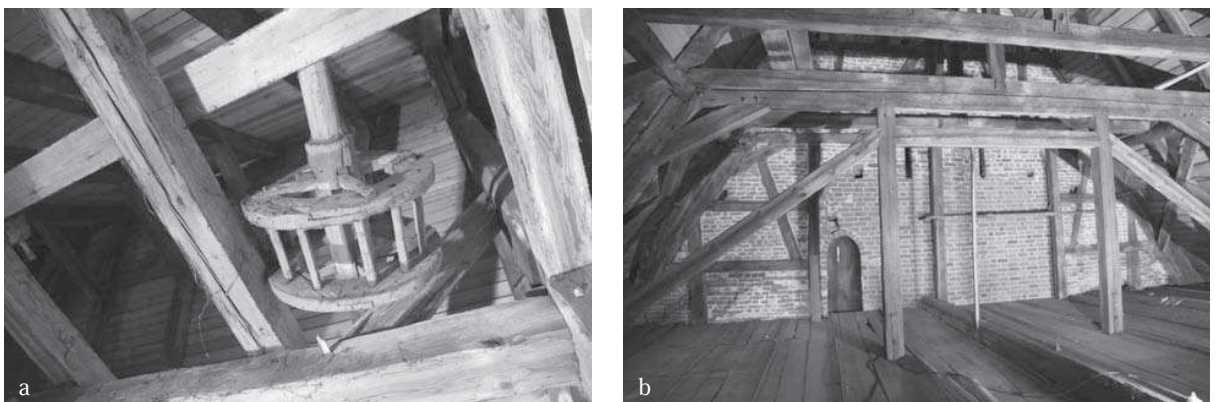
Fig. 5. Church attics: a) near the construction crane in presbytery; b) nave, 2010 (photo: E. Łużyniecka)

ported by four columns which reach the ceiling. It is possible that in this period the wooden roof framing of the nave was built, which was based on the built up eastern top with timber framing (Fig. 5). Probably the pulpit also dates from the Baroque times. We can also assume that at that time the sacristy interior was extended to the west direction. However, in order to confirm this thesis some additional examinations are necessary.

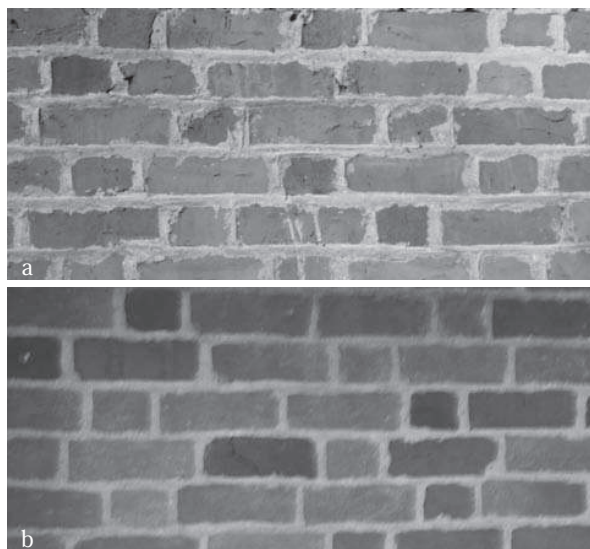
Fig. 7. Brick arrangement in gable between nave and presbytery; fronts: a) eastern, b) western, 2010 (photo: E. Łuzyniecka)

ticular often appears in southern Poland, is considered to be earlier than the gothic one. In the case of the church in Dobrzyki both techniques of placing the building material were used at the same time. The top, which separates the nave attics from the chancel, constitutes the proof of this. The eastern face of the top was built of bricks with the gothic arrangement, while the western front – with the Vedic arrangement (Fig. 7).
