Church in Marianka by Pasłek. The results of analysis of the inner face of the walls carried out during research and conservation works on the mural paintings

Gothic church of St. Peter and Paul¹ in the village of Marianka by Pasłek is a single-aisled building with narrower, single-spanned choir with a five-angled closure², with adjoining rectangular vestry from the north. Half the way along the side walls, both from the north and from the south there are small, rectangular porches. There is also a rectangular, four-storey tower adjoining from the west (Fig. 1a). The choir has been covered with a crystal vaulting, the vestry with groined one. In the ground floor of the tower there are abutments preserved, for an intended vaulting that however has never been executed. The nave and both porches have been covered with flat wooden ceilings. The church was built of brick, on field-stone foundation, erected in several stages. The choir is regarded to be the oldest part of the edifice (according to various authors ca 1334 or after 1342, the nave, tower and north porch followed in mid- or in the 4th quarter of 14th cent. The south porch might have been erected in the same time, or later.

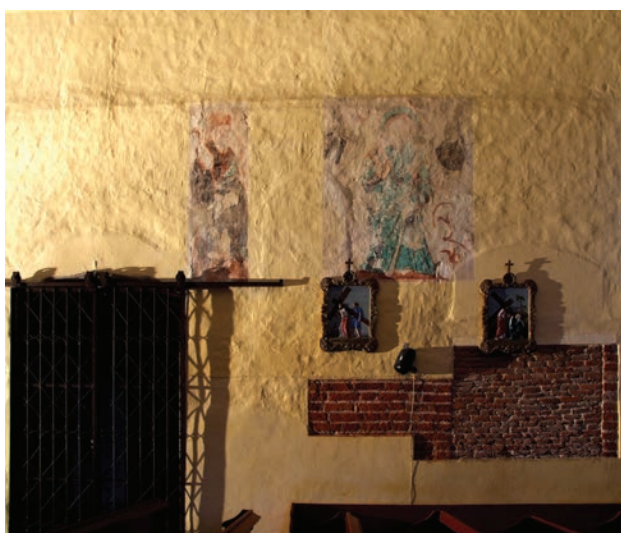
Fig. 2. Photograph of the inner face of the wall in raking light, a base for further analysis (detail of the south wall) (photo: J.M. Arszyńska)

First pieces of information on the occurrence of bricked-up recesses in the church walls have been obtained already during the initial research works carried out at the end of the year 2007, when – among others – an analysis of the nave walls in raking light was performed (Fig. 2) More information was collected during the mentioned above strip-sampling carried out in summer of 2008. At the end of 2008 and in summer of 2009, following the conservators' recommendations the secondary plastering – applied in the 1950's – along with a layer of bitumen insulation of lower section of the walls have been removed – except the west and east (rod) wall³. In result of those works the brick face of the lower part of walls has been revealed, which allowed to complement the information on the size, shape and location of the existing alterations and bricked-up recesses (both in the nave and in the choir). Subsequent information on the recesses has been collected during conservation works on mural paintings on the north wall of the nave initiated in summer of 2008. In that time the scene of the Ecstasy of Mary Magdalene has been revealed from under numerous secondary layers of white-wash and paint, as well as the boundaries of five recesses present in the east section of northern wall [3]. Two of them, accessible from ground level without any scaffolding have been next completely uncovered (i.e. emptied of secondary bricks), which allowed to measure their depth.

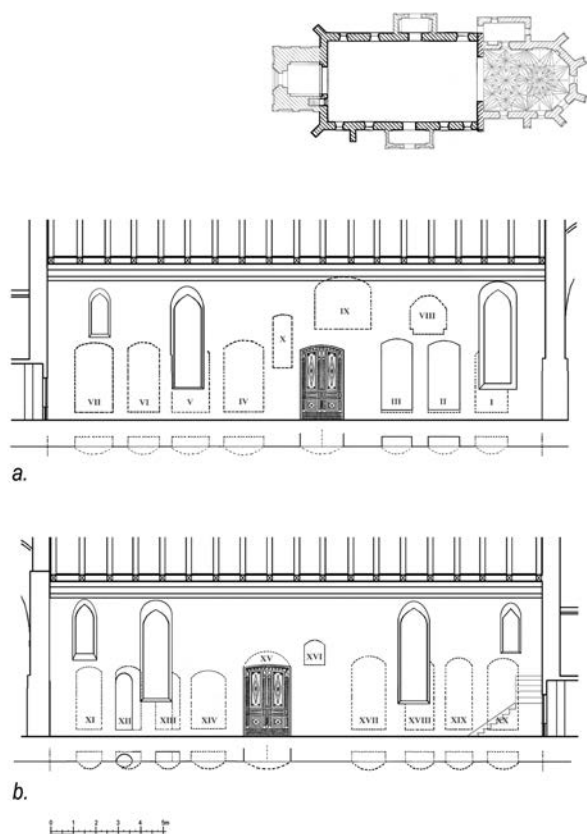
Fig. 3. Recesses in the church walls: a) south wall, b) north wall (drawn by M.R. Gogolin, J.M. Arszczyńska)

In the south wall of the nave the location and extent of 9 large recesses have been traced (ca. 120–150 cm wide and ca. 200–300 cm high) in the bottom part of the wall (ca. 30 cm above the present floor level). Two of them (No. XIII and XVIII) are only partially preserved (damaged during enlarging the windows) and two (No. XII and XIII) have been at least two times altered and changed both their shape and dimensions. Moreover, in the upper part of the wall, in its central area one recess have been found (No. XVI), of much smaller size (ca. 100 × 100 cm). There is a secondary opening, in which a door leading to the south porch has been set in 19th cent., located in a large recess found in the middle section of the wall (No. XV). The original shape of the recess is marked by a characteristic, regular outline of the boundary of modern plaster patch above the door, on the level matching the upper edges of recesses located in the west section of the wall (Fig. 3a). Earlier, this recess contained much smaller, pointed arch opening, the remnants of which are traceable on the porch-side of the wall.

In the north wall of the nave the location and extent of 7 large recesses (ca. 150 cm wide and ca. 300 cm high) have been found in the bottom part of the wall (ca. 30 cm above the present floor level), including two only partially preserved (No. I and V – damaged in 19th cent. during enlarging the windows). Moreover, one smaller recess (No. VIII, ca. 150 × 150 cm) has been found in the upper part of the wall in its east section as well as two openings (No. IX and

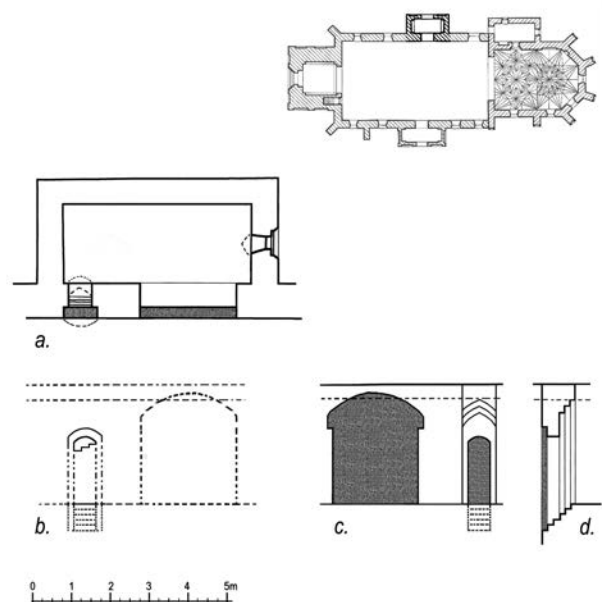
Fig. 4. Preliminary interpretation of the openings in the upper floor of north porch: a) rzut na wysokości odkrytych otworów, b) widok od strony nawy, c) widok od strony poddasza, d) przekrój na wysokości mniejszego otworu (rys. M.R. Gogolin, J.M. Arszczyńska)

X), that used to connect the church with some room on the upper floor of the north porch (Fig. 3b and Fig. 4).

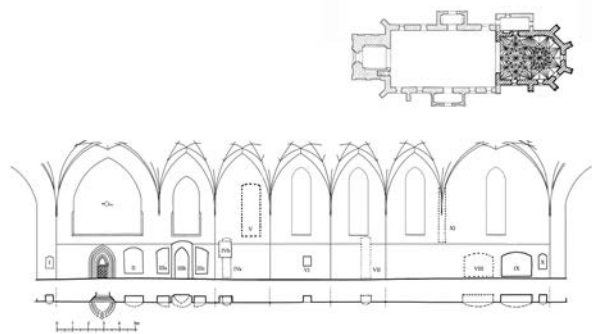
In the walls of the choir the location and extent of 11 recesses of various shape and dimensions have been traced. Some of them have been emptied off the secondary bricks. In the north part of rod wall (the choir side) one small recess (ca. 70 cm wide and 100 cm high) has been found. This is the only one that has originally been plastered inside. Directly on the plaster there are traces of quite long inscription executed in bright-red paint, unfortunately hardly readable. In the north wall of the choir, right of the vestry door there is one recess ca 120 cm wide and ca. 150 cm high. Further to the east a set of three recesses have been discovered. Their composition suggested, that they might have served as sedilia. The middle recess, ca. 120 cm wide and ca. 170 high (measured from the present, secondary floor level, the original profile reached much deeper) is closed – as the majority of others – with a segmental arch. Both side recesses, lower and narrower, each measuring ca. 80 cm. wide and ca. 120 cm. high (from the present floor level) end 30 cm. above the present floor level and are closed with half- segmental arches, sloping sidewise. After emptying those recesses off secondary bricks (summer 2009) it turned out, that inside the middle one there is next, somewhat narrower (ca. 100 cm. wide) and lower, pointed-

Fig. 5. Recesses in the walls of the choir (drawn by M.R. Gogolin, J.M. Arsyńska)

arched recess. A crevice in plaster along the brickwork filling the recess and its side wall suggested, that the bond between them is rather weak. This has been confirmed by a strip-sample, that revealed information indicating, that there was an opening in the choir wall. Its inner walls have been carefully plastered and its location and dimensions roughly match the location and dimensions of a bricked-up, pointed-arched opening visible from the outside. This may suggest, that at the early stage of the church history, there was a vestry adjoining this section of the choir wall, probably erected in a not durable technology, that was later replaced by the present, brick-built one. After the inner opening was bricked-up, the remaining three recesses might have for some period serve as sedilia; later they have been closed and the inner face of the wall was smoothed.

In the next section of the choir wall (north-east) an elongated, narrow recess (No. IVa) has been discovered, completely bricked-up. In its upper part later another recess (No. IVb) has been made, to house a wooden sacarium with painted, figurative decoration, dated back to mid-15th century⁴. On the wall above the sacarium,

In the south wall of the choir, below a console supporting the vaulting a narrow (38 cm) recess was found, ending at the level of 262 cm above the present floor level. Defining its function requires further research. If the presence of the same structures is confirmed in proximity of other supports of the vault, one will be entitled to draw a theory, that there was some other conception of vaulting planned at the stage of building the walls, finally not executed (Fig. 5).
