*The mediaeval roof structure over the nave  
of the cathedral in Kamień Pomorski  
in the light of architectural and dendrochronological research*

The subject of this article is the roof structure over the nave of the cathedral of St. John the Baptist in Kamień Pomorski.

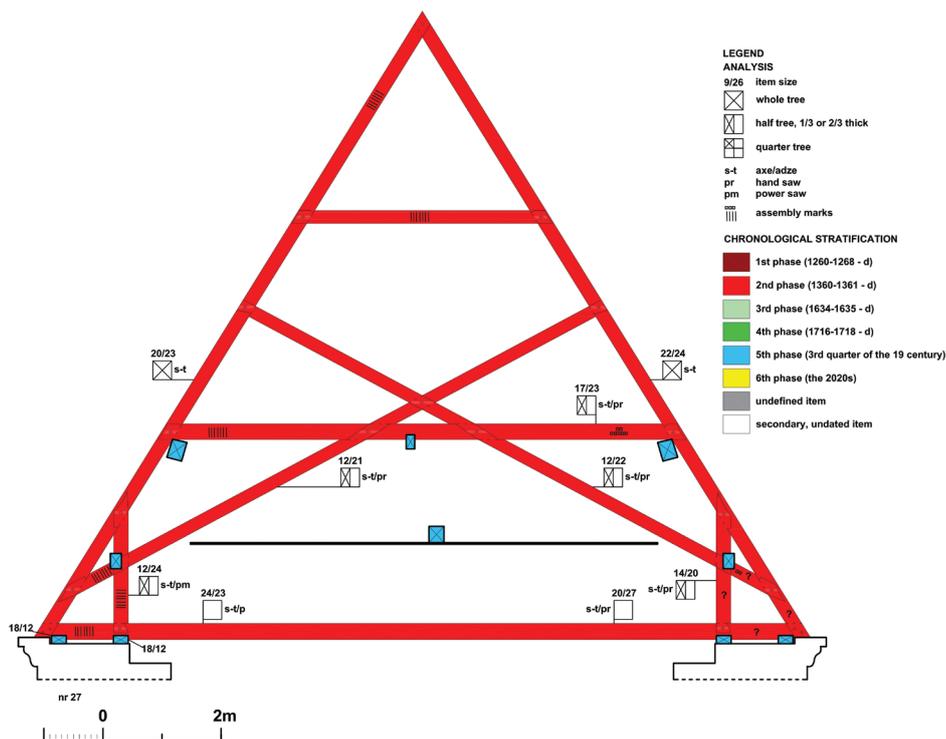
Fig. 1. Kamień Pomorski, cathedral, roof structure above the aisle, principal rafter truss, No. 27, analysis and stratification (elaborated by U. Schaaf, M. Prarat)

In the principal rafter trusses (19, 20, 27 – Fig. 1), the tie beams rest at both ends, each time on two wall plates lying on mural crown of the outer walls of the nave. These tie beams are connected with rafters with a length of about 12.50 m, which are supported by two rows of collar beams. The almost vertical down braces connect the tie beams with the rafters roughly in the axis of the inner wall plates and stiffen the trusses in the lower zones. Long intersecting passing braces form additional stiffening and at the same time support the rafters. They connect to the rafters just above the tie beams, intersect with the passing braces, the lower collar beam, and with each other, and end at the opposite rafters approximately halfway between the lower and upper collar beams. Paired common rafters (Fig. 2) differ from the principal rafter trusses only

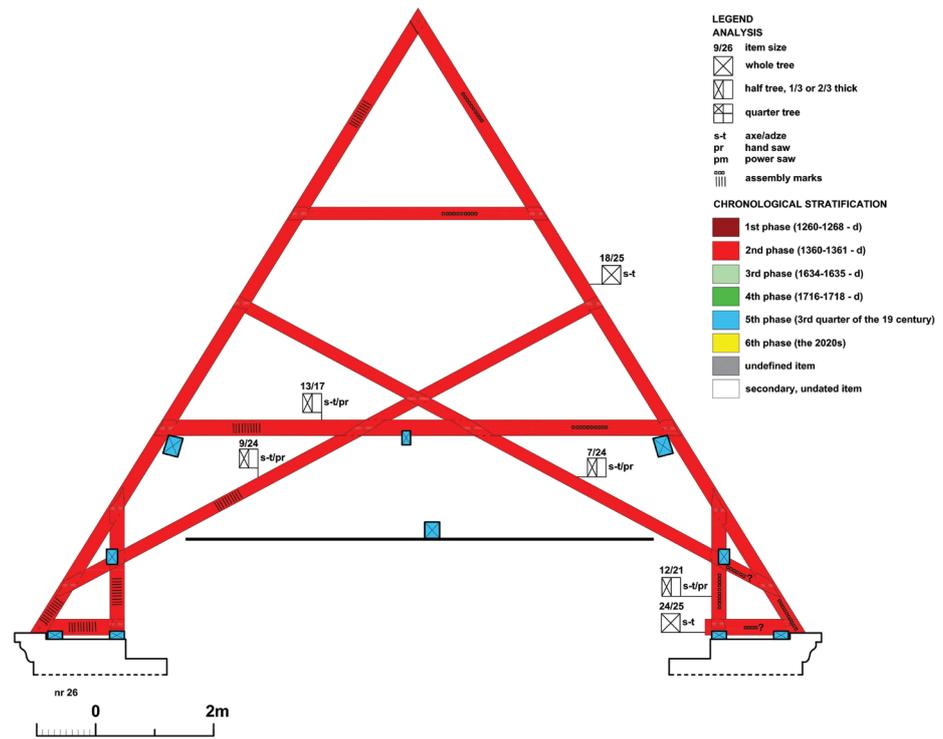
Fig. 2. Kamień Pomorski, cathedral, roof structure above the nave, paired common rafter, no. 26, analysis and stratification (elaborated by U. Schaaf, M. Prarat)

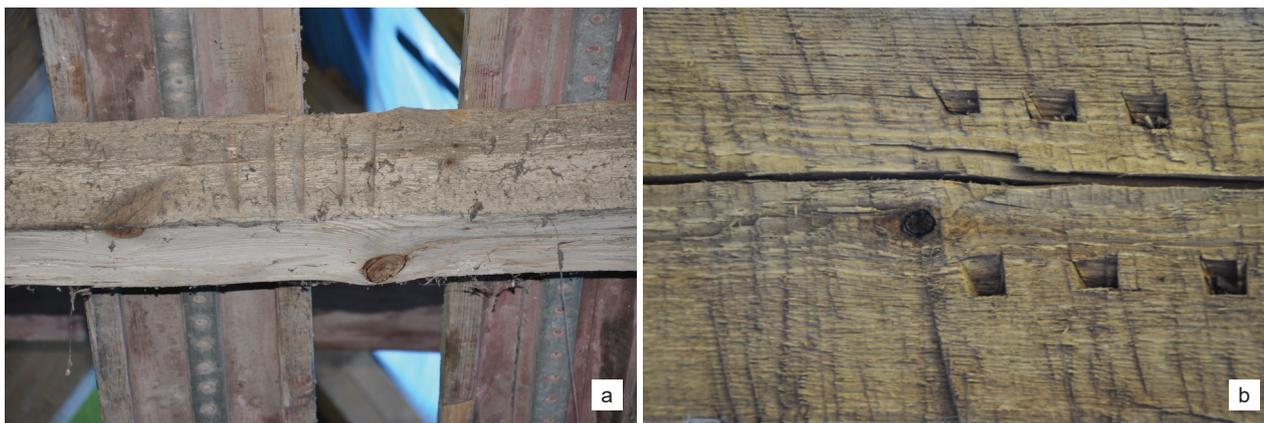
In the following trusses, from 20 to 27, the elements on the southern side were marked with line marks made with an axe or a hand adze (Fig. 3a), and on the northern side, with rectangular marks made with a chisel (Fig. 3b). Theoretically, the marks could grow from three to ten. However, during the assembly, there was probably confusion of the trusses, because the actual numbering in the trusses 20–27 is as follows, from the west to the east: 3, 4, 5, 6, 8, 9, 10, 7. However, this mistake did not create any problems, because all the common rafters, unlike principle rafters, have the same arrangement<sup>3</sup>.

Fig. 3. Kamień Pomorski, cathedral, roof structure above the nave: a) assembly mark in the form of straight lines made with a hand axe, b) assembly mark in the form of rectangular cuts made with a chisel, building material processed from the side of timber framing with a hand saw (photo by U. Schaaf, M. Prarat)

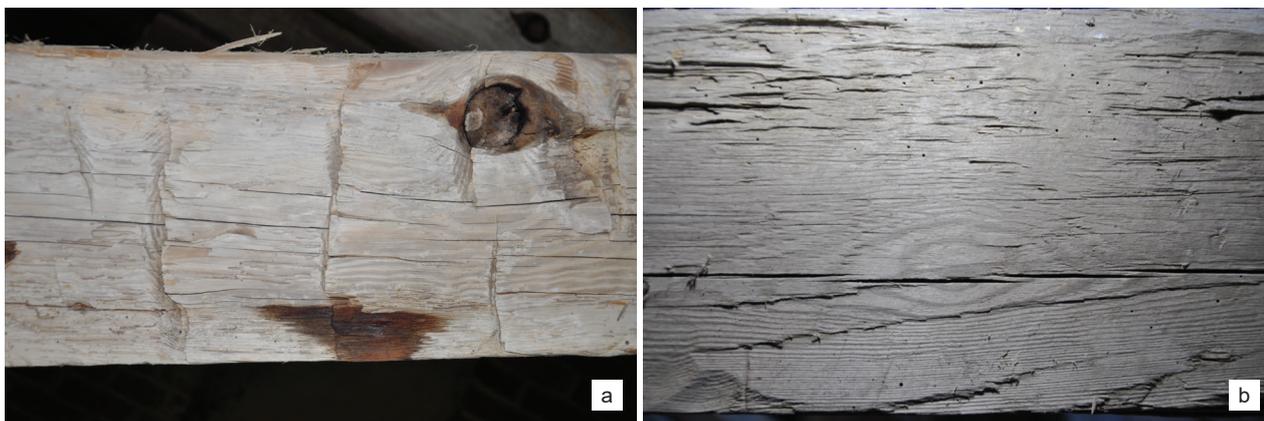
Fig. 4. Kamień Pomorski, cathedral, roof structure above the nave: a) initial processing of wooden building material made with an axe, b) smoothing of pre-processed wooden building material made with an adze (photo by U. Schaaf, M. Prarat)

An axe was used for the pre-treatment of the building material, with some traces in the form of “V” shaped cross-sections transverse to the direction of the fibres (Fig. 4a). Then the building material was smoothed with a carpenter’s adze, which left on the surface typical long and slightly rounded cuts running almost parallel to the fibres (Fig. 4b). Some of the elements processed in this way, called whole trees, were divided into smaller ones by dividing them with a hand saw. This process is evidenced by slightly oblique notches running unevenly across the

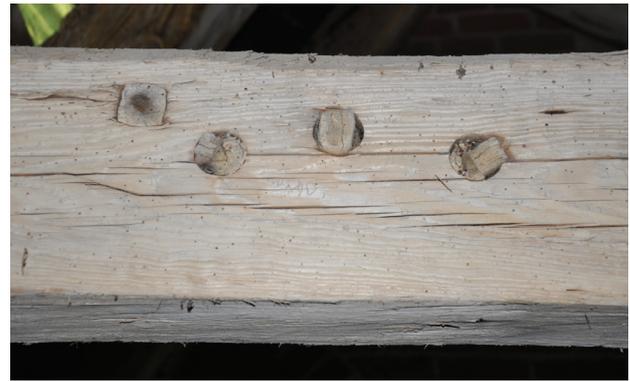
In some structural elements, two round holes, about 3 cm in diameter, with remnants of withes and wedges have been observed (Fig. 5). This proves that at least some of the structural elements were transported by rafts from the felling site in or around the forest to the site near the construction site. These rafts must have been built each time from several branch-stripped logs, connected to each other by a pole placed over them in a transverse direction, and attached to each log with a withe and secured with two wedges. The greater number of holes with remnants of withes and wedges suggest that the raft was repaired or rebuilt during transport. These traces also prove that the logs were floated first, and then the building material was made of them.

Fig. 5. Kamień Pomorski, cathedral, roof truss over the nave, building material with traces of float in the form of round holes with the remains of wedges and withes (elaborated by U. Schaaf, M. Prarat)

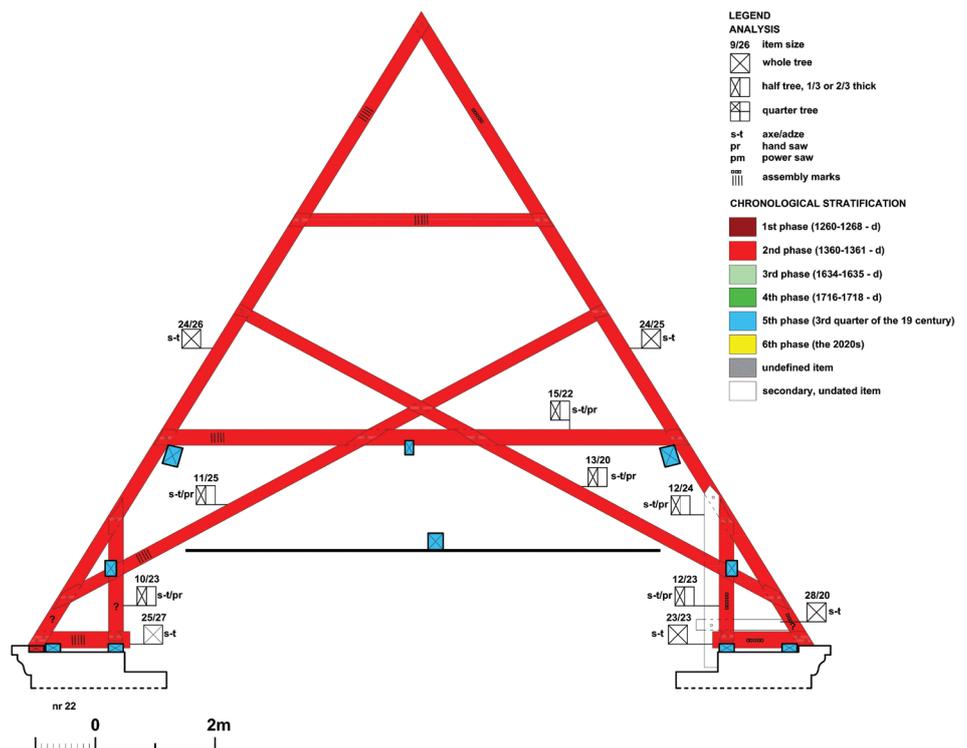
In truss 22 (Fig. 6) on the southern side, the down brace zone was re-strengthened by introducing an additional sole piece placed on the primary sole piece and an additional down brace adjacent to the primary brace. These elements are connected with each other and with the original structure using pegged lap joints of various shapes. These are traditionally processed with an axe, adze, and handsaw in the case of a brace, but have no carpentry assembly marks.

Fig. 6. Kamień Pomorski, cathedral, roof structure above the nave, paired common rafter, no. 22, analysis and stratification (elaborated by U. Schaaf, M. Prarat)

The architectural research has shown that in truss 22, an additional sole piece and an additional down brace were built into the northern side. These elements have not yet been dated.

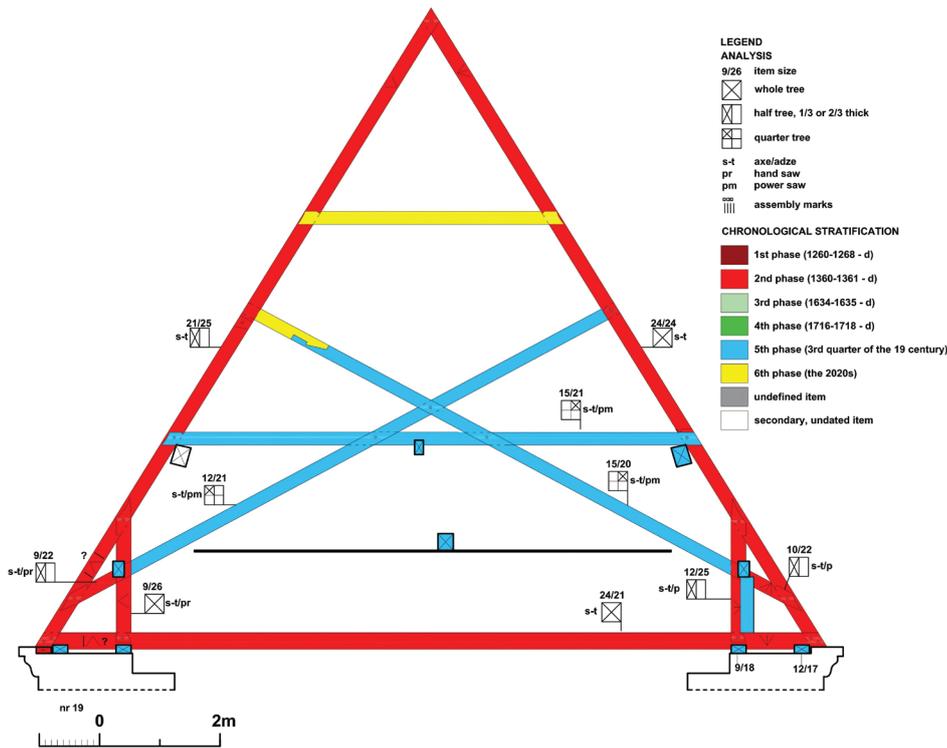
Fig. 7. Kamień Pomorski, cathedral, roof structure above the nave, paired common rafter, no. 19, analysis and stratification (elaborated by U. Schaaf, M. Prarat)

The secondary origin of the lower collar beam and intersecting passing braces (except for their lower ends) in truss 19 (Fig. 7) is evidenced, inter alia, by their treatment with a power saw on two sides, the lack of carpentry assembly marks on them and straight lap joints as carpentry joints. The passing braces were also connected to the rafters not from the timber framing side, but from the rear

In one of the passing braces in truss 19 (cf. Fig. 7) the upper end was replaced, as evidenced by its processing with a modern power saw on all sides and a scarf joint, which connects both parts of the brace. The same treatment is applied to the upper collar in truss 19, the lower part of the northern rafter and one of the intersecting passing braces in truss 20. Among other things, this treatment and the lack of assembly marks and signs of weathering make it possible to combine the assembly of these elements with the repair that has been ongoing since the end of the last decade.

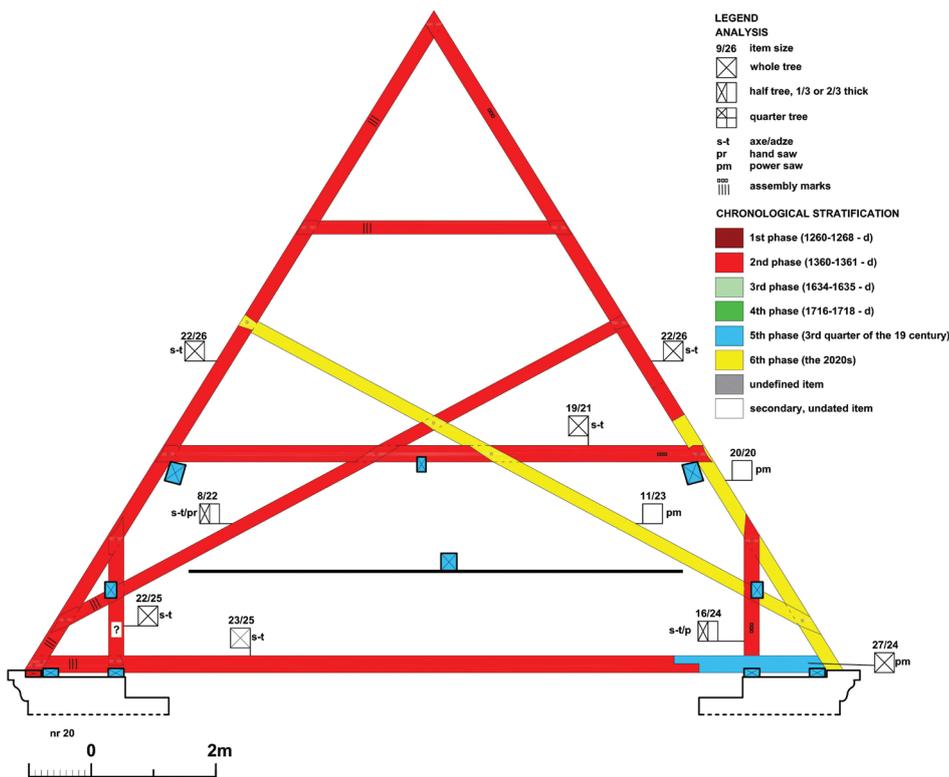
Fig. 8. Kamień Pomorski, cathedral, roof structure above the aisle, paired common rafter, no. 20, analysis and stratification (elaborated by U. Schaaf, M. Prarat)

side. The tie beam in truss 20 (Fig. 8) consists of two parts connected to each other by a straight lap joint, secured with a screw vertically, and iron flat bars attached to the side and also connected with screws. The short part on the north side was machined with a power saw, which allows its classification as secondary. In many fragments, the wall plates are also of a secondary nature. This is evi-

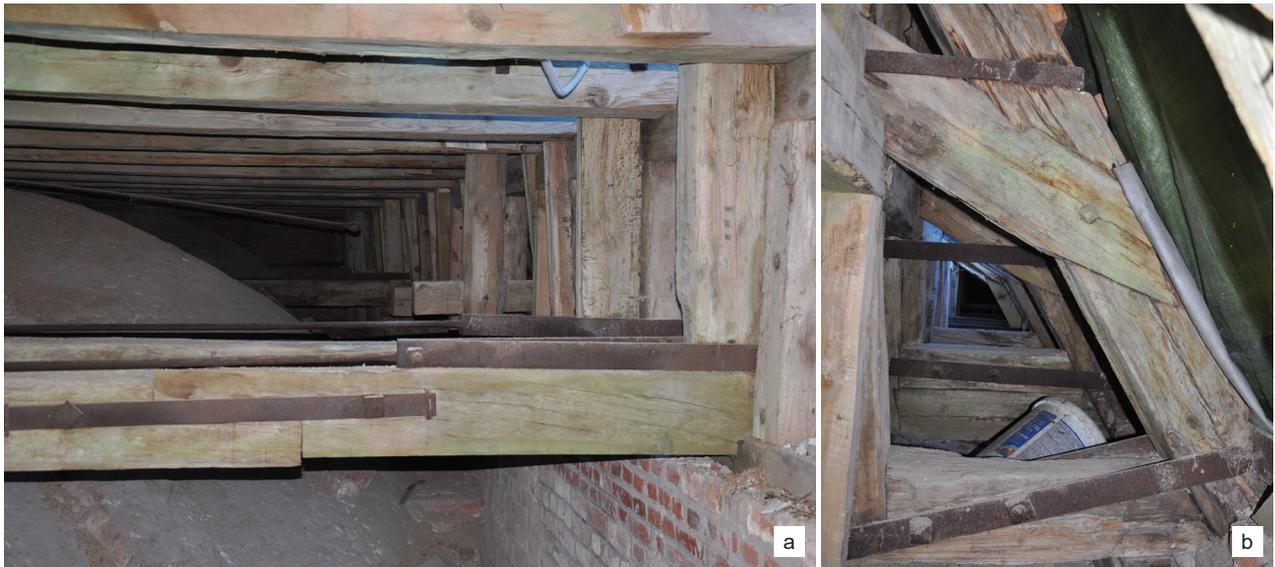
Fig. 9. Kamień Pomorski, cathedral, roof structure above the nave:  
 a) reinforcement of the connection of two parts of the tie beam (principal rafter truss 20) with a flat bar, securing the principal rafter trusses with tensile-resistant anchors (19–20) above the principal rafter truss beam,  
 b) connecting the sole piece with the rafter using two flat bars, joining the (secondary) upper plate with the passing brace and rafter using a flat bar (photo by U. Schaaf, M. Prarat)

The period of repair should also be related to the introduction of iron elements both to protect the cross-braced collar beam roof structure against parting and to strengthen its wooden connections. This is indicated by the use of identical iron elements and the method of their fastening as in the case of entablature, the queen and king post structure.

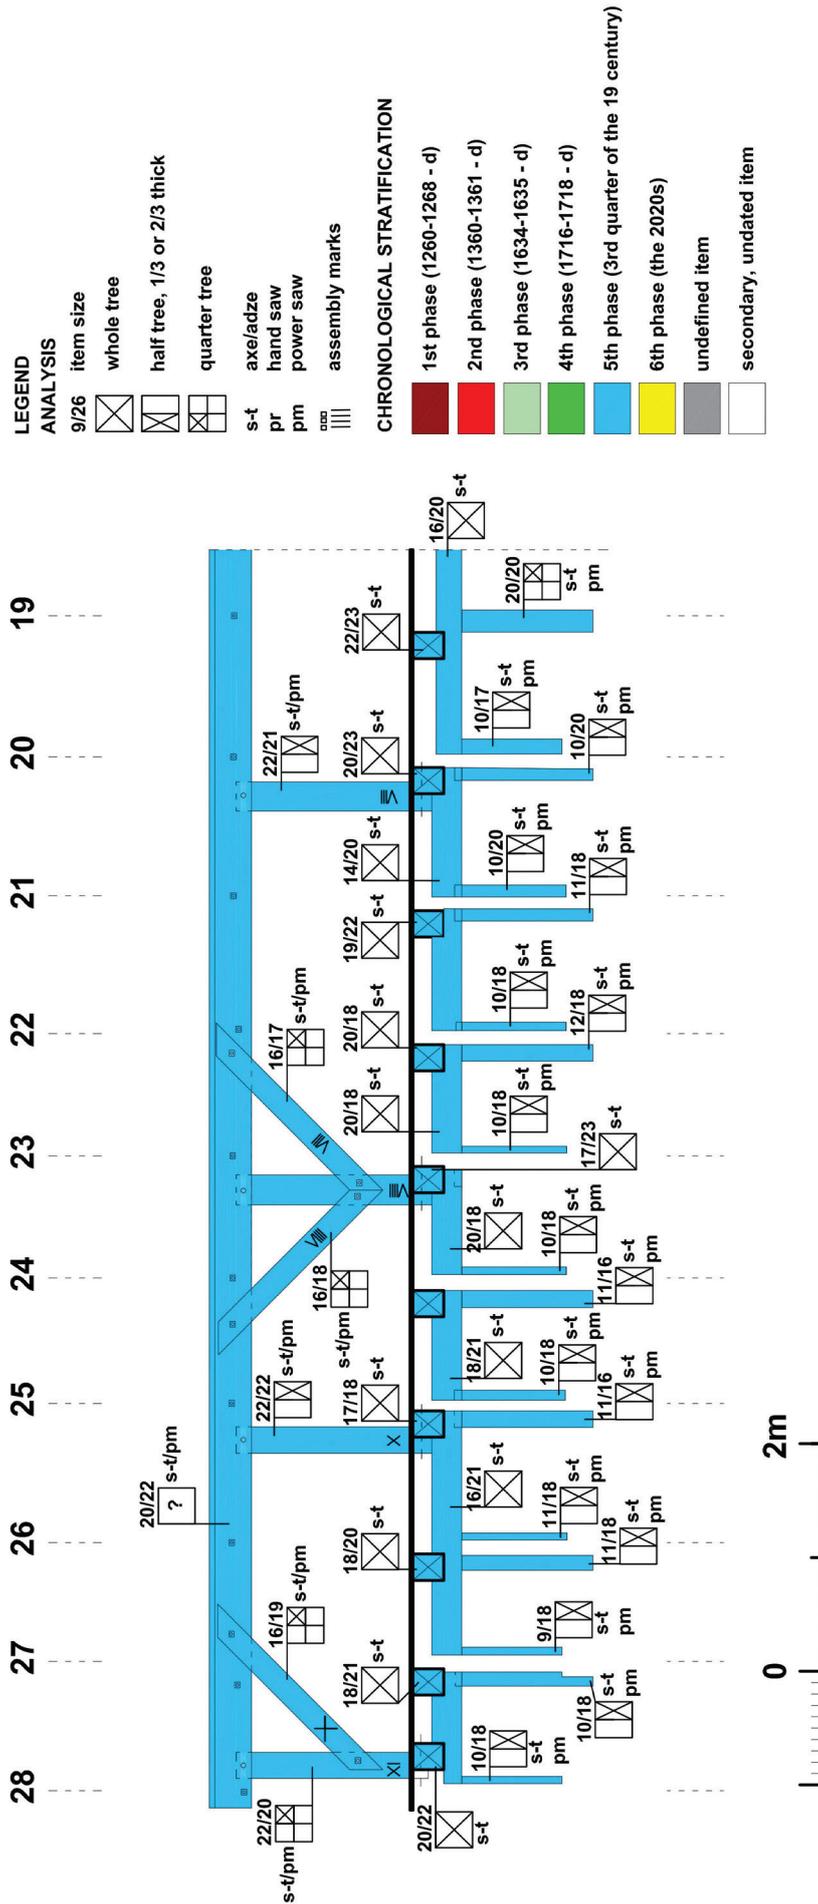
Secondary *frames of the inclined queen post structure* stand on the entablature and support the lower collars of the original roof structure at the connection to the rafters. Each frame consists of posts, oblique, but not parallel to the rafters, an upper plate, and up braces, which stiffen the frame in the longitudinal direction at every other post. The roof strengthening is devoid of a straining beam in the transverse direction, and therefore, the upper plates and the primary rafters were fastened with screws with square heads and nuts. The posts are joined at the lower end with beams using a straight lap joint without a mortise, and at the upper end with wall plates using pegged tenon joints. The straight lap joint was also used to connect the braces with the posts and upper plates. The lap joint on both ends

Fig. 10. Kamień Pomorski, cathedral, roof structure above the nave, eastern part, secondary entablature with a frame of the inclined queen post structure, analysis and stratification (elaborated by U. Schaaf, M. Prarat)

of the brace goes into the mortise, but is not in one plane with the posts or the upper plate. Each time it is only secured with a screw. Also, in the case of frames with an inclined queen post structure, auxiliary lines were drawn with a pencil for making the joints. The studs and upper plate were made of building materials with a cross-section of about 20/22 cm. They were treated on one or both sides with an axe and an adze, and on the other sides with a power saw. The entire southern frame of the queen post structure is marked from west to east with carpentry assembly marks in the form of Roman numerals. The posts within the examined eastern fragment have marks from VII to XI, while the braces from VII to X. This means that the posts and braces were counted separately. The northern frame of the queen post structure is marked essentially in the same way. Marking was made first with a pencil using Arabic numerals, and then with a chisel using Roman numerals. This marking is a logical continuation of the system of assembly marks used in the western parts of the roof structure and proves the homogeneous nature of both secondary roof strengthening frames.

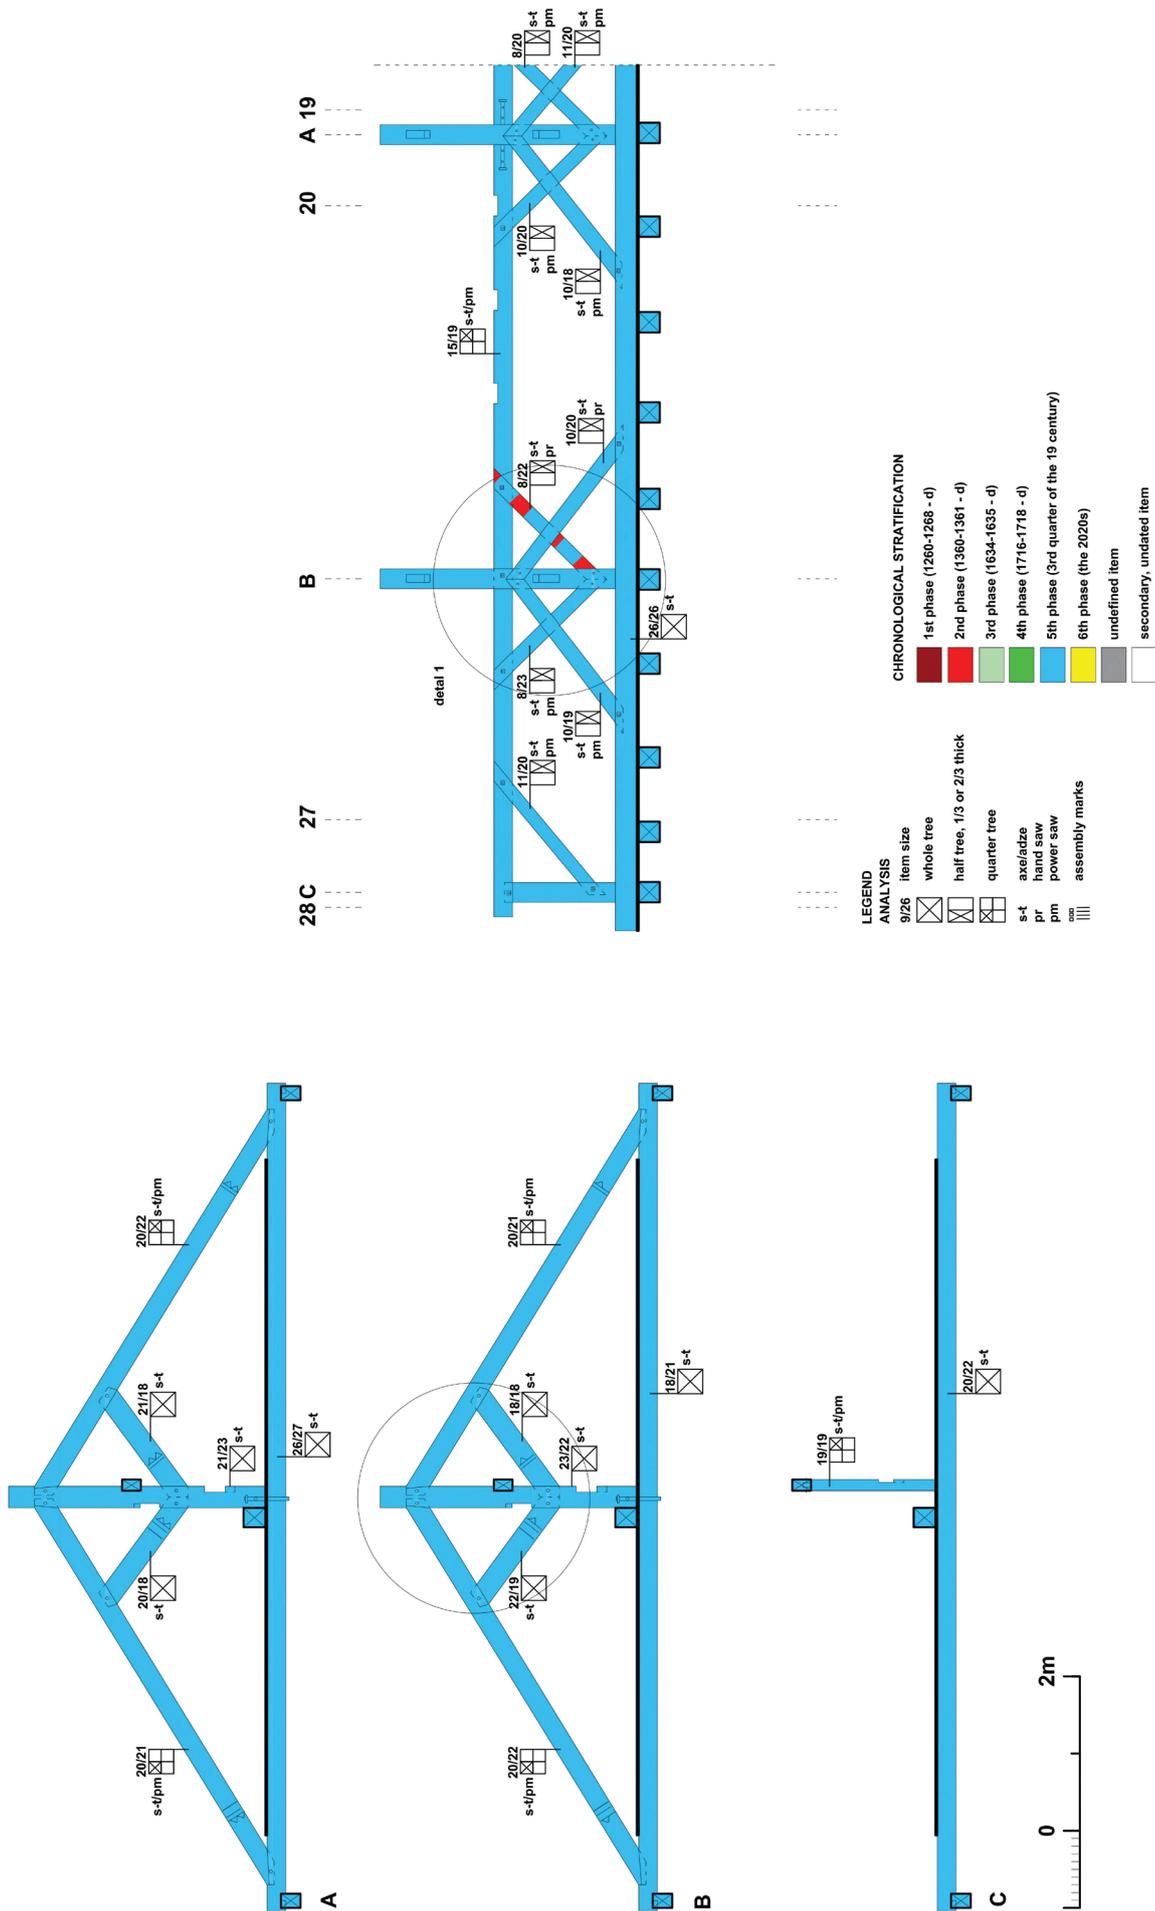
The secondary *king post structure* (Fig. 11) consists of three trusses and a longitudinal frame. Two full trusses (A-B) each consist of a king post and two long braces supporting it, a tie beam acting as a tension tie and two short braces connecting the king post with long braces. The third truss (C) is not a king-post truss, as it consists of only a tie beam and a stud standing on it. The longitudinal frame consists of king posts, an upstand binder from which an entablature is suspended above the vault, a spandrel beam, and stiffening braces. The upstand binder is situated next to the king post on the northern side. The spandrel beam on the southern side enters only 2–4 cm into the mortise made in the king post. In trusses A and B, the long braces connect to the beam and the king post by a pegged tenon with a notch. A pegged tenon joint was used to connect the braces with the king post. The beams were suspended from the king post by means of a flat bar (stirrup) fastened with screws. Moreover, this flat bar is bent at both ends and additionally fastened with small cramps. The same straight lap joints are used in the longitudinal frame as in the case of the queen post structure. They are secured with either screws or nails. The individual parts of the spandrel beams are connected to each other by a scarf joint. This connection was additionally reinforced with a nailed flat bar, and with bent ends secured with small cramps. The auxiliary lines needed to make the joints were made with a pencil. The system of carpentry assembly marks basically consists in marking structural elements in the trusses from east to west with triangular marks adjacent to thin lines – one triangle in truss B, two triangles in truss A. Both sides of the symmetry axis are additionally distinguished by line marks – one on the southern side, two on the northern side. This system of marking the king post structure is continued further on the west side and proves the simultaneous introduction of this structure in the entire roof structure above the nave. In the trusses, king and queen posts (only king posts) (about 23 × 22 cm) and braces (about 21 × 19 cm) were made from the whole tree processed with an axe and an adze, and passing braces (about 20 × 22 cm) were made of a quarter tree,

Fig. 11. Kamień Pomorski, cathedral, roof structure above the nave, eastern part, secondary entablature with a king post structure, analysis and stratification (elaborated by U. Schaaf, M. Prarat)

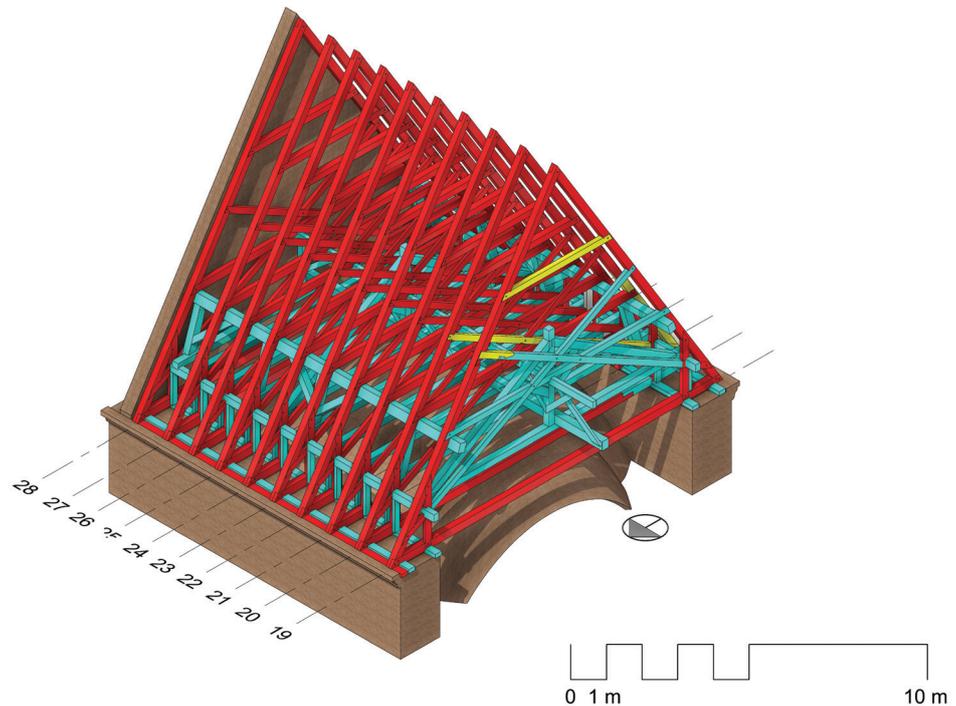
As a result of the analysis of the existing material substance, literature review, and dendrochronological research, it was possible to distinguish three construction phases: the period of construction of the roof structure and the period of two repairs, as described below. Not all items could be dated; they are listed at the end of the stratification (Fig. 12).

Fig. 12. Kamień Pomorski, cathedral, roof structure above the nave, trusses 19–28, stratification (elaborated by U. Schaaf, M. Prarat, drawing by M. Kumorowicz-Brzeska)

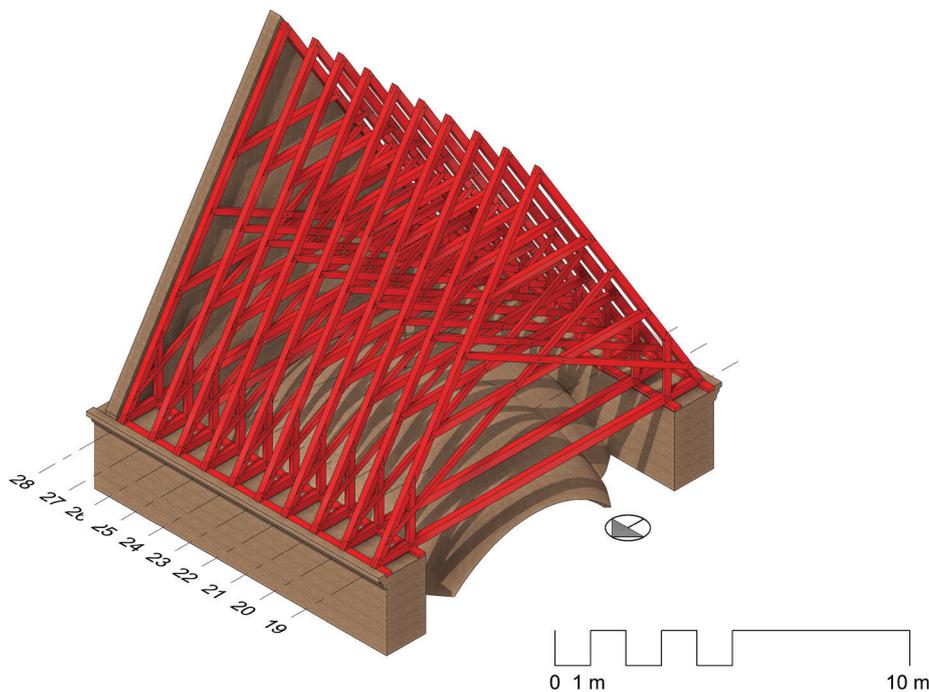
The architectural research has made it possible to reconstruct the original roof structure over the nave of the cathedral in Kamień (Fig. 13). The reconstruction shows

Fig. 13. Kamień Pomorski, cathedral, roof truss of the nave, trusses 19–28, reconstruction of the original cross-braced collar beam
