Beata Piaskowska*, Maciej Prarat, Artur Róžański***,
Tomasz Olszacki****, Ulrich Schaaf*******

The ruins of the castle in Koło in the light of the latest architectural and archaeological research, and their conservation issues

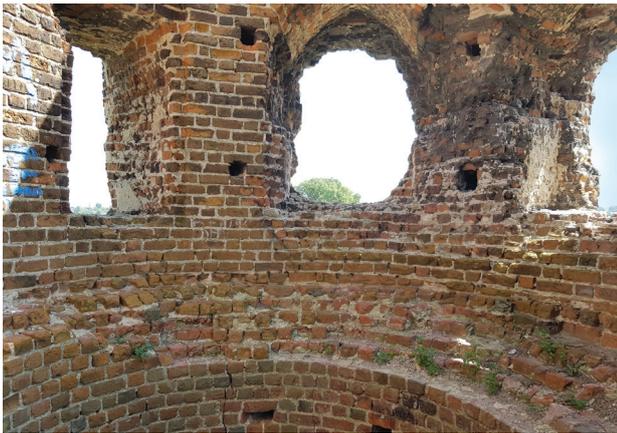
Fig. 2. Koło, ruins of the castle.
The interior of the upper level of the tower
(photo by M. Prarat, 2020)

provide additional lighting. In the middle, about 15 layers below these openings, the walls of the tower narrow down (Fig. 2). In the northern part, in the thickness of the wall, there are stairs leading to the highest level. The southern wall has been preserved to a height of just over 1 m above ground level, mostly without a face. At a distance of about 8.8 m from the tower, there are relics of two walls of the gatehouse. The castle was built entirely of brick on a high stone foundation. The crown of the wall was secured with a varied number of layers of contemporary bricks with a liquid ceramic “cap” on top.

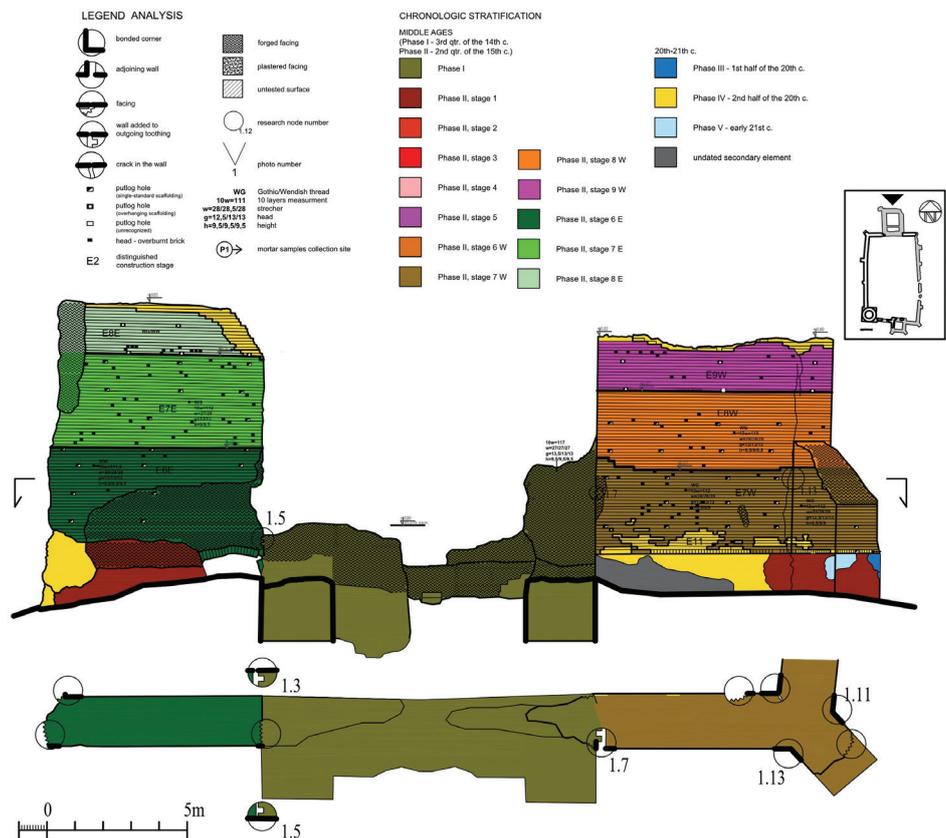
Undoubtedly, the oldest structure of the castle are the relics of the residential tower in the northern part (Fig. 3) [2], [3]. It was founded on a rectangular plan with external dimensions of 12.10 × 15.47 m (187.2 m²). Therefore, it was larger than it was presented in the existing literature on the subject. The main walls of the building were on average about 2.55 m thick in the above-ground part (southern wall: 2.50 m, northern and eastern walls: 2.56 m, western wall: 2.60 m), the interior of the tower was originally planned as a partition wall with a thickness of 0.68 m in the ground section (it was implemented after the outline of the outer walls was erected). It separated two rooms on the lowest floor: the southern one (room A with dimensions of 2.30 × 6.80 m) and the northern one (room B with dimensions of 6.80 × 7.20 m). The building structure of the foundations was quite complex and the same for all the walls of the tower, with minor differences in the height of individual zones (an exception was observed only for the eastern and western faces of the main wall within room A). The construction process began with a layer of “flexible” foundation, made of sand erratic stones arranged in a narrow, tight excavation. Further – also in the excavation, yet widened – there were erratics supplemented with fragments of bricks. In the upper part, wooden framework was used, in which a wall with a face made of erratic stones and rather rarely used sandstone blocks was laid. Above the framework, there were applied sandstone blocks arranged in regular layers

Fig. 3. Kolo, ruins of the castle.
Northern façade.
Results of architectural research
(elaborated by M. Prarat,
U. Schaaf)

At one of the stages, the north-eastern wall (E6E) was also connected to the residential tower (Fig. 3, research nodes no. 1.3, 1.5). In the lower part, the stone foundation was lowered at the tower due to the relieving arch installed there (below the first arch there is another one, which was shown during earlier archaeological research). In order to support it on the existing structure of the stone residential tower, it had to be slightly chiseled. Perhaps the space between the arches was used to drain water from the courtyard (Fig. 9). Further on, the wall was built up (E7E) and provided with a breastwork (E8E), yet higher than the western wall, i.e. 1.5 m. At that time, the perimeter of the castle was closed.

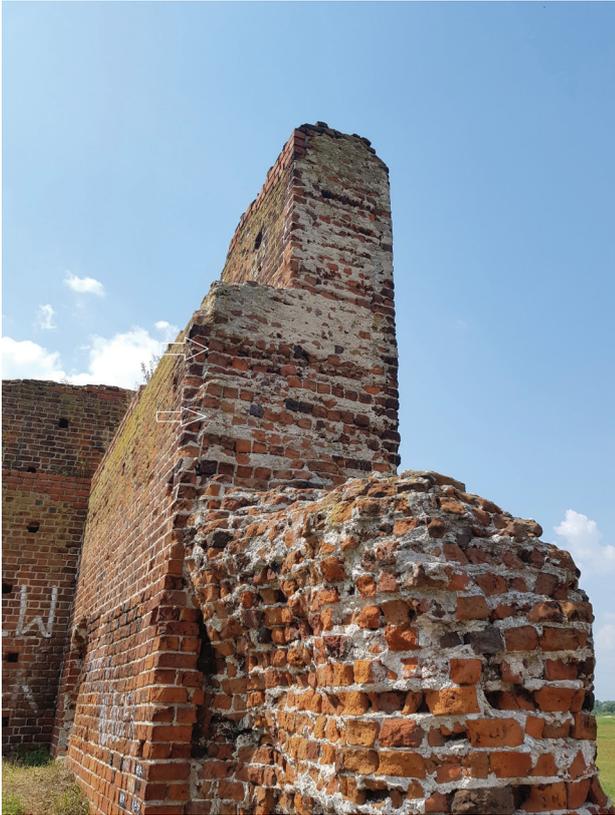
In both corners, south-east and west one, at the time of construction, outgoing toothing was made, to which the perimeter walls were to be attached. In the case of eastern toothing, the wall was bonded to its planned width, i.e. 1.8 m (Fig. 3, research node 1.5). In the case of the western toothing, the bonded wall turned out to be slightly wider (2.10 m). Hence, at least from the northern side, it slightly overlapped the toothing (Fig. 3, research node no. 1.7). The size of the bricks used in the construction of the tower is similar to the size in the newer parts of phase II. The greatest difference is visible in the joint, slightly darker and undercut on one side vertically and horizontally. The negative imprinted on the wall in the preserved western curtain, which was later added to it, determines the height of this volume at least equal to the preserved section or even much greater (Fig. 4).

Fig. 4. Koło, ruins of the castle. Northern façade.
View of the western wall with the imprint
of the residential tower (photo by M. Prarat, 2020)

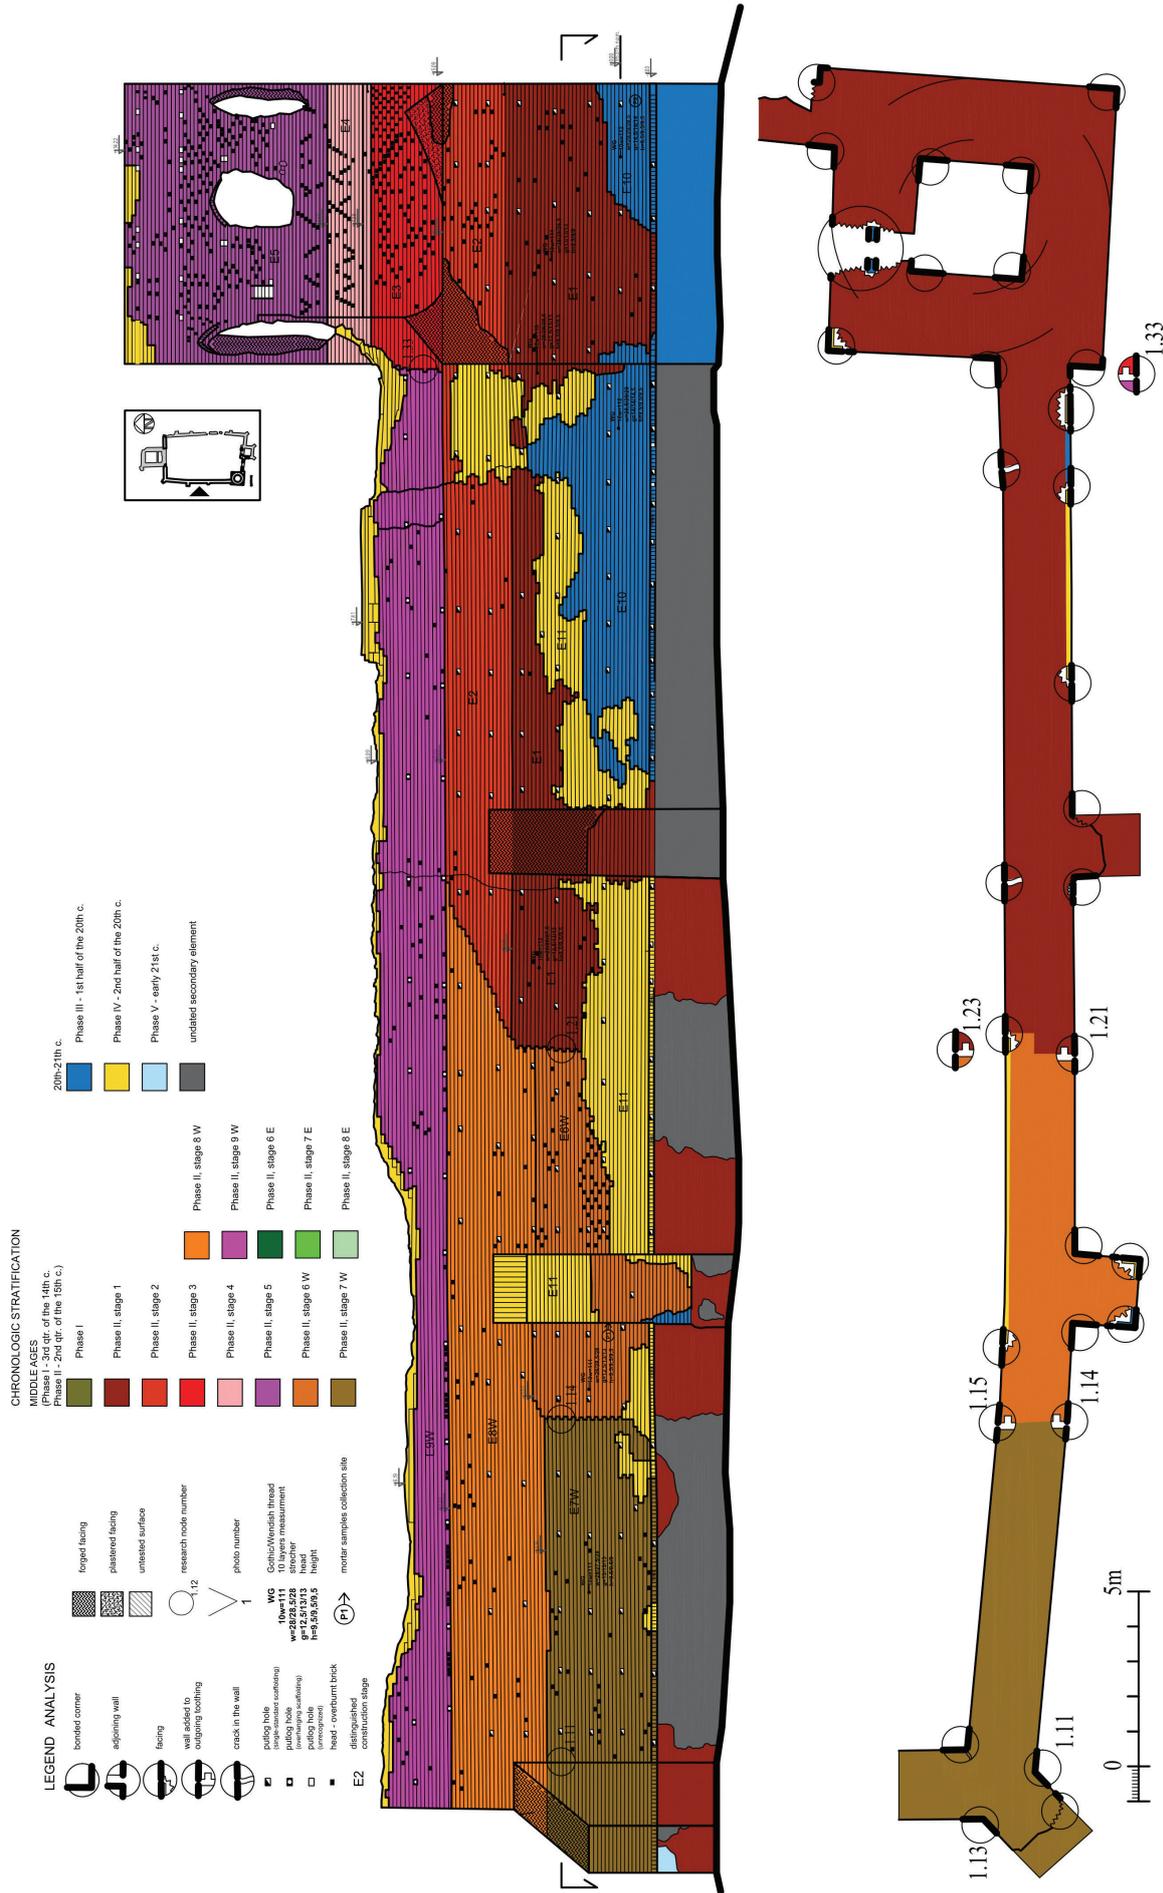
Fig. 5. Kolo, ruins of the castle. Western elevation, view from the outside. Results of architectural research (elaborated by M. Prarat, U. Schaaf)
 Il. 5. Kolo, ruiny zamku. Elewacja zachodnia, widok od strony zewnętrznej. Wyniki badań architektonicznych (oprac. M. Prarat, U. Schaaf)

As for the analysis of the western curtain, after the construction of the tower, the middle lower fragment with the northern buttress was constructed by bonding it to the southern toothing and remaining toothing from the north (E6W) (Fig. 5, research nodes no. 1.14, 1.15). The last stage

of closing the lower part of the curtain was to research node the fragment with the corner (E7W) to the southern tothing and to the western wall of the residential tower (Fig. 5, research node no. 1.14, 1.15; Fig. 3, research node no. 1.7). A diagonal buttress was built together with the corner (Fig. 5, research nodes no. 1.11, 1.13). Only after closing the lower perimeter was a wall built along the entire length from the stepped part of E2 to the residential tower (Fig. 5, research node no. 1.33). Whether there was a wooden battlement between the building of a slightly narrower strip of breastwork (E9W) along the entire length of the western and north-western curtains is not known. There are no traces of such construction. There is no doubt, however, that when the tower was constructed in the earlier stages, this elevation was already taken into account.

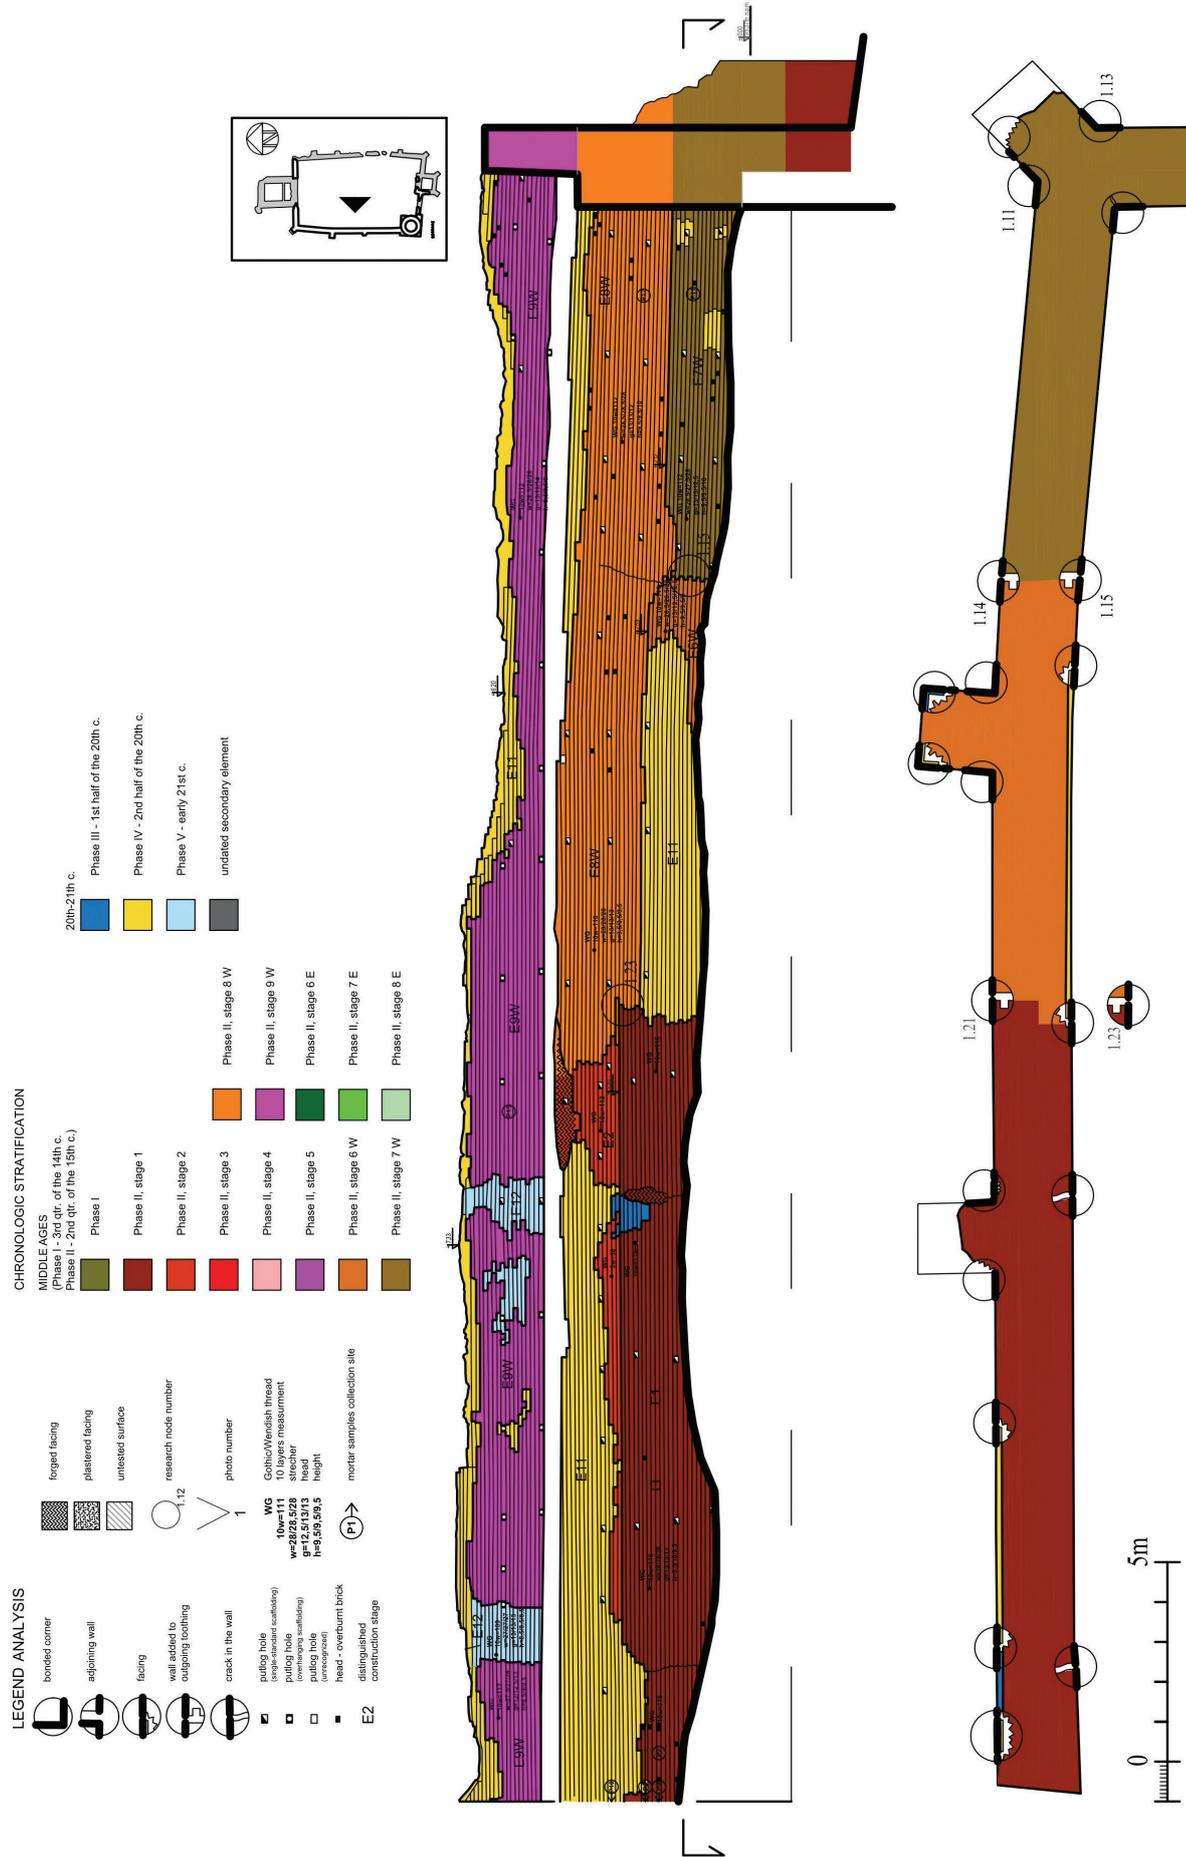
Fig. 6. Kolo, ruins of the castle. Western elevation, view from the courtyard. Results of architectural research (elaborated by M. Prarat, U. Schaaf)
 II. 6. Kolo, ruiny zamku. Elewacja zachodnia, widok od strony dziedzińca. Wyniki badań architektonicznych (oprac. M. Prarat, U. Schaaf)
