The issue of structural failures at St Elizabeth's Church in Wrocław in the light of architectural surveys

Abstract

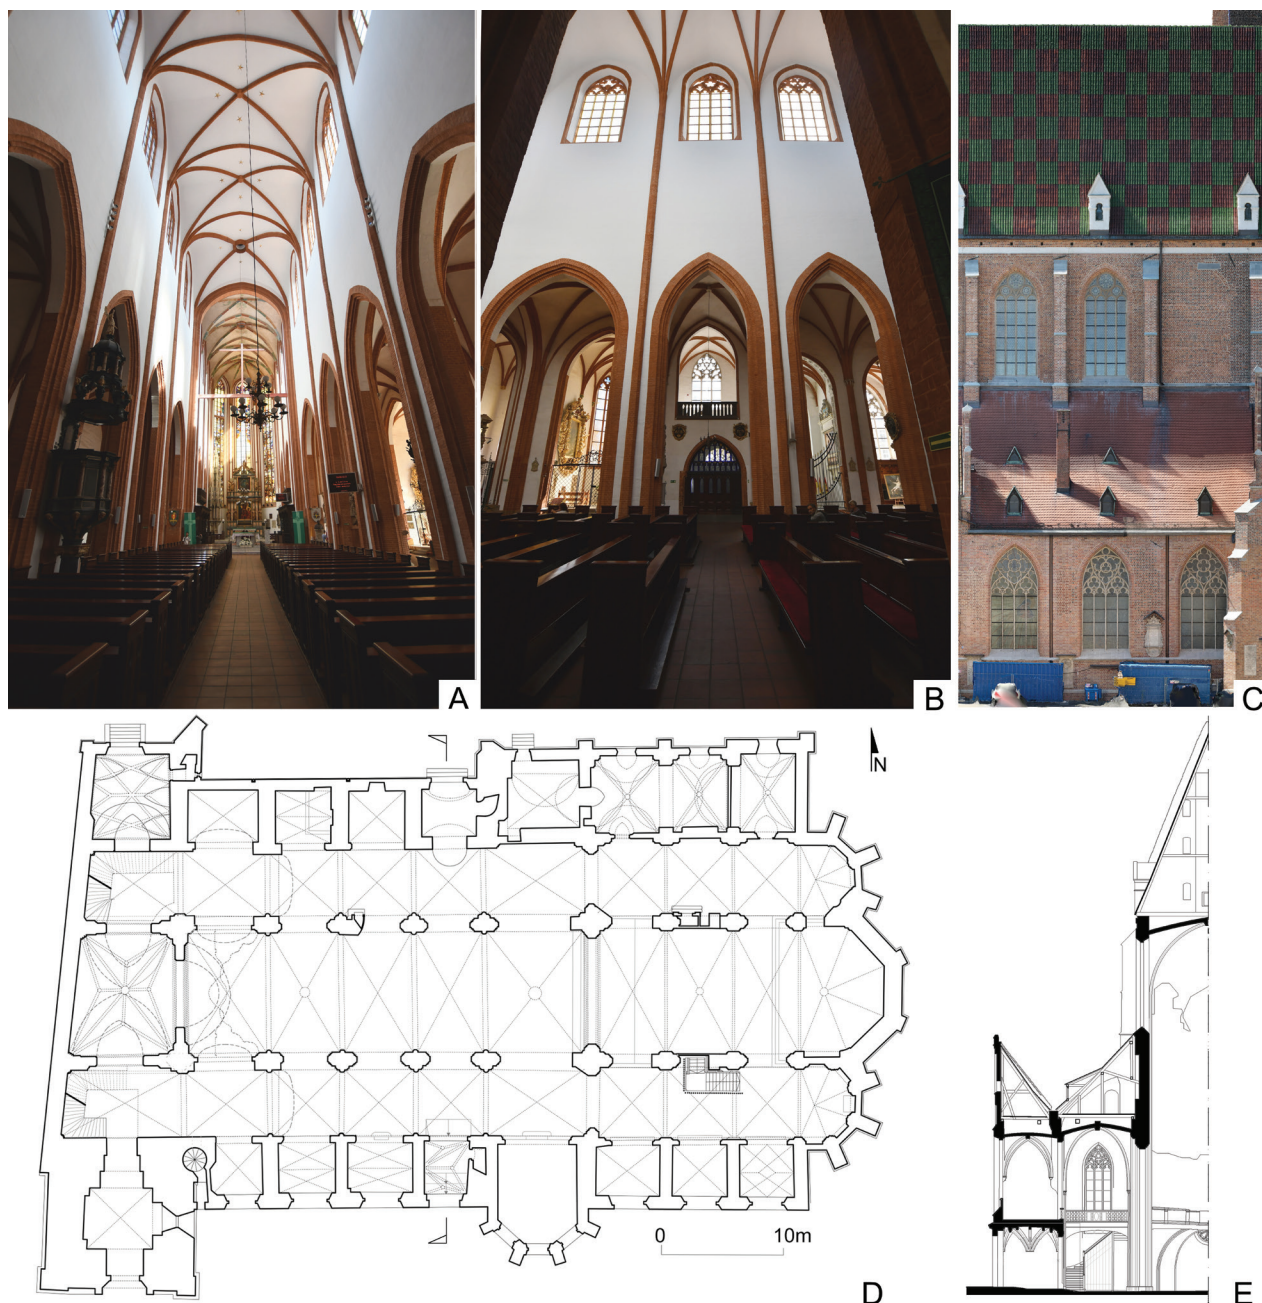
the nave are deviated from the vertical (at the height of the vault support in bay 3 by approx. 14 cm), which indicates a certain imperfection in the structure.

Fig. 1. St Elizabeth's Church in Wrocław: A – view of the interior of the main nave towards the east, B – fifth bay from the west of the nave, arcade (south), C – second, third, and fourth bays from the west in the north elevation (orthophotograph generated from a photogrammetric model), D – plan, E – cross-section through the fifth bay from the west (photo and elaborated by F. Hackemer)

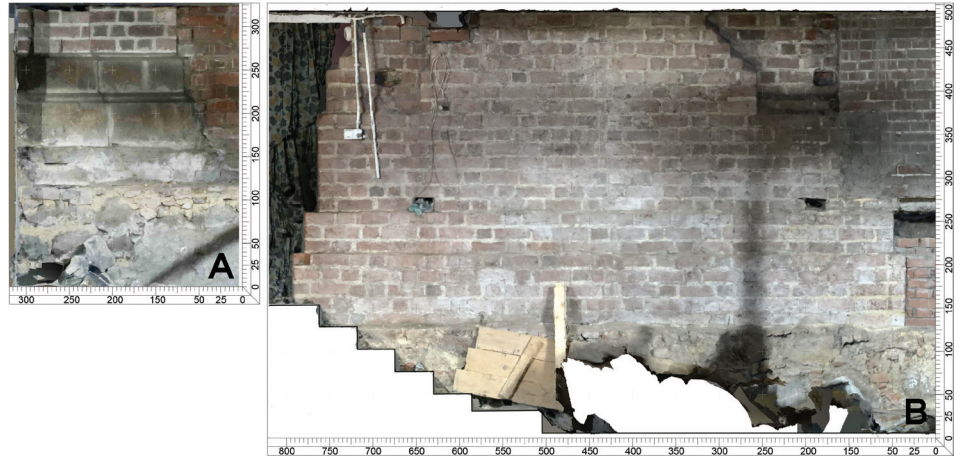
The foundations of St Elizabeth's church are partially visible in the church crypt (Fig 3). These include the foundations of the fifth pillar from the west on the north side of the nave and large sections of the strip and isolated footings supporting the arcades of the chancel. The foundations of the nave differ significantly from those of the chancel. They were created by filling a narrow excavation with erratic stones mixed with ceramic debris and light, yellowish lime mortar (Fig. 3A). The lower parts of the chancel foundation were also constructed in this way. However, brick isolated footings for the pillars were erected on the strip created in this way (Fig. 3B). They are made of bricks measuring 25.5–27 × 11–13 × 8–9 cm in a flemish bond. It is therefore clear that the design of the church's foundation was changed during construction. It is worth noting here that at the same time, a decision was made to raise the usable level of the chancel by about 1.3 m above that designated for the nave. The nave originally had a floor level of approximately 118.80 m above sea level, while the chancel was 120.10 m above sea level. The isolated footings of its pillars were covered with a thick layer of sand (Lasota, Piekalski 1996, 17, 18).

Fig. 3. Foundations of the pillars of St Elizabeth's Church in Wrocław: A – nave, B – chancel (orthophotos generated on the basis of a photogrammetric model; elaborated by F. Hackemer)

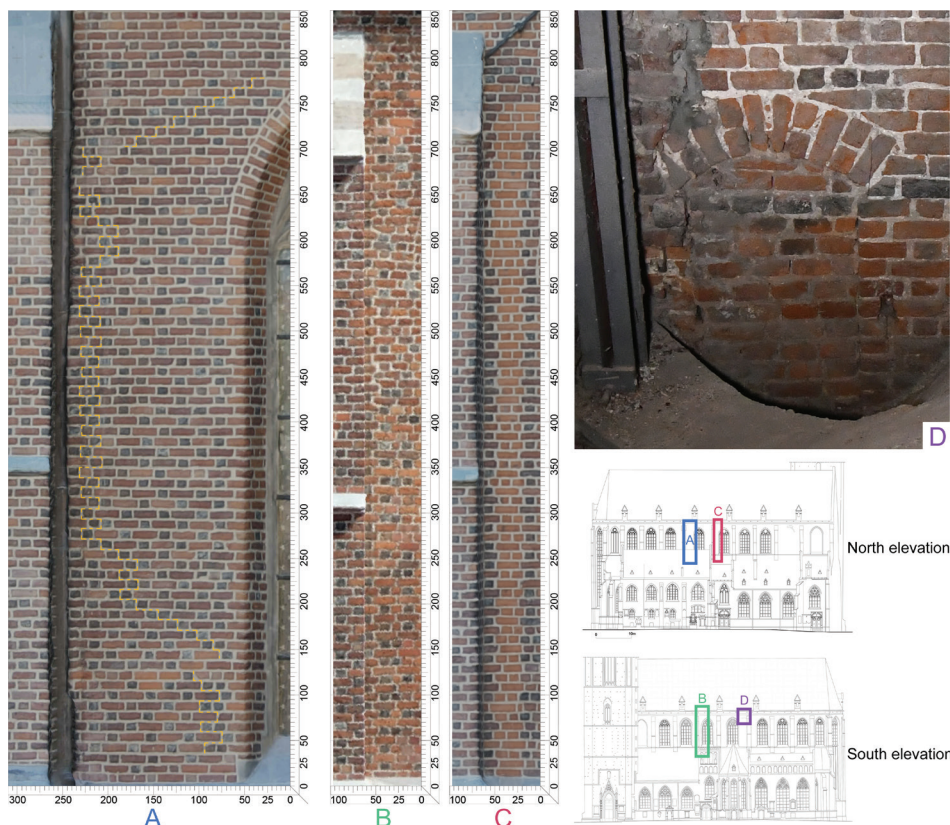
The first structural failure that left traces occurred most likely during the construction of the church. This is evidenced primarily by the junctions of the walls in the fifth and sixth bays from the west. On the south wall of the nave, a secondary filling of a previously existing gap in the wall is visible from the outside. It runs vertically on the right side of the fifth buttress of the nave from the west (Fig. 5). This junction proves that further sections of the wall were added from the east to the existing wall of the fourth bay. This addition reached approximately the line of the chancel arch. This edge is marked primarily by the arch of the former entrance to the staircase, which existed until the 19th century in the sixth bay. It is accessible in the attic of the main nave, above the vaults (Fig. 5). It was built along with the wall in which it is located, but its eastern part rests on a chiselled, previously existing brickwork. This seam is also visible from the outside, above the mentioned arch and the nearby buttress. In the exterior wall of the south nave, in the attic, the seam between the walls can also be seen in the fifth and sixth bays.

On the north side, however, it is more difficult to find signs of the disaster. On the exterior of the main nave wall, in the sixth bay from the west, there is a characteristic trace of double brick headers. At the bottom, it runs from west to east, vertically in the middle, and then returns westward at the height of the window arch (Fig. 5). Double headers occur quite often in the walls of the church. Their sequences can be observed in places where two walls built in different time meet. This is the case, for example, at the bottom of the junction between the tower and the south aisle. The western edge of the addition, which may have existed in the fifth bay, is now difficult to determine. This part of the church was destroyed in a later disaster (1649) and rebuilt, which may have obscured the traces. However, in the eastern part of the fifth bay, a vertical strip of machine-made bricks measuring approximately $27 \times 13 \times 8.5$ cm is visible in the wall, which is the result of conservation treatments in the second

half of the 20th century (Il. 5). Perhaps originally there was a wall seam in this place, which was rebuilt due to its poor condition.

Fig. 5. Visible seams of the walls of the nave in bays five and six on orthophotos from the photogrammetric model:

A – north wall, bay 6,
B – south wall, bay 6,
C – north wall, bay 5,
D – arch of the former staircase opening in the south wall of the nave (from the interior, main nave attic)
(elaborated by F. Hackemer)

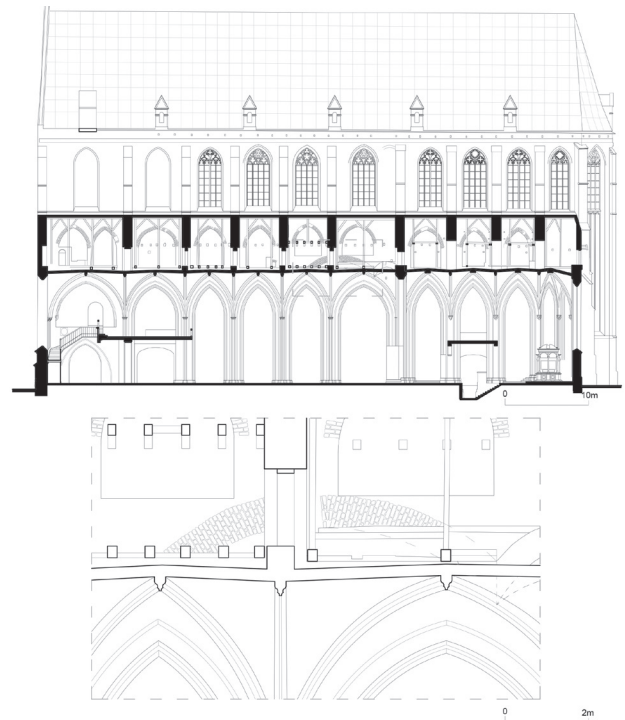
wall above the arcades. It was stretched between the fourth and sixth pillars from the west (Fig. 6). It is clearly visible in the attic of the south nave. It was built simultaneously with the wall in which it is embedded, as evidenced by the lack of traces of chiselling. This can only be explained by the assumption that at the time of its construction, both pillars that it connects already existed.

The cause of the disaster can be attributed to the poor foundation of the pillars. This is evidenced primarily by the arch in the southern wall of the main nave, which relieves the load on the pillar below it. The builders must have been aware that the collapse of two bays of the nave was caused

Fig. 6. The structural arch in the southern arcade wall on the cross-section through the south nave and a detail of the arch (elaborated by F. Hackemer)

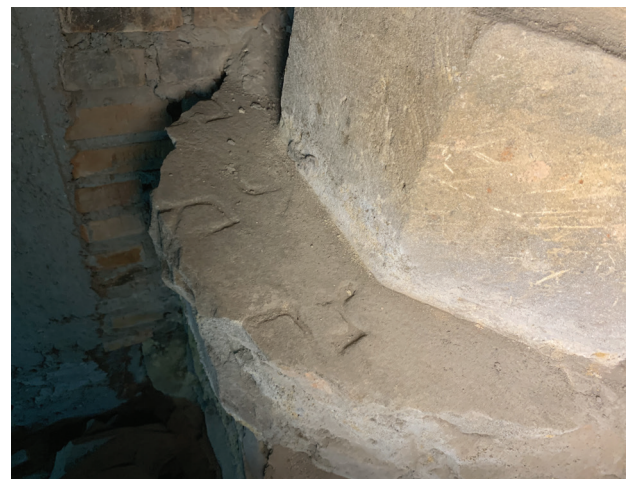
The matzeva used as a floor slab under the base of the fifth pillar from the west on the north (Figs. 3, 7) is of particular interest. It is worth mentioning the year 1345, when John of Bohemia abolished the 30-year-old inviolability of the Jewish cemetery, allowing the use of tombstones in the construction of the city's fortifications. These slabs appeared in many buildings in Wrocław from that period (Wodziński 1996, 197, 198). The matzeva under the pillar of the nave could date from after 1345. This cannot be known for certain, but it seems very likely. It is difficult to imagine that after the collapse of two bays of the nave, the pillar was demolished down to the floor slab and then rebuilt without strengthening the foundations. It can rather be assumed that the lower parts of these supports were built around 1345. The disaster must therefore have occurred later. It should also be remembered that at the time of the collapse of the nave bays, the chancel had already been raised at least to the level of the window sills.

Fig. 7. Fraction of a matzeva used as a floor slab under the fifth pillar from the west in the north aisle (elaborated by F. Hackemer)
