Marek Konopka*

About the quality of the Prudnik and Gogolin railway landscape

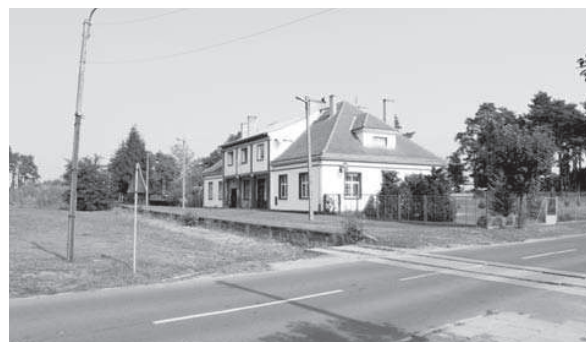
Fig. 1. Krapkowice Otmęt passenger stop. In the foreground the hole after a removed track. The railway station building has been completely transformed into living quarters and is preserved in good condition. It is one of the few modernist stations in the Opole region (photo: M. Konopka, 2009)

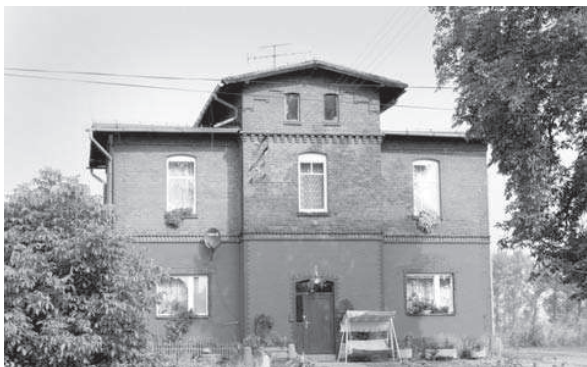
Fig. 2. Lubrza station. The building has been transformed into living quarters. Windows on the ground floor have been rebuilt and all the frames have been ineptly exchanged. The ground floor elevation has been painted (photo: M. Konopka, 2009)

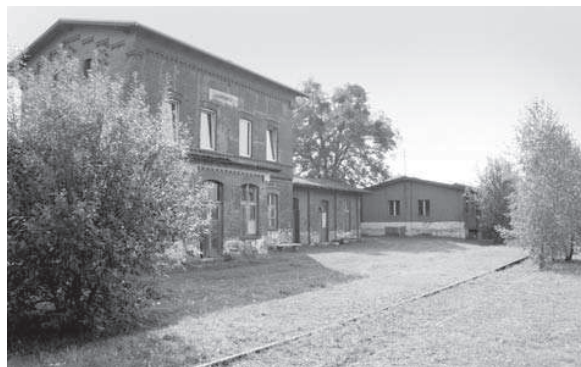
Fig. 3. Krapkowice station. The building is inhabited on the first floor. The ground floor has been unused since 1990. The building is squalid. New and ill-selected window frames in the flat are explicit (photo: M. Konopka, 2009)

to serve as a passenger service department, is still closed (Fig. 3). The residents of this building – without permission but in good faith – occupied a fragment of the station railway tracks and are trying to keep it in order. This view is complemented by two big signal boxes flanking the station entrances in Krapkowice, which are left alone and ruined. People could cross the River Oder through a huge steel bridge from which the track was removed. It still exists because it has a footbridge which significantly facilitates transport between Otmęt and Krapkowice (Fig. 4, 5). The stations in Zielina, Łowkowice, Moszna and Krobusz were treated very drastically (Fig. 6), where all the buildings were pulled down. The rest of the structures, which are connected with this railway line are not used and ruined. We can mention here the railway stations in Biała (Fig. 7), Łącznik (Fig. 8), Strzelczki (Fig. 9) as well as the nearby warehouse and utility buildings. At the station in Biała there is also a water-tower. The route between the stations is treated differently. On the way from Prudnik to Krapkowice all railway crossings are preserved and new crossings were built along the by-passes of Prudnik and Biała. Completely different actions were taken on the way from Krapkowice to Gogolin. After the railway track had been destroyed, the embankment was crossed with several roads, including a highway, and there were no pos-

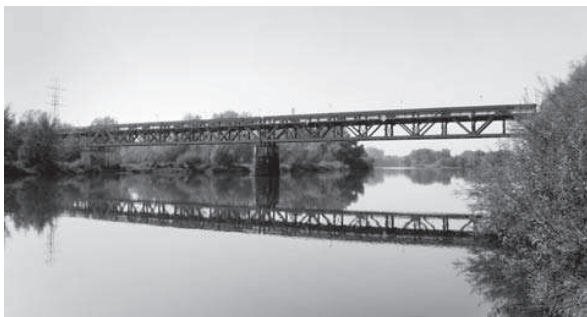
This track functioned in such a form till the 1980s. Progressing regression of the railway in Poland did not omit it either. In the 1990s passenger and then goods traffic was withdrawn gradually [4]. The flood of July 1997 made it impossible to cross the Odra River through the bridge and the bridge did not function any longer. Since that time the transport of goods took place only between Prudnik and Krapkowice and it was soon limited to the distance Prudnik – Biała. At the end of the first decade of the 21st century the traffic on this railway line was stopped [1].

Fig. 4. The railway bridge over the Odra between Krapkowice and Otmęt. The western span fell down during the July 1997 flood. It was repaired but the traffic has not been restored (photo: M. Konopka, 2009)

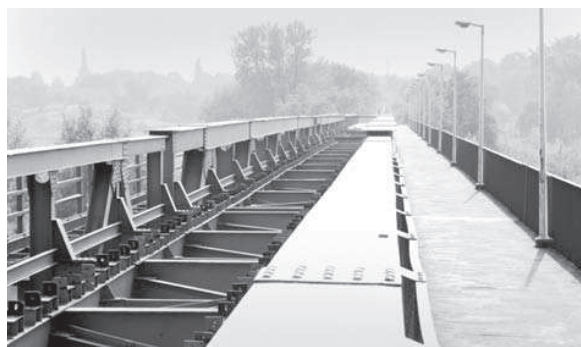
Fig. 5. The pedestrian footbridge on the railway bridge over the Odra between Krapkowice and Otmęt. The track was removed after the July 1997 flood. A pedestrian footbridge has been in operation here since the 1930s. At present the reconstruction of the bridge into a road one is under consideration (photo: M. Konopka, 2009)

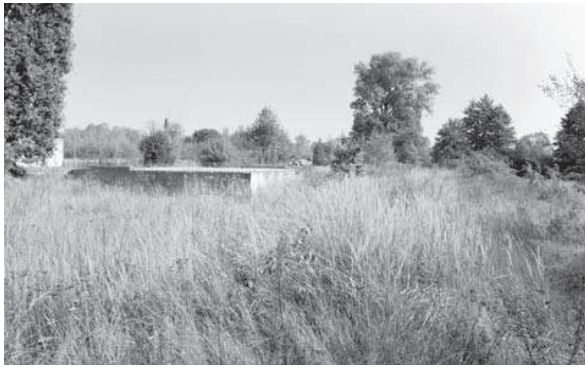
Fig. 6. Zielina station. The station buildings have been torn down. Only fragments of the ramp have remained (photo: M. Konopka, 2009)

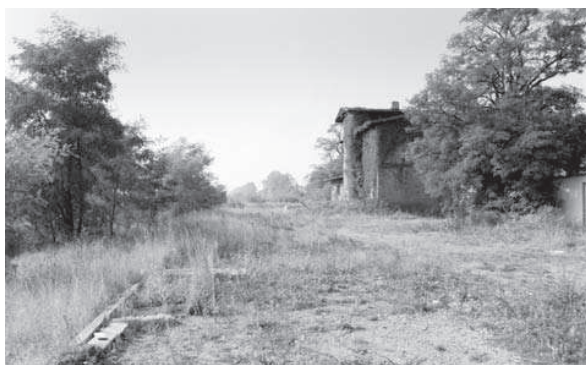
Fig. 8. Łącznik station. Currently the station building is unused. Periodically small wholesale outlets function there (photo: M. Konopka, 2009)

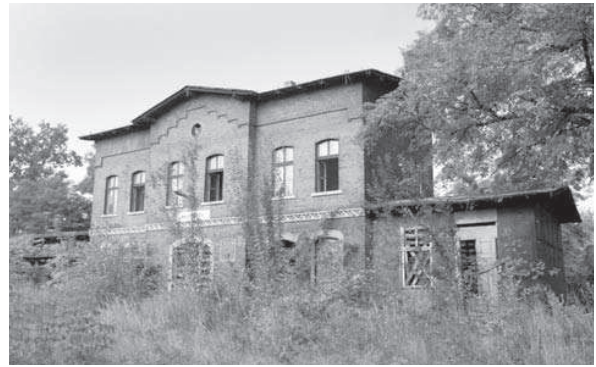
Fig. 7. Biała Prudnicka station. The station is abandoned and squalid. In comparison with other stations on this line it boasts richer brick details (photo: M. Konopka, 2009)

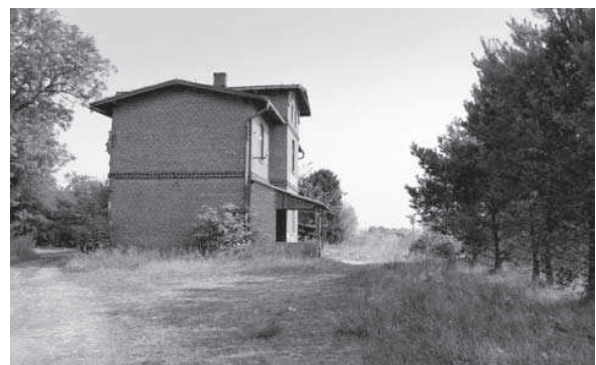
Fig. 9. Strzelczki station. The building is abandoned and unsecured, and the area around squalid (photo: M. Konopka, 2009)

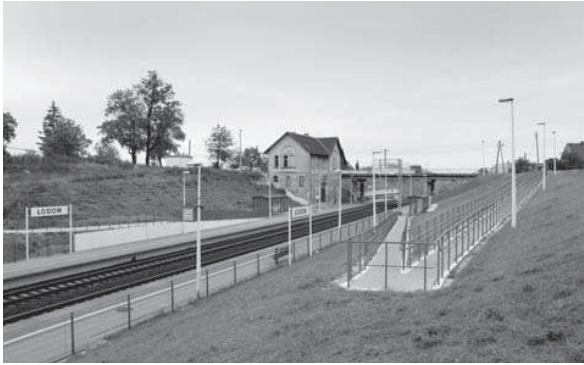
Fig. 10. Łosiów station on the Opole–Wrocław line, rebuilt in 2005–2006 as a passenger stop. Platforms were rebuilt, monumental wheelchair ramps were built, the loading ramp and additional tracks were removed. The building was left unchanged (photo: M. Konopka, 2009)

important during the modernisation. Nevertheless, these objects were adapted to the present needs of the railway transport. Functions of technical buildings were changed (signal boxes – gateman's lodges), buildings of local goods transport service were liquidated (loading platforms, railway sidings, weighing machines), buildings of passenger service department (platforms, shelters, waiting rooms) were renovated and rebuilt. At the same time, accompanying residential and warehouse functions were preserved.

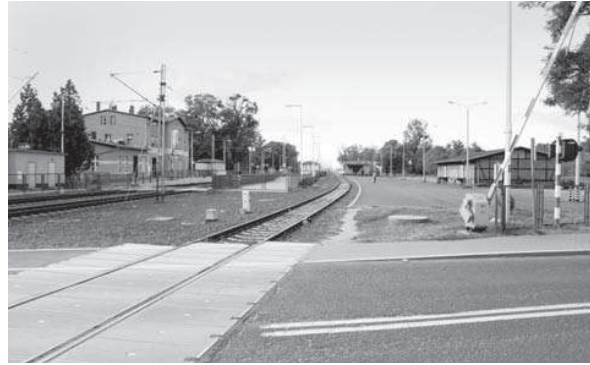
Fig. 11. Lewin Brzeski station on the Opole–Wrocław line, rebuilt in 2005–2006. Platforms were rebuilt, the network of tracks was reorganised, the signal box was reduced to the role of a level crossing attendant's post. The station building was renovated inside and the elevation was rebuilt. The freight yard was renovated. The warehouse and housing buildings were left unchanged (photo: M. Konopka, 2009)
