Wessel de Jonge*

Concrete heritage in the Netherlands. Valuation and conservation of concrete and reinforced concrete structures

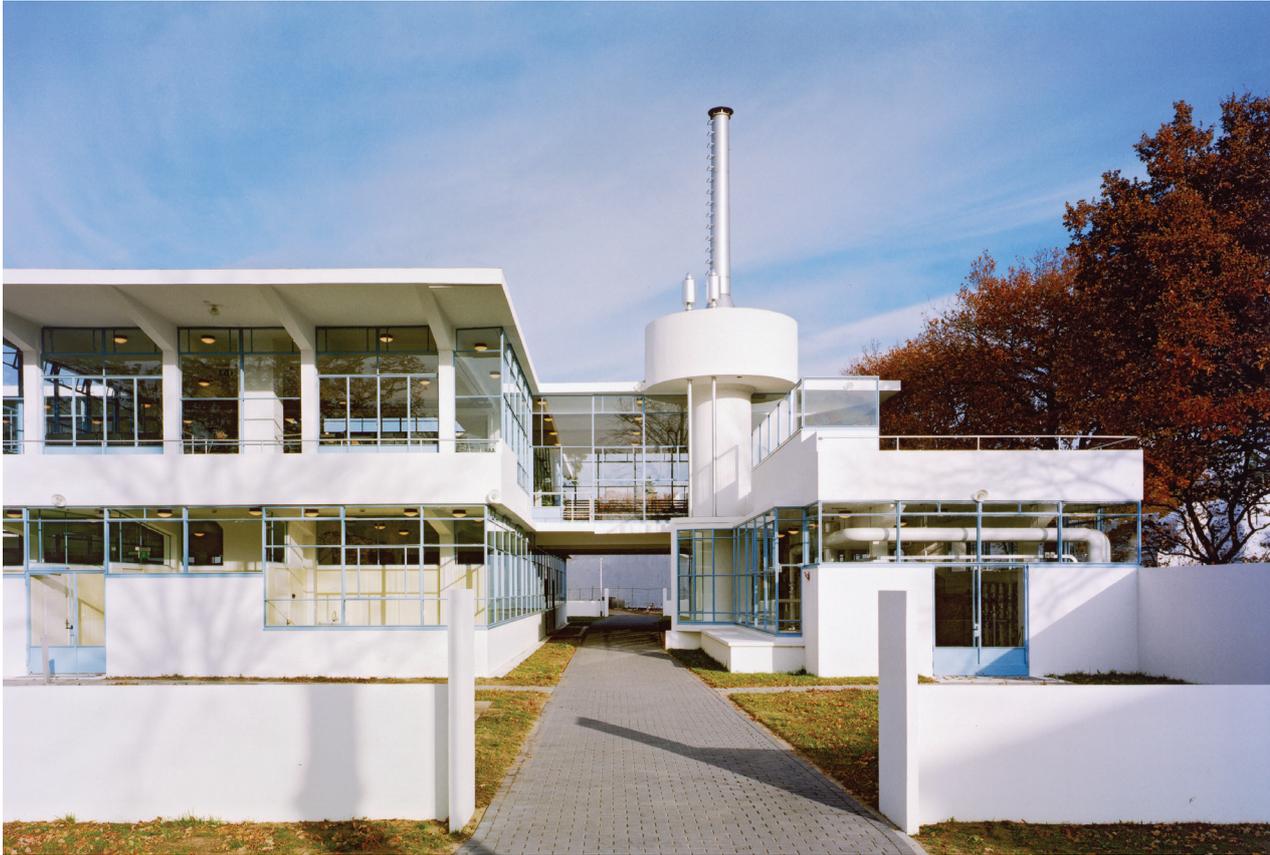
Fig. 1. “Zonnestraal” sanatorium, main building (1928) after restoration in 2003. View through one of the driveways that were restored (photo: © M. Kievits/S. Voeten, 2003, WDJArchitecten Archives)

In his publication *Hoogbouw*, or *High rise construction*, the Dutch Modern Movement architect Jan Duiker (1890–1935) argued in 1930: *It is required, through clear calculation of loads on to beams, on to supporting columns, and on to the fully loaded foundation piles, to try the most economical solution, which, at the same time, will be the lightest. Cantilevered constructions will reduce the static moments considerably, and reduce the intervals of supports* [4, p. 33]. This way, the load bearing structure is reduced to floor slabs with beams on minimal bearings, which is convincingly demonstrated by the slender concrete structural frame of Duiker’s “Zonnestraal” sanatorium of 1928 (Fig. 1).

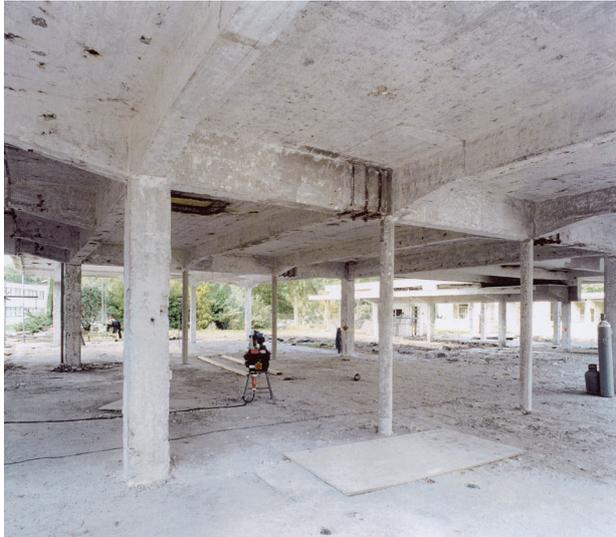
Fig. 2. "Zonnestraal" sanatorium, main building (1928), ground floor during the restoration works.

The render and plaster finishes have been blasted off revealing the slenderness of the actual reinforced concrete structure. The metal brackets involve a repair that dates to the time of construction (photo: © WDJArchitecten, around 2002)

Similar to the ancient Greek masters who modelled their natural stone structures according to traditional timber buildings, the design of early reinforced concrete constructions was borrowed from common building technologies in timber and cast iron. Also, the famed Hennebique system⁴ was based on the use of columns and a structural grid of primary and secondary beams to support the floor slabs. In contrast to timber and iron structures however, Hennebique’s system involved a monolithic structure. Next to the Monnier system, Hennebique’s was one of the most widespread structural systems in reinforced concrete, and it has often been used in the Netherlands. The reinforced concrete frame of the former sanatorium “Zonnestraal” for instance, has a similar structure of main beams and lighter secondary beams (Fig. 2).

For the restoration contract we decided to have all concrete surfaces blasted as very little of the original plaster remained (Fig. 2). The concrete was then repaired in the classic way with epoxy-based repair products. The presence of a layer of plaster in the original state appeared to be an advantage as it could be replaced by shotcrete to obtain sufficient strength and as an additional alkaline cover on the reinforcement of the concrete itself. By applying a thin film of plaster of a composition similar to the original, the appearance and the dimensions of the concrete work are virtually identical to the original. In practice, the shotcrete application appeared to be technically required only locally.

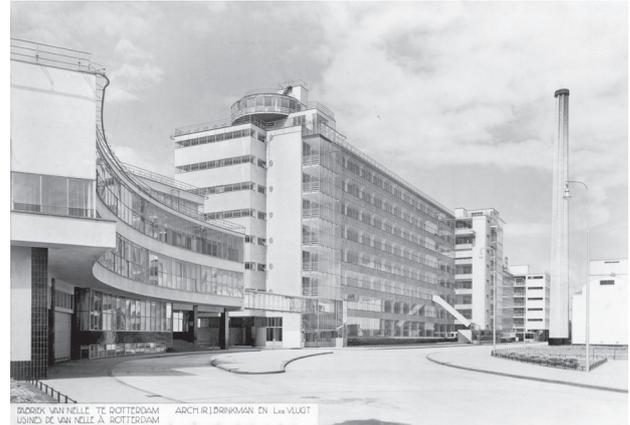
Fig. 3. The Van Nelle Factory in 1930.

The cantilever of the floors reduces the static moments which allows for a more economic design of the reinforced concrete slabs. Also, the curtain wall could run uninterruptedly over the full height of the building (photo: © E. van Ojen 1930, "Historisch Archief de Wed. J. van Nelle, Stadsarchief Rotterdam")

simultaneously with his structural design for the sanatorium buildings (Figs. 3, 4). Thanks to the absence of floor beams, half a meter of construction height was saved from each floor, thereby reducing the height of the building by 3.50 m. The reduction of the façade surface, and also of the

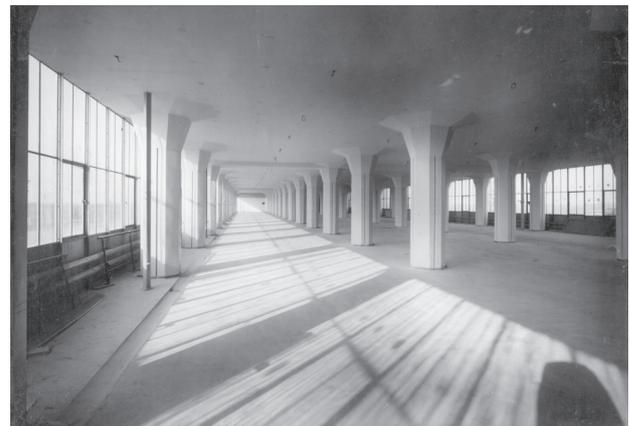
Fig. 4. The Van Nelle Factory interior shortly before completion in 1928. The octagonal mushroom-head columns allowed for the use of floorslabs without beams. The flush ceilings benefit daylight conditions.

The columns feature metal rails on four sides for the fixing of production equipment (photo: J. Kamman, Historisch Archief de Wed. J. van Nelle, Stadsarchief Rotterdam)

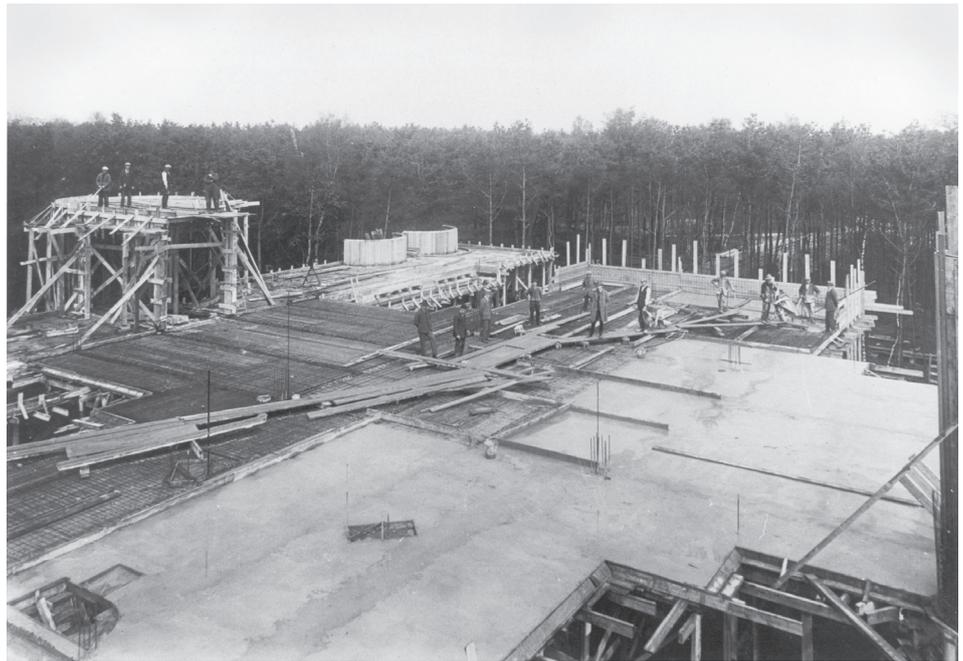
Fig. 5. “Zonnestraat” sanatorium, main building during construction around 1927. The concrete slurry was mixed by hand which resulted in inhomogeneity, which was worsened by the onsite transportation in small batches by wheel barrows (right) (photographer unknown, from Duiker’s personal archive, coll. Jelles and Alberts, HNI Rotterdam)

When it comes to the execution of the works generally we see that the lack of experience and sophistication of equipment on site were not helpful to the quality of early architectural concrete [10, particularly: pp. 90, 97–109]. In particular mixing concrete by hand did not result in a homogeneous mortar so that the quality of such concrete often shows great variety. This was often worsened by the use of wheelbarrows for onsite transportation and the consequent load by load pouring of the slurry (Fig. 5).

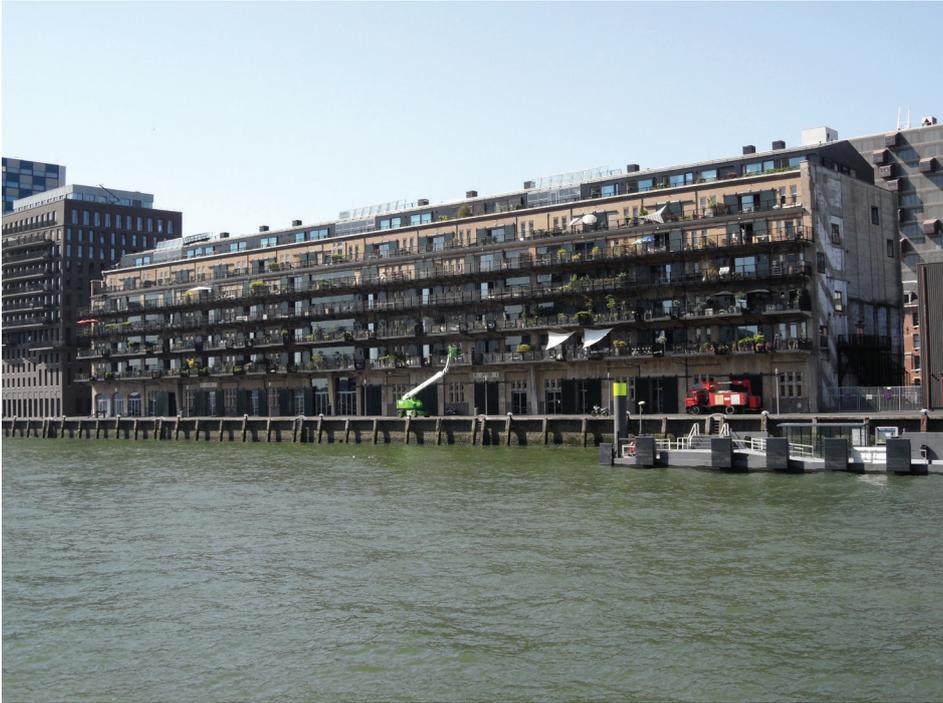
Fig. 6. The St. Jobsveem warehouse (1914) in the Rotterdam docklands after conversion into a condominium with 109 apartments in 2007. Due to the ample loadbearing capacity of the huge reinforced concrete loading platforms these could be transformed into hanging gardens.

The same may be true when concrete is covered with other materials like render and plaster. In eclectic buildings we often find plastered surfaces that are dressed so as to remind natural stone – which was rare and therefore expensive in the Netherlands. A case in point may be the Sint Jobsveem, a 1914 warehouse in the Rotterdam docklands, which was converted into apartments in 2007¹⁴ (Figs. 6, 7).

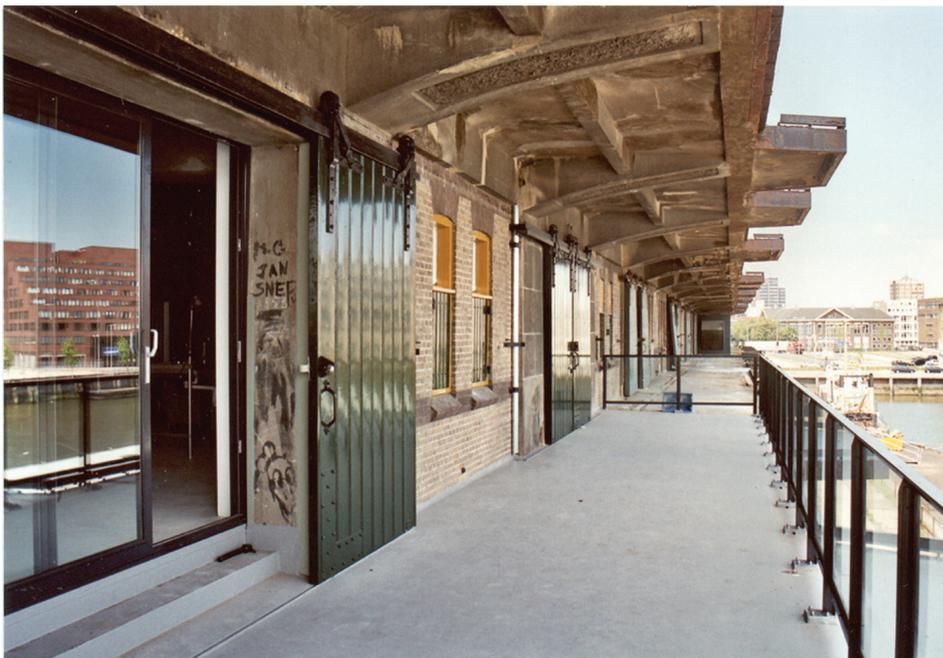
Fig. 7. Former St. Jobsveem warehouse. The installment of a model apartment included trial repairs of the concrete decks that were to serve as terraces. The underside of the platform above still shows the damage to the plaster finish that was originally dressed to mimic natural stone

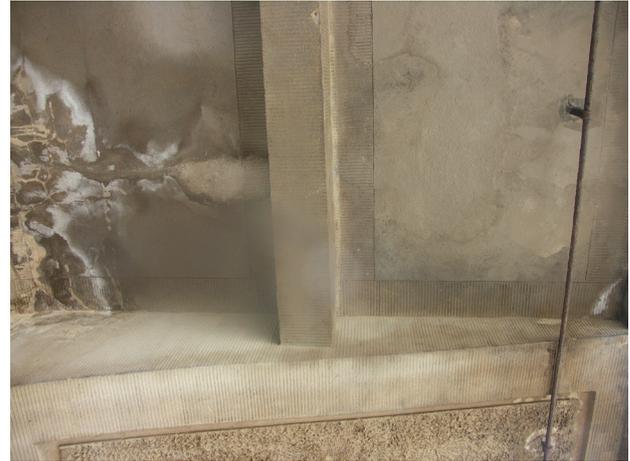
Fig. 9. Former St. Jobsveem warehouse.

A similar area after concrete repair and partial restoration of the dressed plaster finishes, including the combed finish of the secondary beams and around the smoothly finished ceiling. The colour is touched up with a stain (photo: © M. van Hunen, 2006, WDJArchitecten Archives)

For the plaster finish special mortars have been composed by Remmers Building Chemicals, toned with various pigments into a palette for repair on the spot. Finding the right colour for the mortar was a minor challenge as compared to the choice of the proper aggregates and the proportion between them, which required several series of trials. On the basis of the results, a small palette of repair mortars has been selected, in slightly different shades, allowing the craftsmen on the scaffolding to select a tone from spot to spot, depending on the adjacent material. The 1914 combs have been remade in order to give the renewed patches the same surface texture (Fig. 9).

Eventually, we could convince the client that a more restorative approach would be a better choice. The major part of the plaster finishes has been retained and repaired with the same type of repair mortars as elsewhere. The differences in colour and brilliance between old and new have been touched up with a stain, Keim Restaura Lazur, that has been toned with a dash of pigment (Fig. 9).

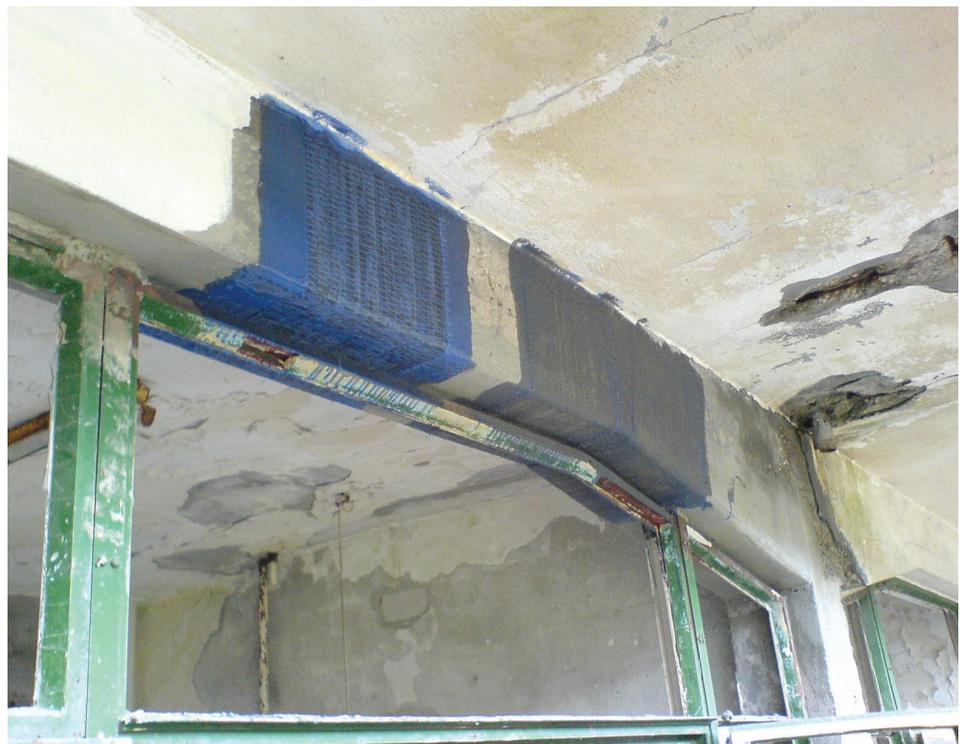
Fig. 10. Sample tests of strengthening the bearings of the longitudinal beams with carbon fabric, after removal of the render and plaster finishes. The method proved effective but could not resolve the lack of load-bearing capacity of the columns themselves (photo: © WDJArchitecten, 2006)

In order to master the static problems with the beams, we have tested the use of “Carbon Shear”, a thin carbon-fibre fabric, that was attached to the sides of the beams after removal of the plaster. It worked well, although it appeared rather expensive. Again, the original layers of render and plaster were helpful, as it allowed to conceal the carbon fabric later within the replacement finish (Fig. 10).

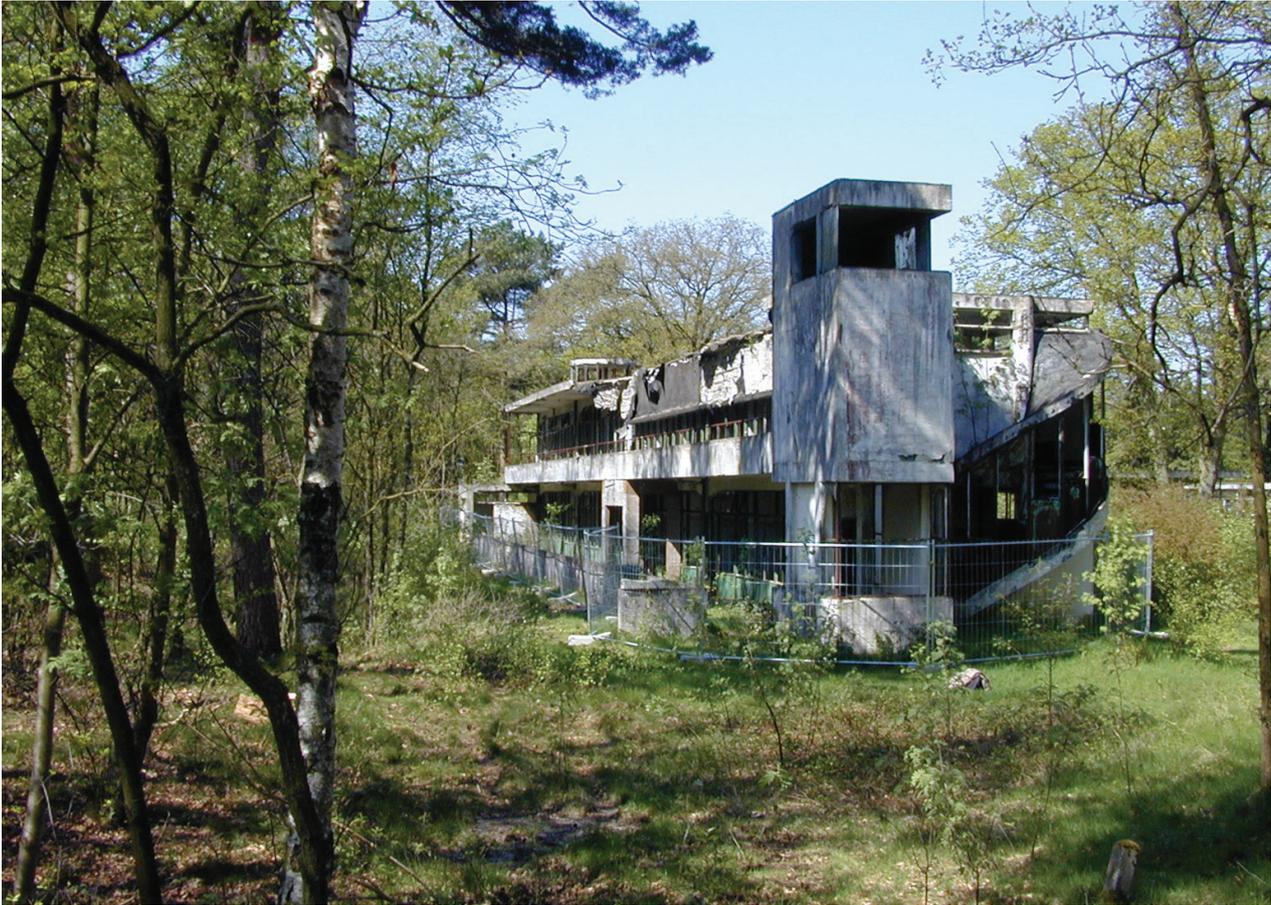
Fig. 11. „Zonnestraal”, Dresselhuys Pavilion (1931) after the collapse of the chloride-infused reinforced concrete roof slab. The exterior restoration of this structure was completed in 2013 (photo: © R. Wielinga, 2001, WDJArchitecten Archives)

Still, in addition, the worst columns had to be completely replaced, as were all the balconies and the roof slab, which showed persistent damage of pit corrosion as a result
