Aleksander Piwek*, Tomasz Jażdżewski**

The room above the porte cochère of the Kwidzyn castle in the times of the Pomesanian chapter

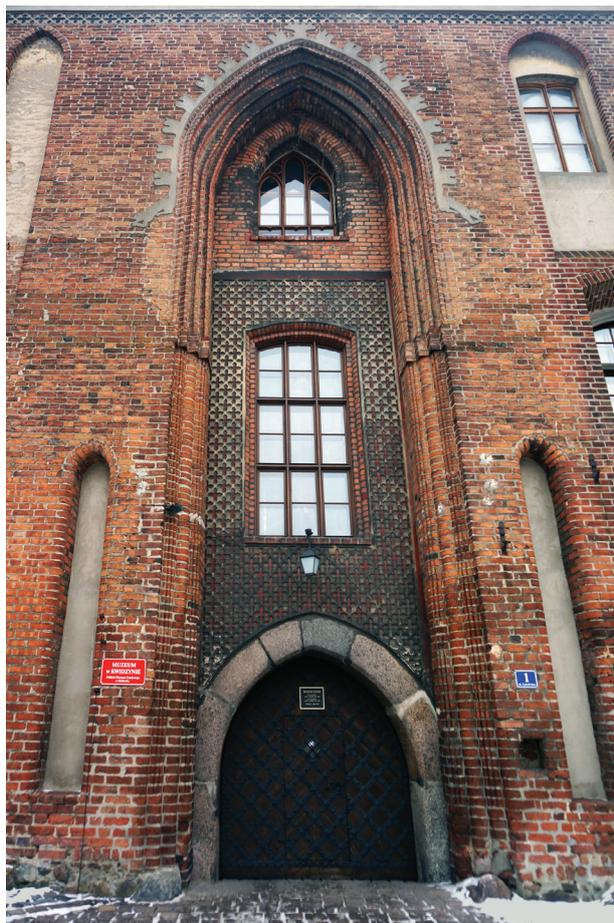
Fig. 2. View of the entrance and the rooms located above from the north (photo by A. Piwek)

one). A low porte cochère located in the northern wing led to the interior of the complex (Figs. 1, 2). Above it, there was a room whose history was connected not only with the porte cochère but also with the fate of the castle inhabitants. Their aspirations and needs significantly influenced its interior.

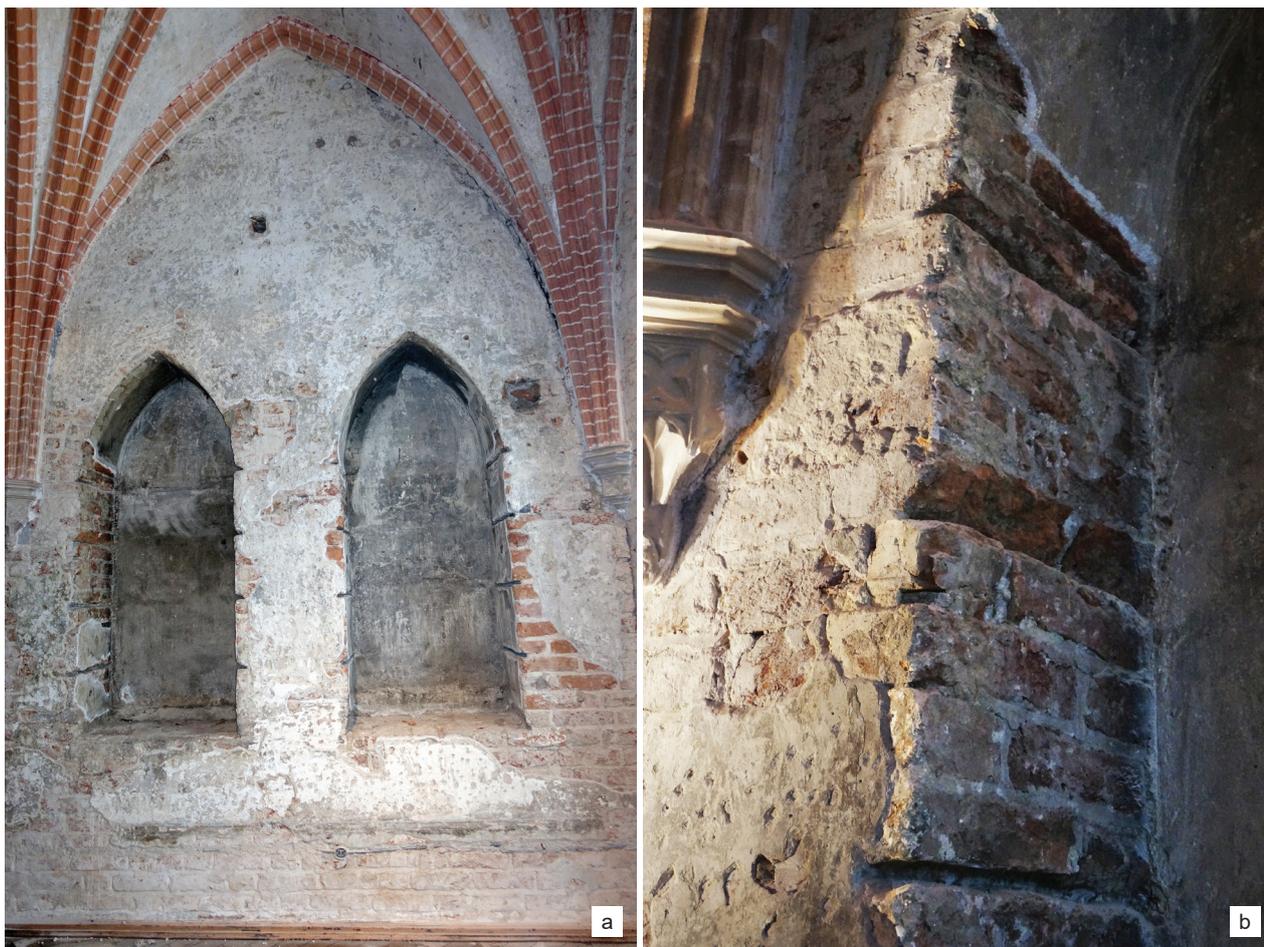
Fig. 5. The northern bay of the western wall with a pair of ogival recesses. Their side walls contain horizontally bevelled and right-angled cuts so that shelves could be fitted: a) general view, b) detail with cuts in the southern wall of the second recess from the north (photo by A. Piwek)

The western wall contains mainly $30.5\text{--}31.0 \times 14\text{--}14.5 \times 7\text{--}7.5$ cm bricks classified as medieval. In the north bay, two ogival recesses were found 95 cm wide, 235 cm high (up to the keystone), bricked up with $30.5 \times 14.0 \times 8.5$ cm bricks, as well as $25 \times 15.0 \times 9.0$ cm bricks and medieval shaped stones (Fig. 5a) [9, p. 9]. After their removal, it was possible to determine the depth of these recesses – 45 cm on average. The side walls of the recesses contained intentionally made small indentations (Fig. 5b), four on each side. In the second recess to the north, there was a marked variation in their execution. The two uppermost rows and the third row on the north wall were bevelled at the top, while the rest were right-angled. Bevelled cuts were also found in both recesses where the vertical walls meet the base of the recesses. A similar recess to the two described above was found in the south bay, between the passage to the hall adjacent to the western and the southern wall of the room under study, except that its southern wall was

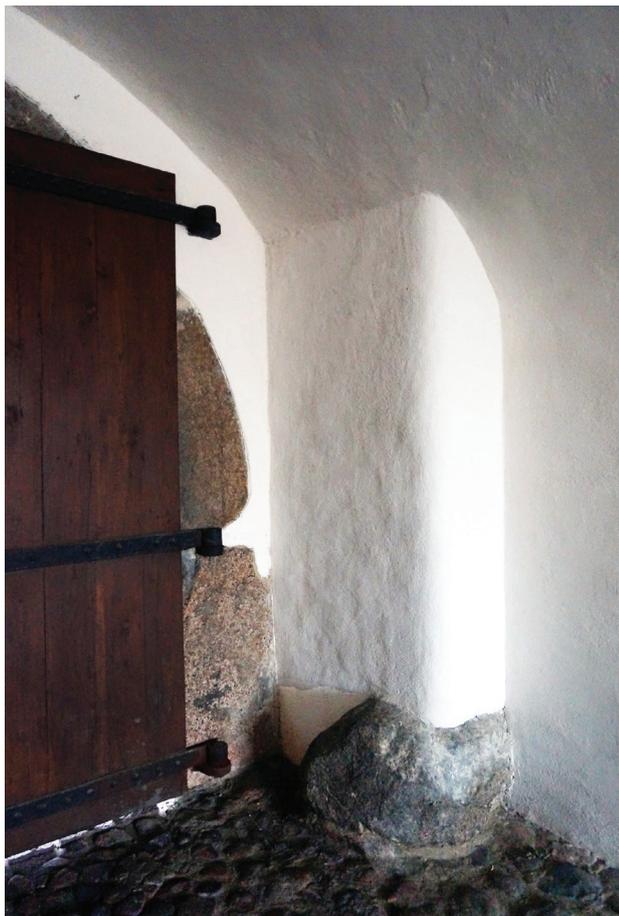
Fig. 7. The eastern fragment of the medieval entrance to the Kwidzyn castle with a late-Gothic extension (pilaster) and a modern segmental vault (photo by A. Piwek)

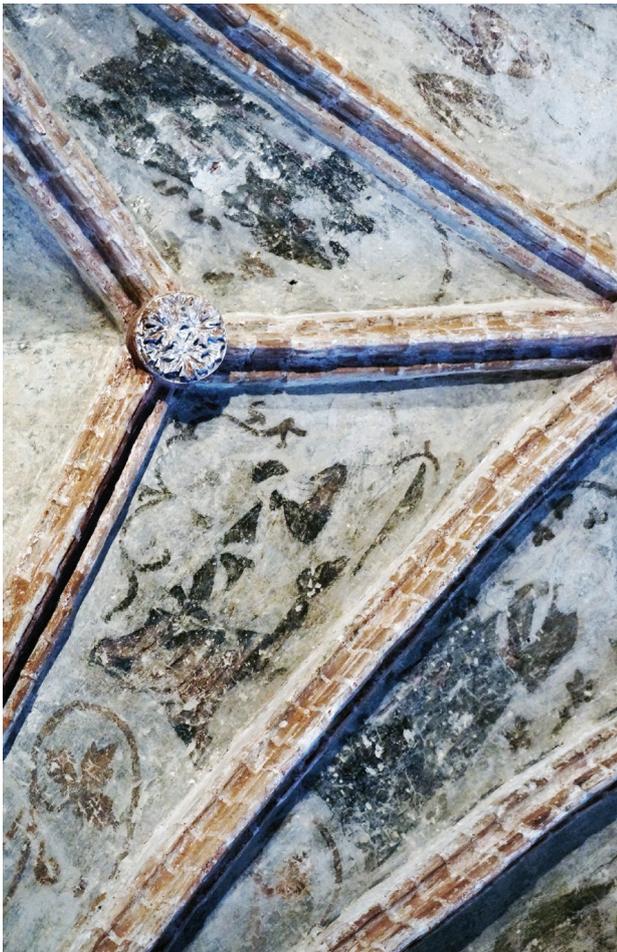
Fig. 9. Part of the northern bay vault with traces of exposed polychrome (2nd quarter of the 15th century?) (photo by A. Piwek)

The completely uncovered polychromes (Fig. 9) indicate the sacral function of the room and the time of its creation. It is assumed that they were made between 1400 and 1450 [10, pp. 8, 9], although this is not the only possibility¹³. Their sacral content (figures of saints) corresponds with the new use of the hall. Their appearance only on the vaulting of the northern bay has not been explained yet. The suggested reason is the start of the war in 1409 [9, p. 8] and its consequences. There is also another explanation. When a wooden partition is placed in the middle of the interior, it separates parts intended for users of different status – the clergy and the castle servants.
