Bernát Bérczi O. Cist.*

*The ruins and reconstruction of the medieval Cistercian Abbey of Zirc***

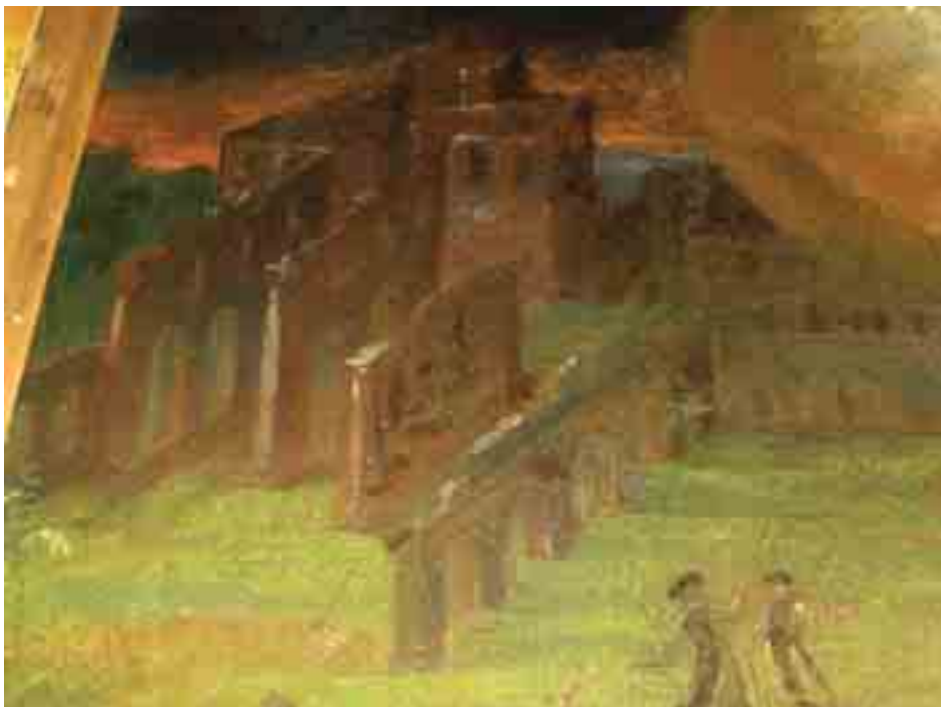
Fig. 2. Detail from the bottom left part of the high altar-piece of the Roman Catholic church of Olaszfaalu

Chronologically the last record which does not have full source value is the high altar-piece of the Roman Catholic Church of Olaszfaalu²². In the lower left corner the presumed ruins of Zirc Abbey can be seen together with two Cistercian monks. The ruins on the high altar-piece show us a Latin cross church with basilican layout and the eastern wing of the Abbey in ruins. It completely agrees with the above mentioned account of Abraham Wabrzig concerning its building and the designed items²³. Yet, the artist used his artistic freedom: he did not make a precise plan but a painting, therefore the piers and some other items are schematic. The name of the painter and the date of the painting are unknown. According to Mária Aggházy the painter may have been Bernhard Krause and the painting date from ca. 1770²⁴. We know that Krause has painted several pieces for Heinrichau²⁵. and we can find some more paintings by him in other churches founded by the Abbey of Zirc. However, Krause himself could not have seen the ruins. At his birth, in 1743 they were no longer standing. Presumably he might have made that portion of the painting based on some other painting or drawing, if it was painted by Krause at all²⁶.

²³ It shows the first three bays of the sanctuary, the transept and the nave to be intact. The great rose window however dimly can be discovered on the sanctuary wall. We have to note that in the picture to the left (and to the right as well?) from the sanctuary wall the dark marks of a reparation done possibly in the course of the 19th century can be discovered.

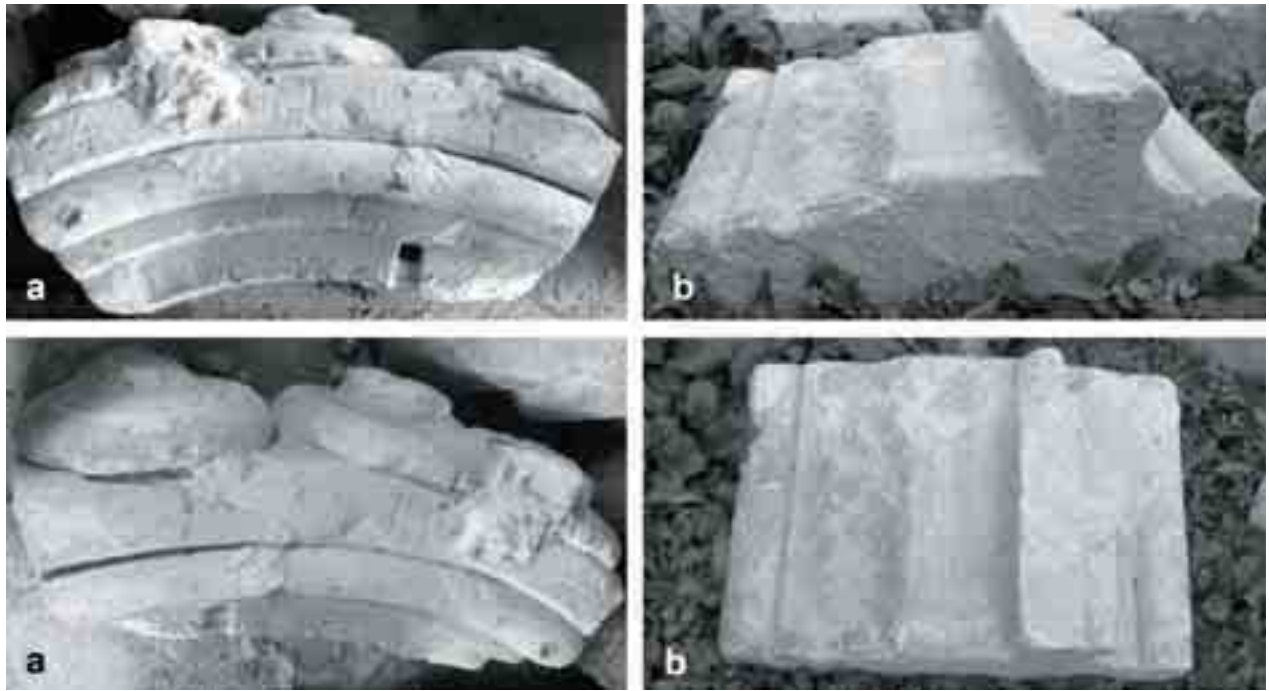
Fig. 6. The fragments of the rose window found in September 2005: a) the hub of the rose window b) the outer frame of the window

most important pieces have been assessed to date. The most significant fragments found are the outer frame and hub (boss) of a wheel window about 6 metres in diameter, to which the spokes had joined. I assume this is the rose window mentioned in 1699 by Abraham Wabrzig in his report; of which about 1729 the returned monks write; and about which the Abbey's *Historia domus* speaks⁴⁵.

The exceedingly significant finds that surfaced in September 2005 were a great help in the reconstruction. This happened when two important pieces of the rose window were found, so it was possible to construct the window, although the missing parts could be replaced only by analogues. Those fragments found at Zirc originate in the eastern outer wall of the sanctuary, according

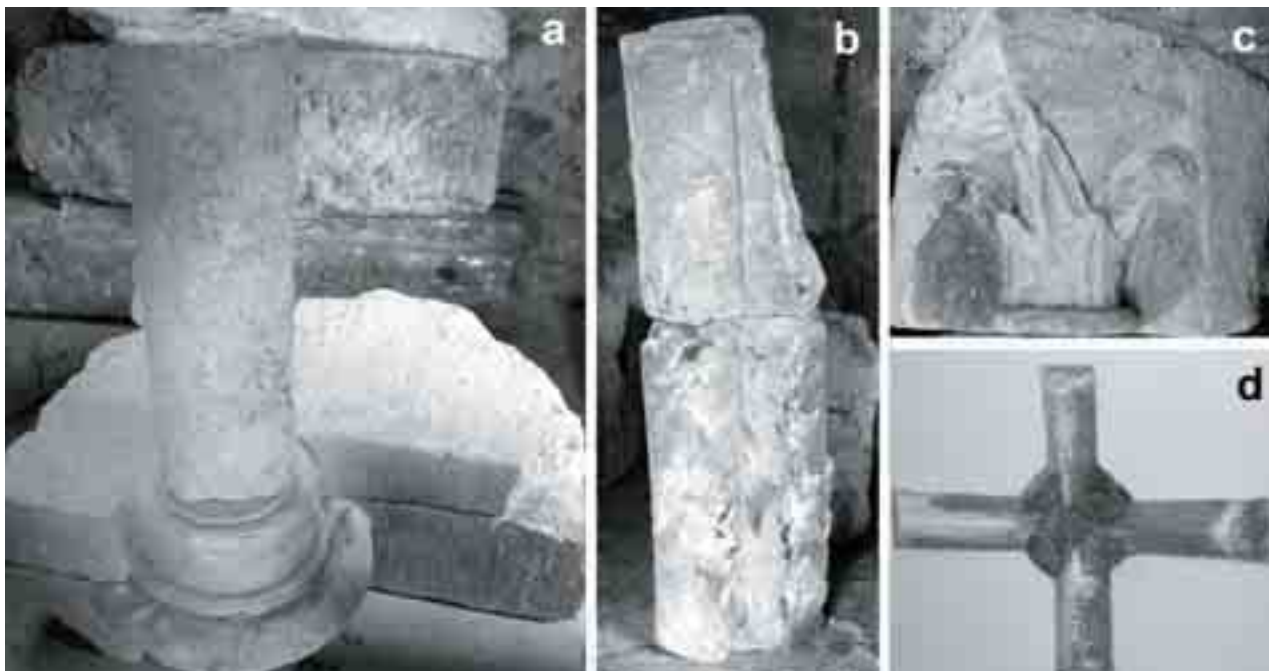
Fig. 7. The stone fragments found in September 2005: a) column ring, b) rib vault, c) column capital, d) vault boss built into the wall of the cloister of the 18th Baroque Abbey

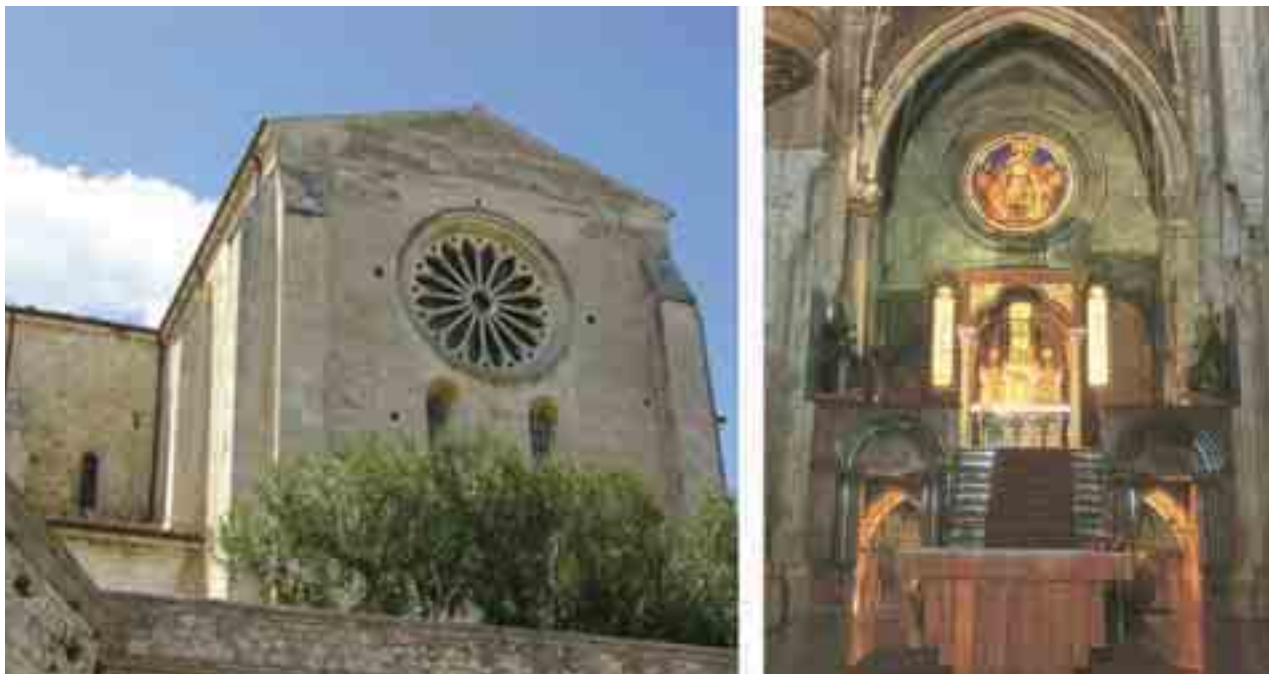
Fig. 10. Rose windows similar in proportions and execution to that in the outer wall of the sanctuary at Zirc: a) Arabona, b) Pannonhalma (photo: Arabona – Leonardo Mazzaschi, 2004; Pannonhalma – Gábor Hegyi [in:] *Katolikus templomok Magyarországon*, Budapest, 1991. Szerk. Erzsébet Déri. 76)

and a large rose window with three simple windows under it – maybe due to Cistercian influence. The analogue is Pannonhalma. The large circular window of the sanctuary is about 4 metres in diameter, and this, in relation to the width of the sanctuary, is almost identical⁴⁸ with the rose window of Zirc, looking at its proportions. It is true that at Pannonhalma in this circular window the spokes are no longer there, but in 1995 during the renovation of the façade, in the outer rim of the circular window a groove was discovered⁴⁹

⁴⁸ At Pannonhalma the circular window measures about 60% of the width of the sanctuary, at Zirc 65–70% (taking into account the currently missing sections).

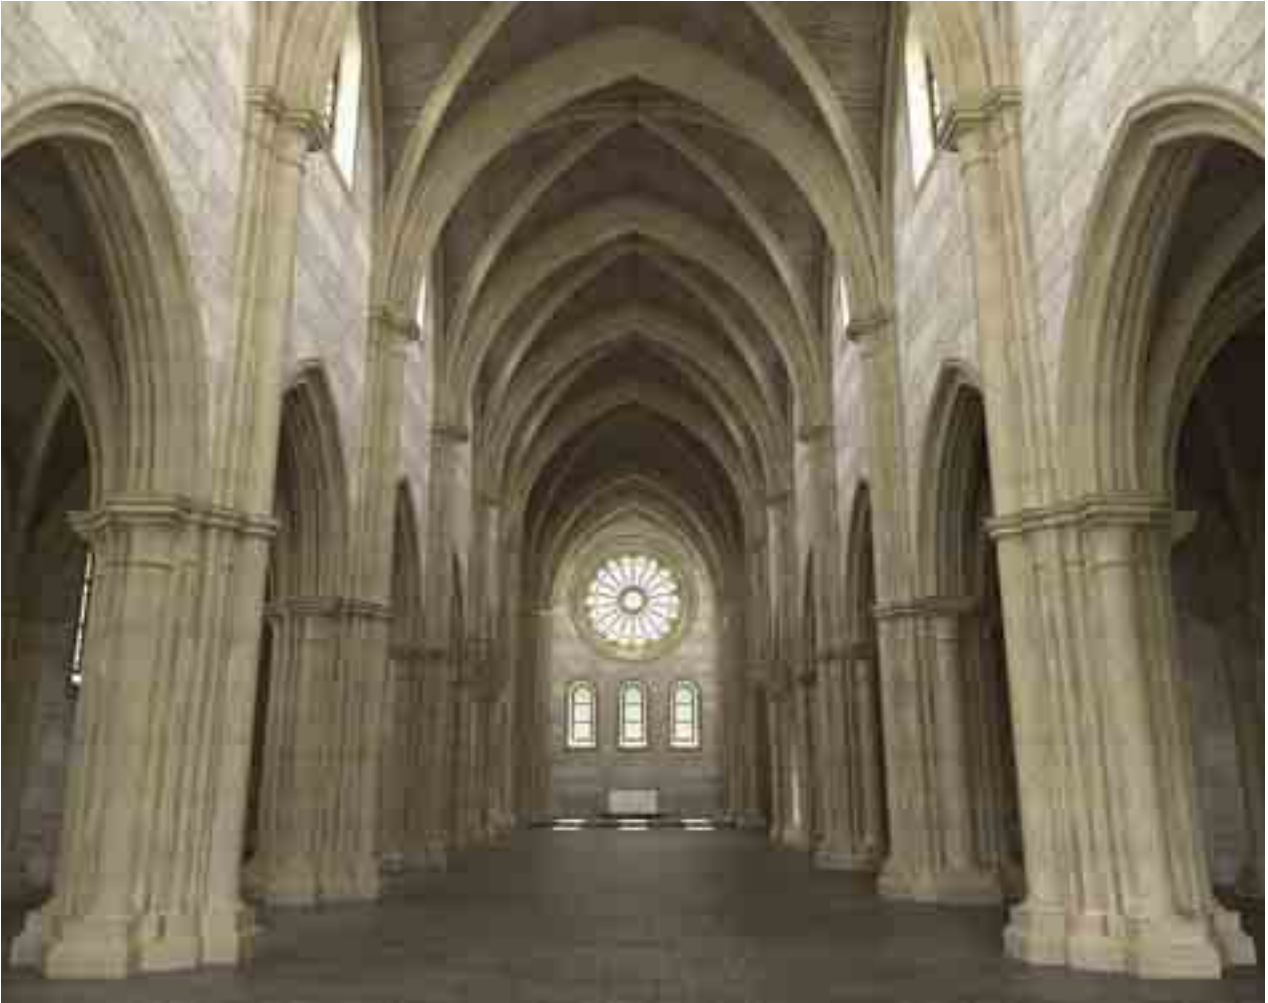
Fig. 11. Reconstruction of the medieval Abbey church; the nave

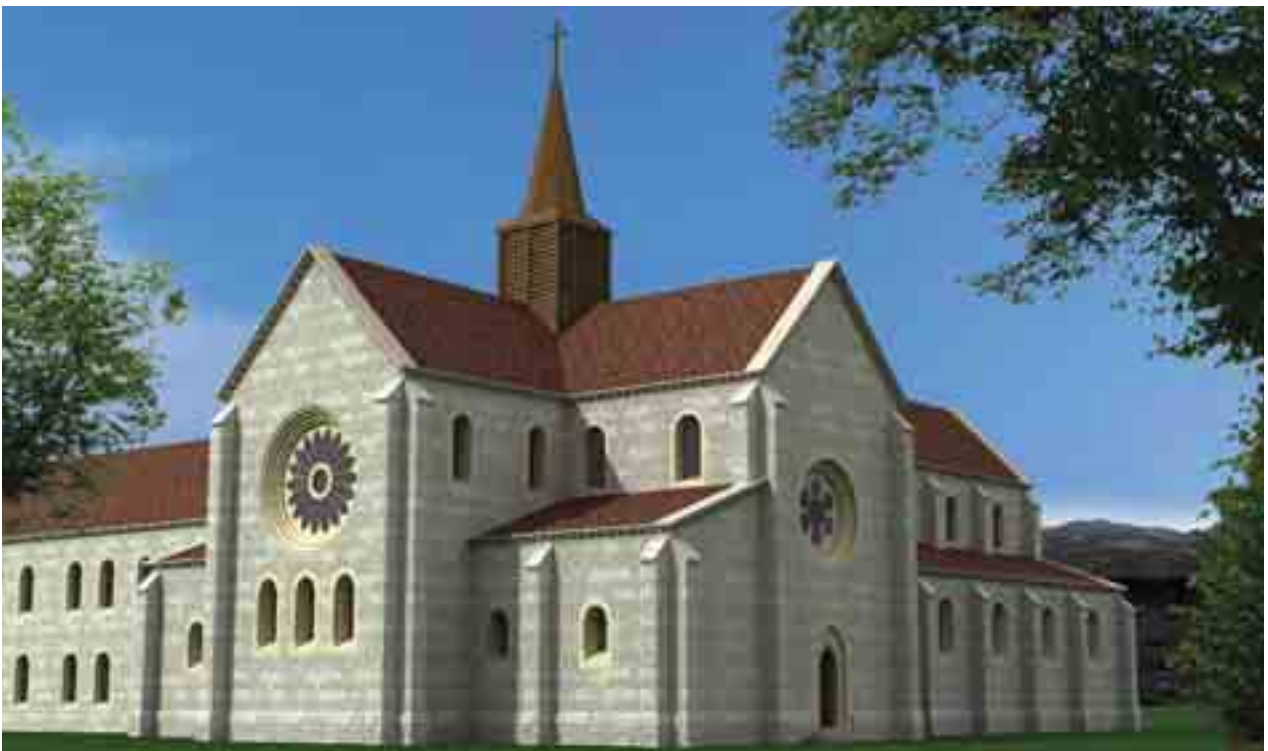
Fig. 12. Reconstruction of the outside of the medieval Abbey church; N-E view
