## *Petrographic, mineralogical, and climatic analyses, and risk maps for conservation strategies*

The natural rock was the main subject of the project “Architectural examination and complex documentation of Samaipata (Fuerte de Samaipata/Bolivia) site from the World Heritage List”, of which this study is a small excerpt.

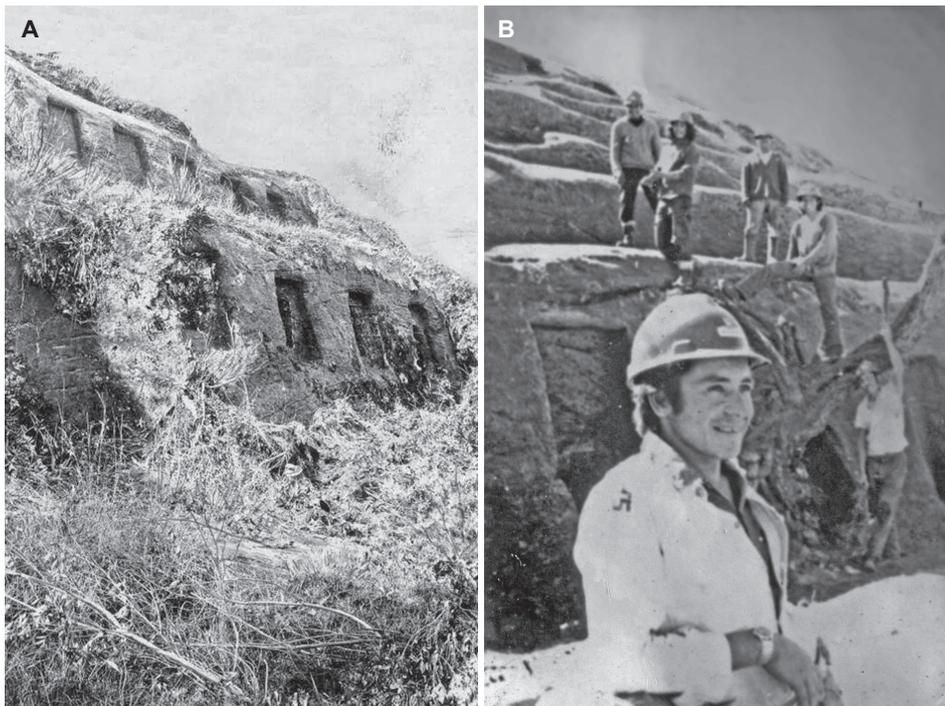
Fig. 1. The southern slope of the rock:  
 A – during the time of research by Erland Nordenskiöld (around 1923) (photo from archives of the Samaipata Archaeological Research Centre);  
 B – in April 1974 (photo courtesy of Damiano Montenegro Fernández)

In the last quarter of the 20<sup>th</sup> century, intensive research combined with the removal of vegetation growing on the rock and the accumulated organic layers led to the exposure of the entire ridge of the rock (Figs. 1A, B). This not only enabled detailed research to be conducted on previously unavailable parts of the whole complex, but also contributed to the popularisation of El Fuerte as an important tourist attraction.

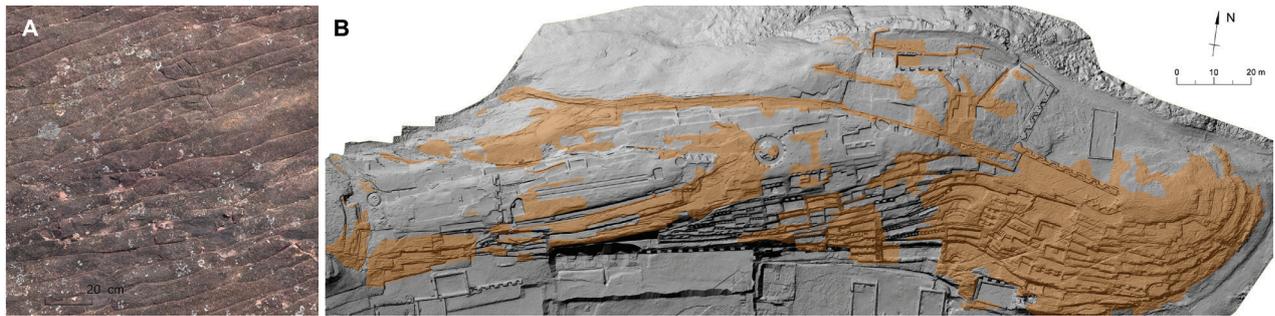
Fig. 2. First stage of erosion:

A – an example of the first phase of erosion (micro-cracks) on 0.3 mm-resolution orthoimage (photo by J. Kościuk);  
 B – areas of numerous micro-cracks in the lithic surface (elaborated by T. Dziedzic)

The first stage of erosive phenomena is micro-cracks appearing on the rock surface (Fig. 2A). Their presence can potentially be associated with thermal shock and the alternation between the soaking and drying of porous rock. Practically, 50% of the Samaipata rock surface is covered with such micro-cracks (Fig. 2B).

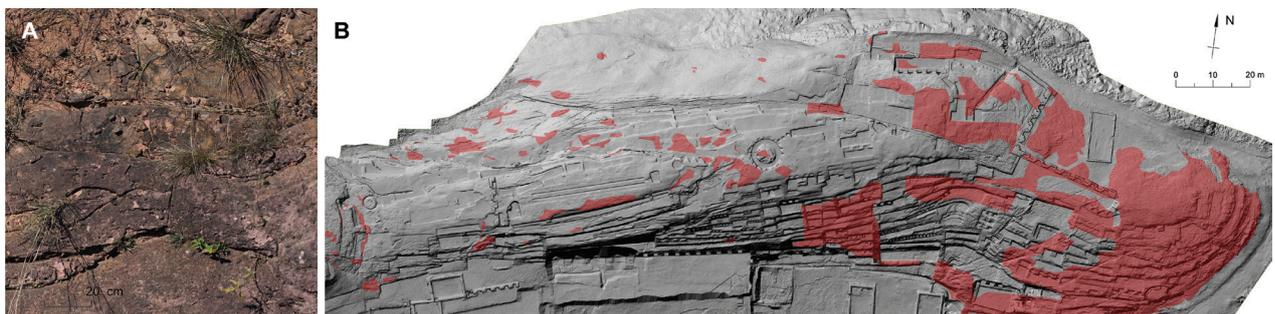
Fig. 3. Second stage of erosion:

A – an example of the second phase of erosion (exfoliation) on 0.3 mm-resolution orthoimage (photo by J. Kościuk);  
 B – areas of exfoliation of the lithic surface (elaborated by T. Dziedzic)

The second observed erosion stage, especially where the natural stratification of the rock is oblique in relation to its surface, is exfoliation – individual layers separate from the bedrock (Fig. 3A). Exfoliation processes are accelerated by the presence of vegetation whose root system penetrates and breaks existing micro-fissures. It is estimated that about 25% of the entire rock surface is at risk of exfoliation (Fig. 3B). A strong correlation is visible between the zones of micro-cracks and the zones where the surface layers of the rock are exfoliating.

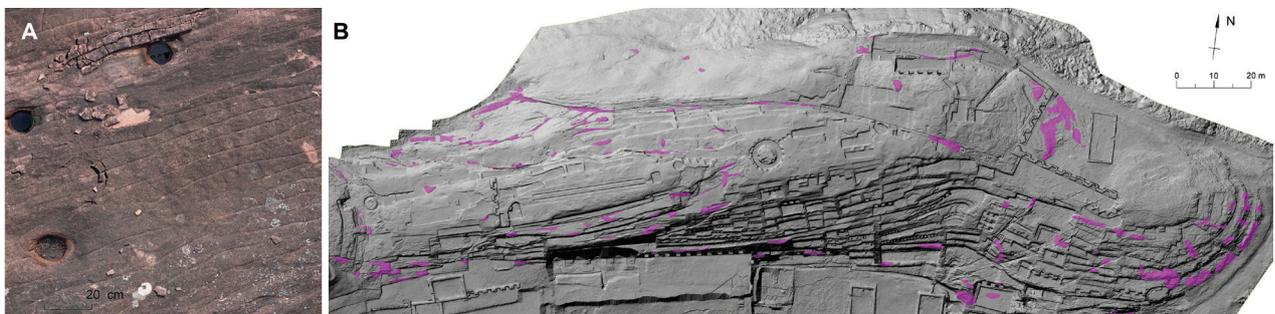
Fig. 4. Third stage of erosion:

A – an example of the third phase of erosion (loose fragments of the rock lying on the surface) on 0.3 mm-resolution orthoimage (photo by J. Kościuk);  
 B – zones of loose lithic material (elaborated by T. Dziedzic)

In the third stage of erosion, detached fragments of rock completely lose contact with the ground and begin to move (Fig. 4A). The progression of this process causes their further fragmentation into ever smaller pieces that are easily

moved by rainwater and wind. Accumulating deposits of such material, additionally enriched with organic particles blown by the wind, are an excellent breeding ground for growing plants whose root system will penetrate the rock deeper and deeper. Zones in which loose lithic material is deposited (Fig. 4B) are increasing every year.

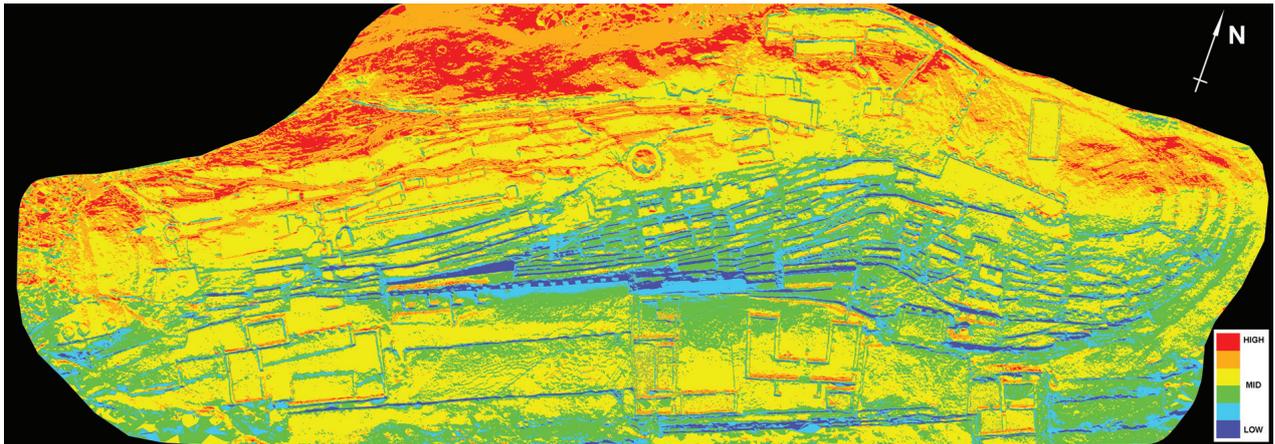
Fig. 7. Rock insolation on 21<sup>st</sup> June (elaborated by J. Kościuk)

Grey-scale visualisations for individual hours of daylight were then stitched together into one image, separately for 21<sup>st</sup> June and 21<sup>st</sup> December, and the resulting images were divided into six classes of grey. Each of the grey classes was assigned one of six basic colours from red for the most illuminated surfaces throughout the whole day, to blue for those that remain mainly in the shadows. In this way, maps were obtained showing to some extent which fragments of the rock could have warmed up the most at these two different moments of the year (Figs. 7, 8), so zones in which one could expect thermal shock due to the rapid temperature changes between day and night.

The juxtaposition of insolation data (Figs. 7, 8) with simulations of exposure to prevailing winds (Fig. 10) determined the zones for which there is the greatest risk of thermal shock. For the June solstice, these are mainly the northern slopes of the hill and all surfaces of niches, terraces, and platforms with northward exposure (Fig. 14).

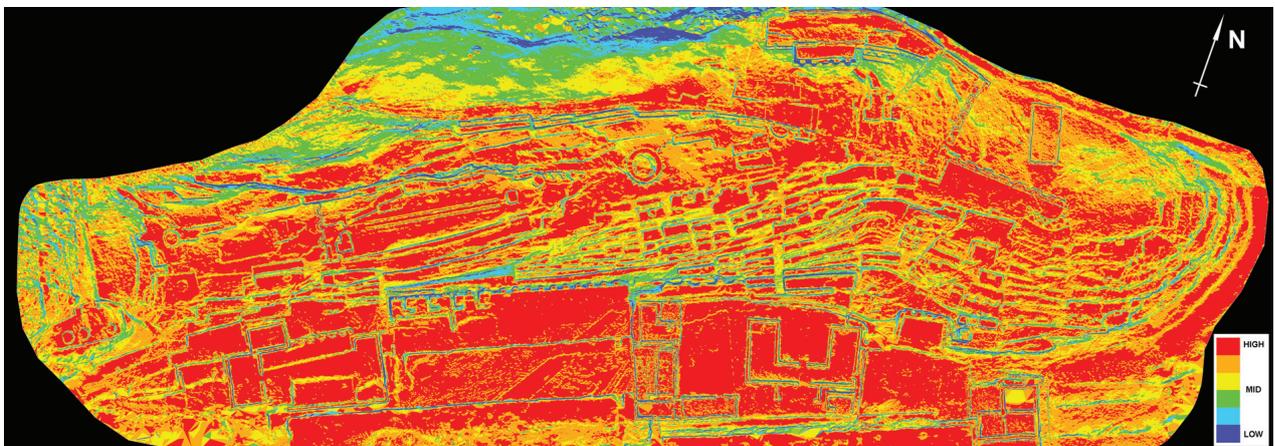
Fig. 8. Rock insolation on 21<sup>st</sup> December (elaborated by J. Kościuk)

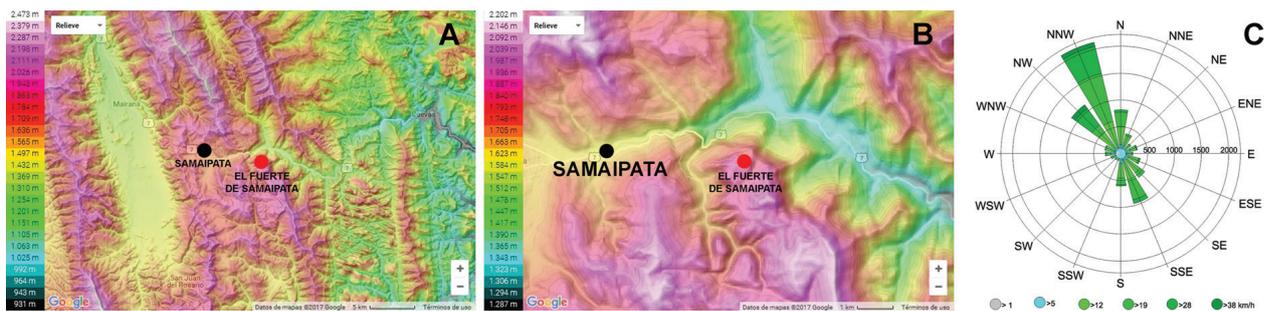
Fig. 9. The topographical situation of El Fuerte de Samaipata (A and B) and the wind rose (C)

The effect of thermal shock is intensified by strong winds blowing over El Fuerte. The specificity of the terrain, with its parallel ranges of mountains and valleys (Figs. 9A, B), means that NNW winds dominate there (Fig. 9C).

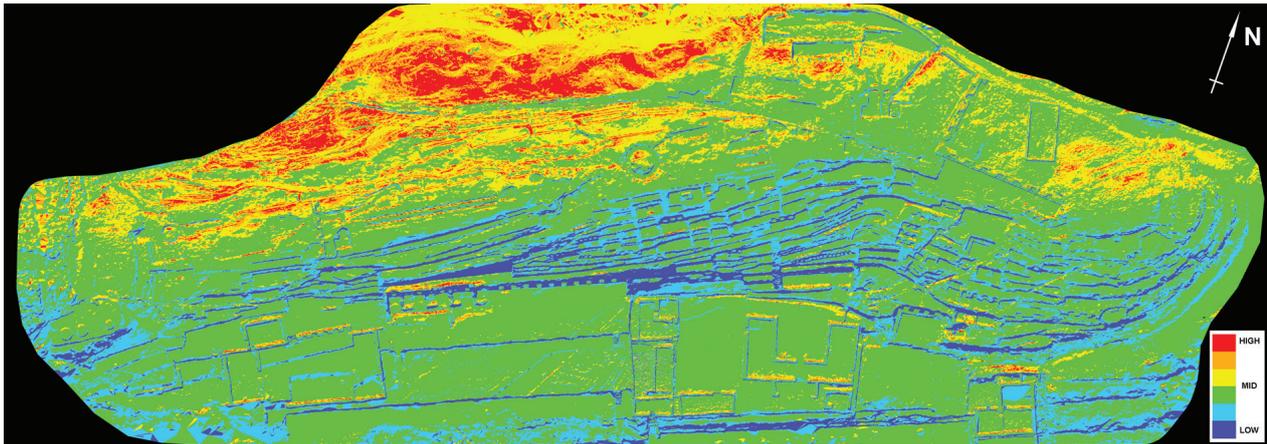
Fig. 10. Exposure to the prevailing wind direction (elaborated by J. Kościuk)

The virtual 3D model of the rock was used again to simulate the influence of wind on the effect of thermal shock. The model was illuminated from a NNW direction (335° from the north) and rendered using the same software. In this way, the most illuminated parts of the hill simulated the surfaces most exposed to the wind, and thus those that cooled down the fastest (Fig. 10). This chart is also an approximate image of the zones where wind erosion effects may occur.

The risk of thermal shock is not the only threat to El Fuerte. The previous section also specified the impact of wind erosion (Fig. 10), slope inclination (Fig. 11), and local depressions (Fig. 12). Summing up these four factors gives us a full picture of the threats caused by climatic factors and the site topography. The resulting map of accumulated risk factors (Fig. 16) indicates that, apart from local depressions that were already discussed separately, the most negative factors add up on all horizontal areas. Therefore, from this point of view, conservation priorities should focus on these areas, and particularly on all petro-

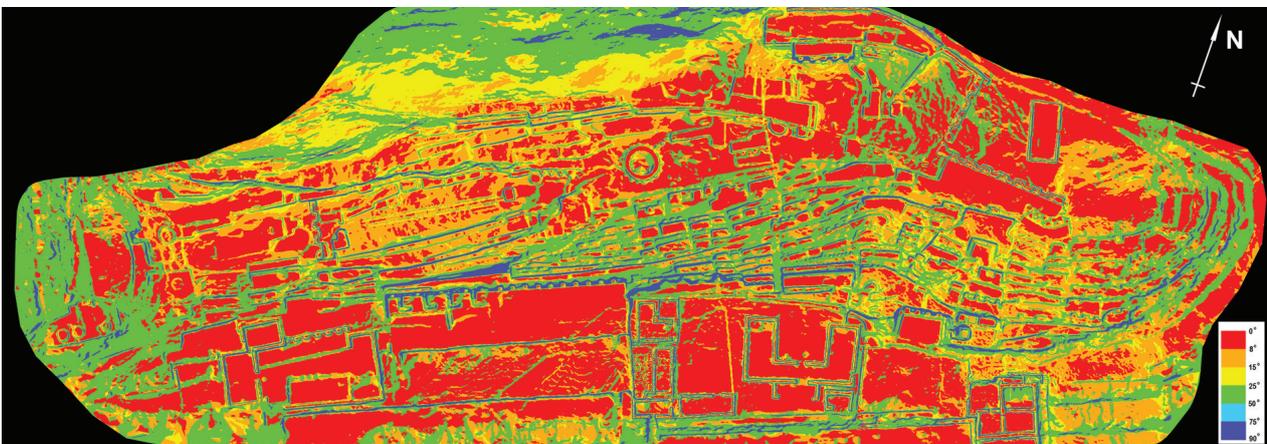
Fig. 11. Slope inclination analysis (elaborated by J. Kościuk)

Fortunately, one of the thematic styles of displaying 3D objects in Bentley MicroStation V8i is slope inclination. With this, as in all previous cases, the results were divided into six classes using a colour scale in which the red corresponded to surfaces where the inclination did not exceed 8°, and the blue meant a slope greater than 75° (Fig. 11).

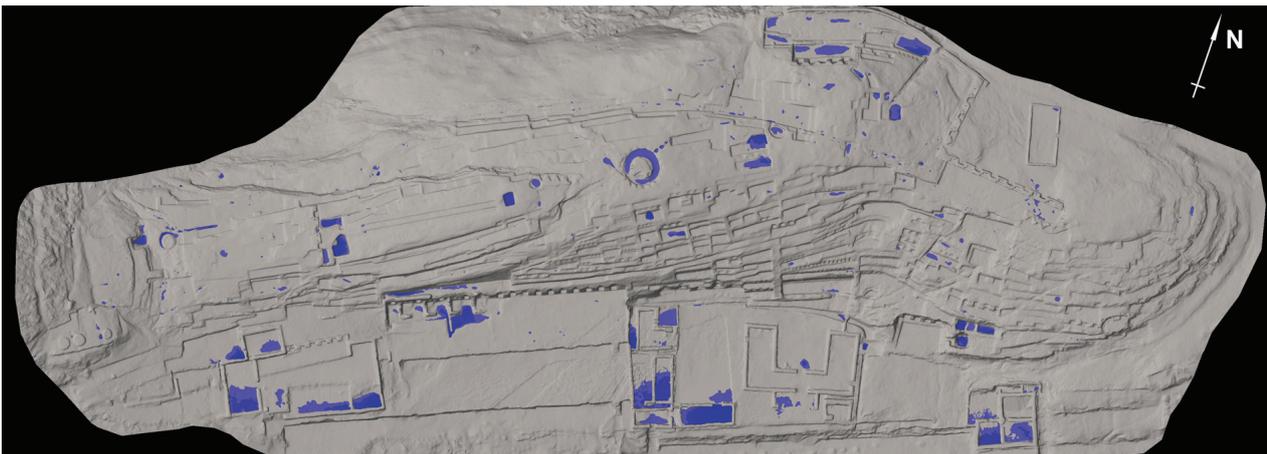
Fig. 12. Depressions without drainage (elaborated by J. Kościuk)

Local depressions were also searched for in the Bentley MicroStation V8i environment – contour lines were generated every 10 cm and those that formed enclosed areas were selected (Fig. 12). The results were presented this time in a different colour scale. The results of all these partial analyses were further used to prepare risk maps for conservation strategies.

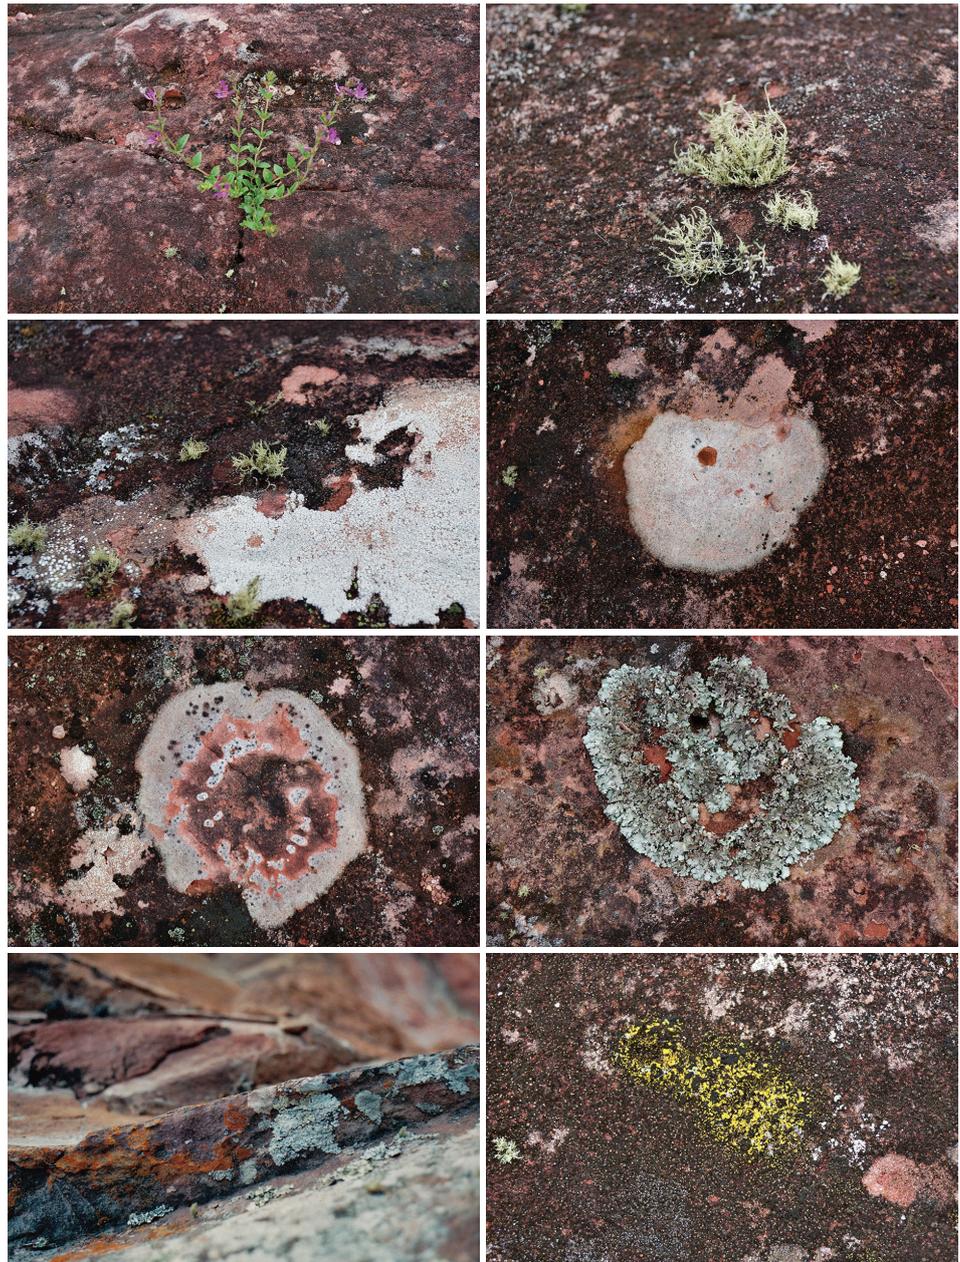
Fig. 13. Examples of various forms of plants, lichens, fungi, and algae growing on the rock surface (photo by J. Kościuk)

have also already been the subject of partial studies conducted by Sonia Avilés [12]–[14]. Nevertheless, numerous plants growing on the rock, as well as lichens, mosses and algae (Fig. 13), distract not only for aesthetic reasons, but mainly due to their impact on erosion. This impact is not only the already mentioned process of breaking micro fissures by penetrating plant roots, but also the biodegradation of the binder of the fine sandstone particles, which is even more invasive.

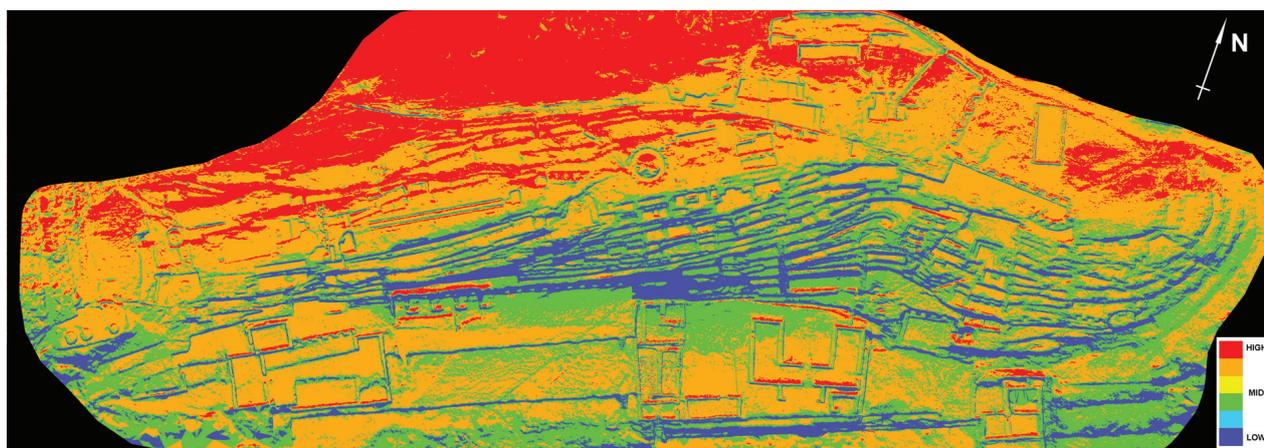
Fig. 14. Risk of thermal shock on 21<sup>st</sup> June (elaborated by J. Kościuk)

It should be clearly stated here that the presented risk scales do not use absolute values. This is particularly important when comparing June data with December data. The risk of negative temperatures on El Fuerte appears mainly in June, July, and August, and these are the months in which the lowest maximum temperatures are recorded. Together with September, this is also the period of the strongest winds. Temperatures dropping below zero and strong winds are the two most important factors for the risk of thermal shock during this period of the year.

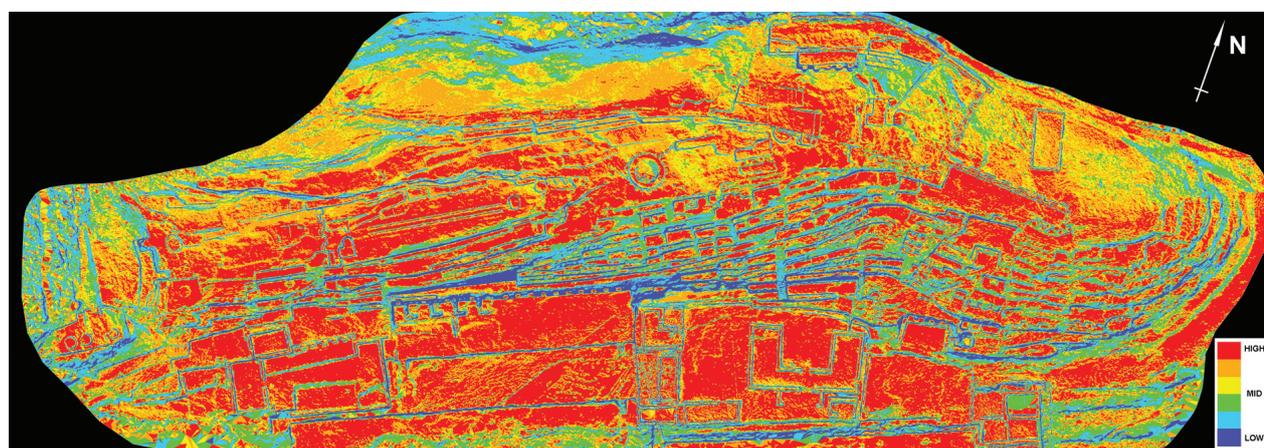
Fig. 15. Risk of thermal shock on 21<sup>st</sup> December (elaborated by J. Kościuk)

Risks of thermal shock for the December solstice are completely different. Mainly all horizontal surfaces are threatened, and on slopes, even southern ones, the risk is much lower (Fig. 15).

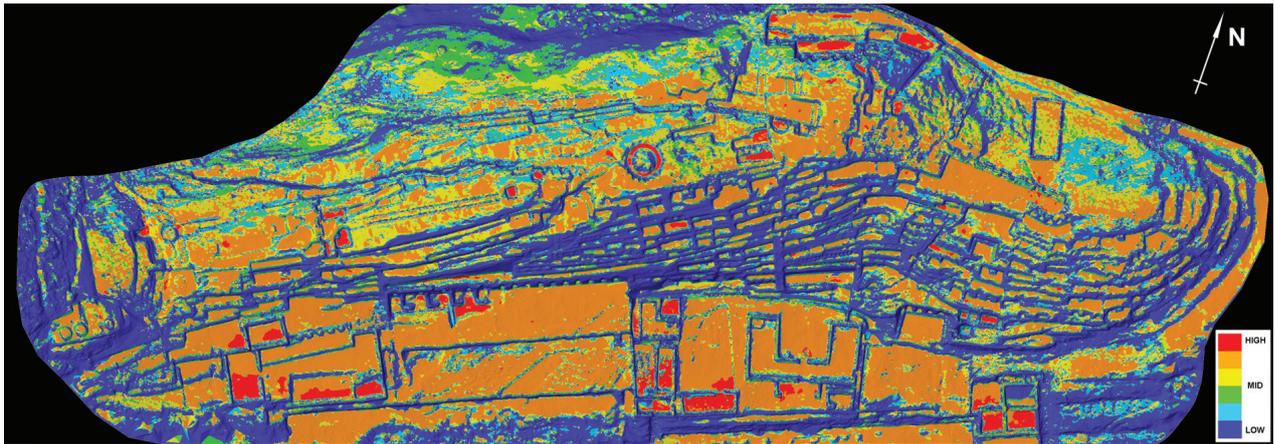
Fig. 16. Accumulated risk factors: slope inclination, depression, thermal shock, wind erosion (elaborated by J. Kościuk)

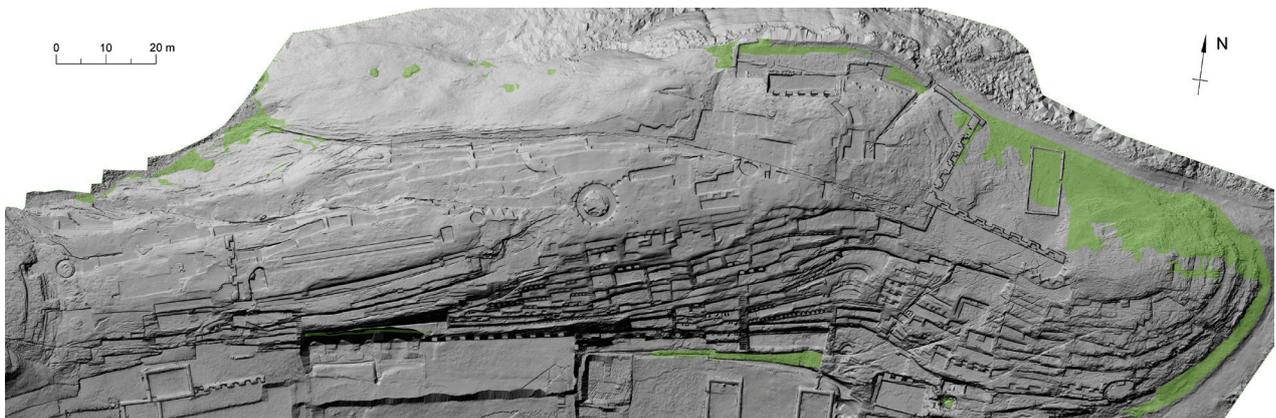
Fig. 17. Green plant zones (elaborated by T. Dziedzic)

The rock is covered with reliefs of varying heights. Due to the presence of artificial (reliefs with symbolic decoration) and natural depressions, there are numerous deposits where water, loose rock fragments, and organic material deposited by the wind collect. The accumulation of humidity and organic material creates favourable conditions for the development of lichens, and as a consequence of their soil-forming activity, also the growth of higher vegetation and mosses (Fig. 17). These plants are

strongly rooted. Attempts to remove them can damage the rock, and root expansion leads to the cracking and breaking of the rock.

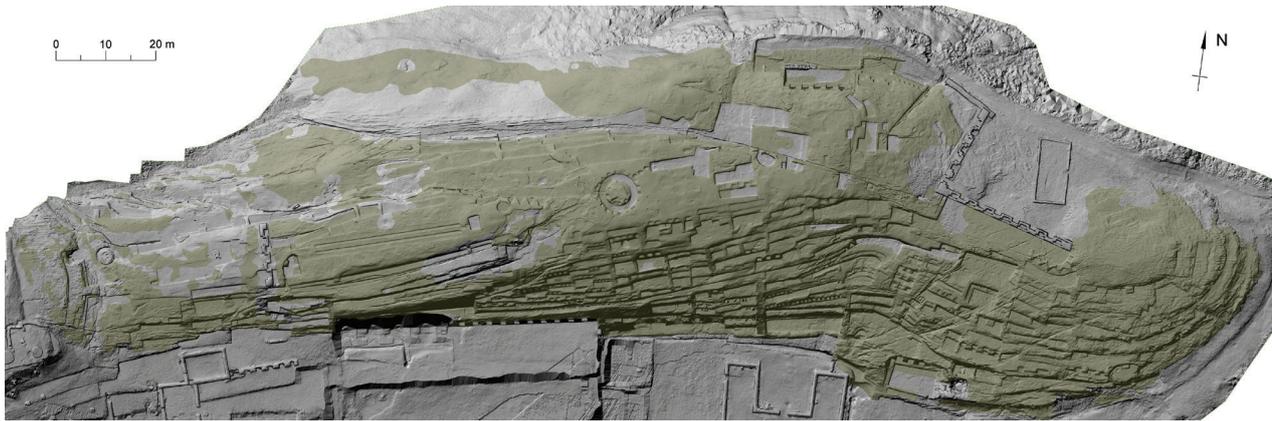
Fig. 18. Zones of intensive occurrence of lichens, fungi, and algae (elaborated by T. Dzedzic)

The growth of numerous types of fungi, algae, and lichens including *Lecanora*, *Cladonia*, *Aspicilia*, *Xanthoria*, and *Rhizocarpon* is observed on most of the rock surface (Fig. 18). Lichens cause moisture in the sandstone to be retained, create colourful spots on the entire surface of El Fuerte, and the acids they produce cause rapid progressive chemical erosion of the rock [16].

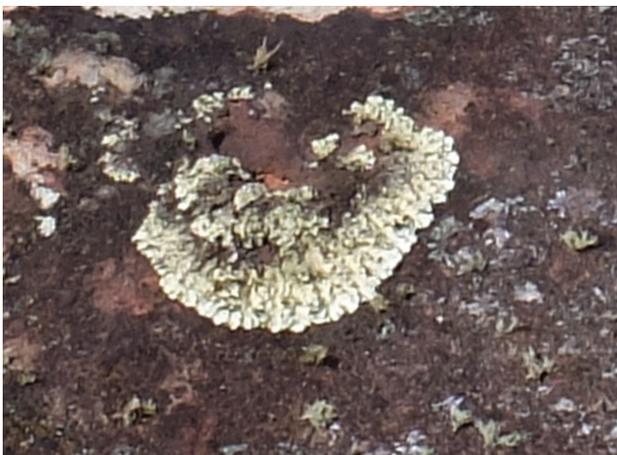
Fig. 19. Prior to application of 40% solution of Biotin R (photo by M. Gąsior)

It was observed that the application of Biotin R caused the decay of lichens at the site (Figs. 19, 20). The effect

was dependent on the concentration applied – the higher the concentration, the more effective the decay. Unfortunately, within a short period of time, it was found that the disinfected area of the rock was quickly inhabited by other lichen specimens. This is a natural process – the special agent used did not restrain the growth for much longer.

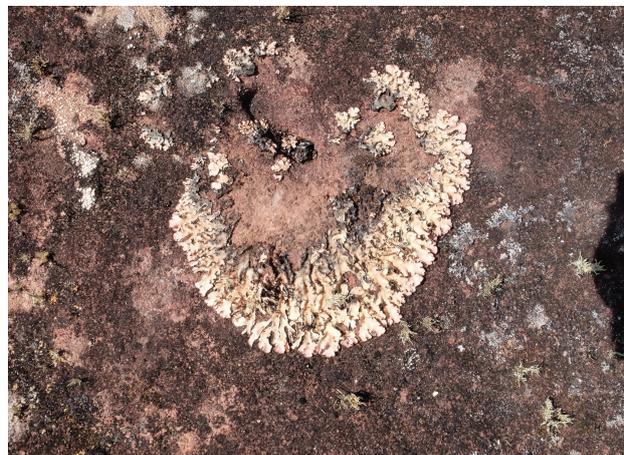
Fig. 20. Seven days after application (photo by M. Gąsior)

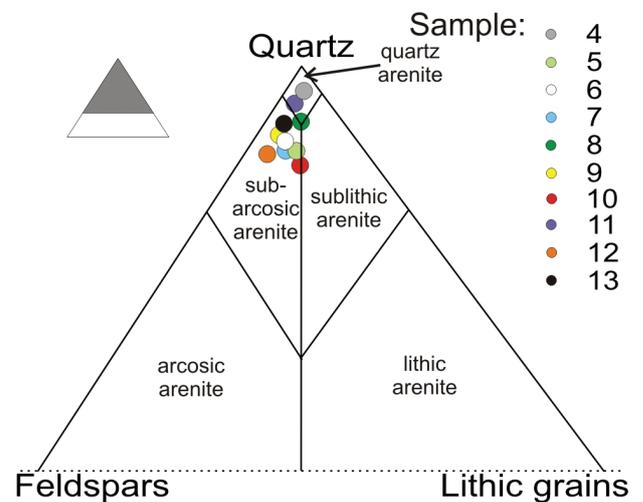
Fig. 21. Classification of investigated Samaipata sandstone samples (elaborated by W. Bartz)

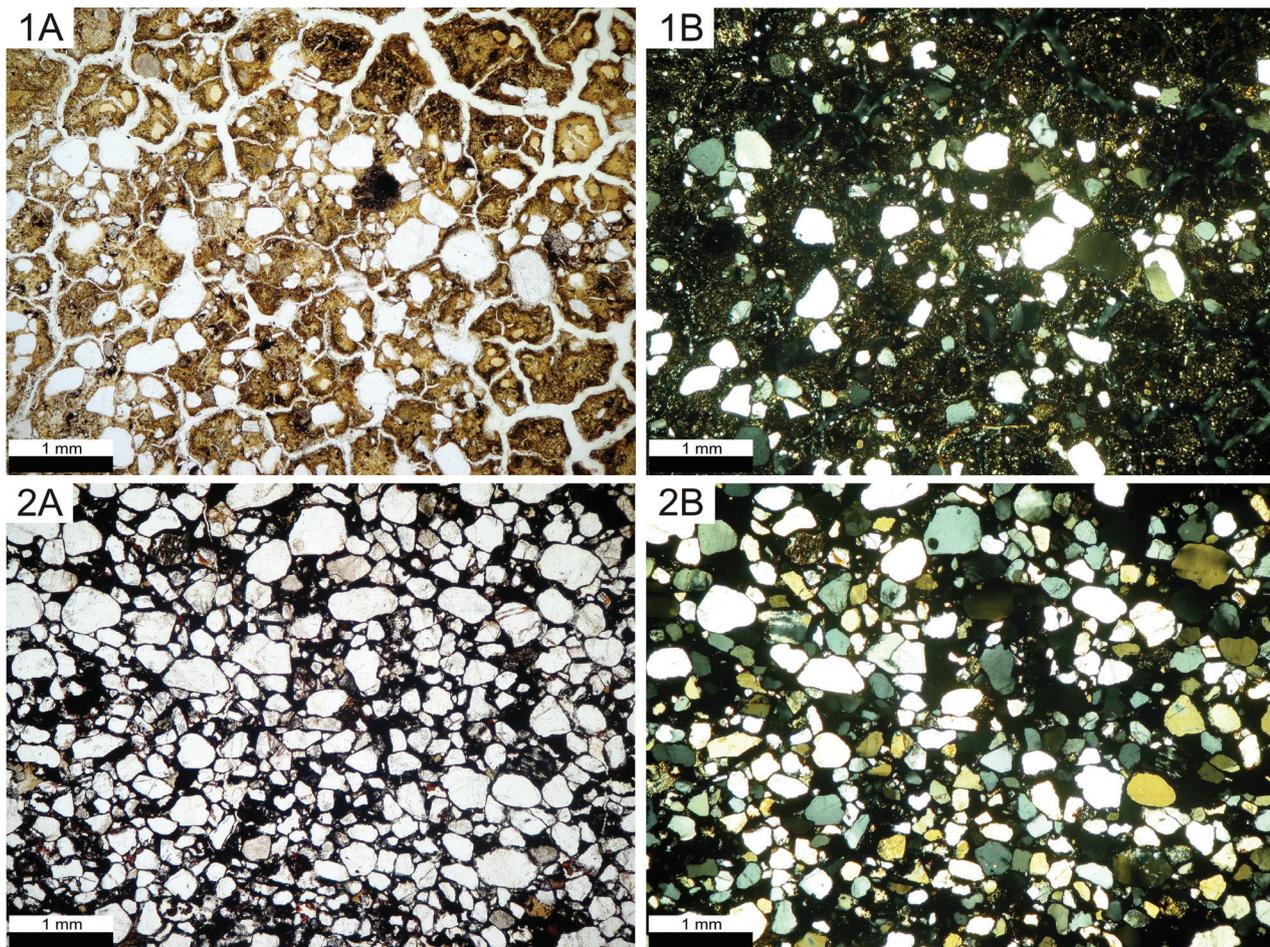
Fig. 22. Samaipata sandstone sample 4 (upper row) and sample 7 (bottom row) viewed in plane-polarized light (A) and cross-polarized light (B) (elaborated by W. Bartz)

and, at the same time, a high content of cement (Table 1). An exact microscopic analysis of the sample showed that it is heavily cracked (Fig. 22) and the framework grains are disseminated in an abundant fine-crystalline mass. The latter shows a yellowish tint, and it is more translucent than typical cement that is seen as black/brown in plane-polarized light. The observed differences presumably result from a significant degree of weathering of the rock.

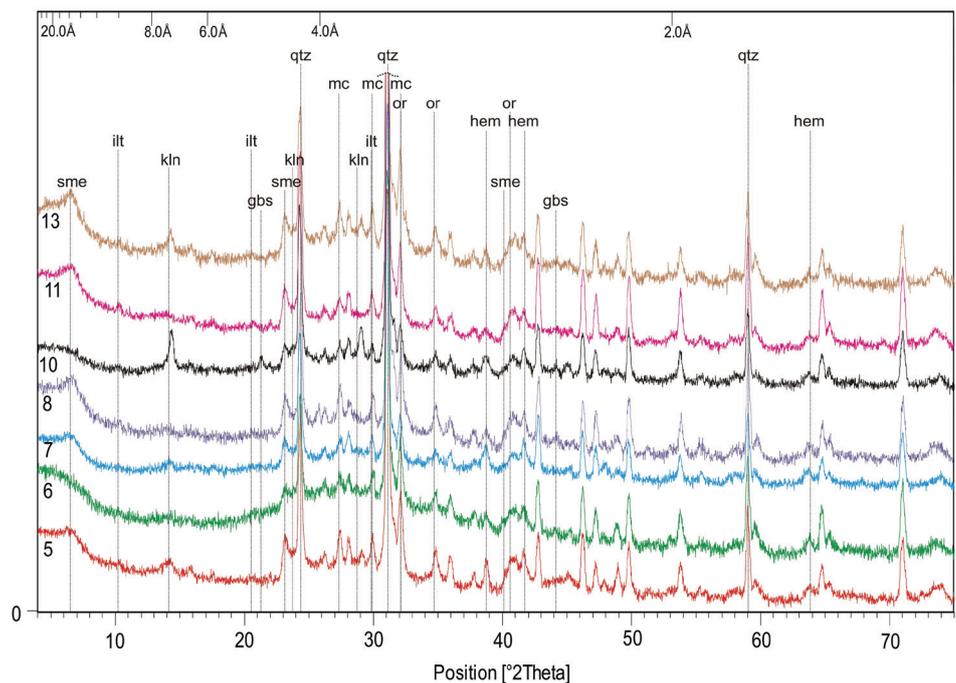
Fig. 23. Results of XRD analysis of sieved fraction <0.063 mm.

Mineral abbreviations:  
sme – smectite, ilt – illite,  
qtz – quartz, gbs – gibbsite,  
kln – kaolinite,  
or – alkali feldspar (orthoclase),  
mc – alkali feldspar (microcline),  
hem – hematite  
(elaborated by W. Bartz)

The next component identified by XRD was iron oxide – hematite, representing the cement of the rock. Its presence is shown by the peaks observed at 2.70 Å, 2.52 Å, and 1.69 Å (Fig. 23).

All of the obtained diffraction patterns are marked with peaks located at low 2Theta values: 10.10 Å, 7.18 Å, and 17.50 Å. They illustrate the presence of clay minerals: illite (or structurally similar muscovite), kaolinite, and smectite, respectively. Illite peaks were also found at 3.35 Å and 5.03 Å, while kaolinite peaks were found at 3.58 Å and 4.33 Å. Peaks located at 4.49 Å and 2.57 Å were attributed to smectite. Aluminium hydroxide (gibbsite) was also identified on the basis of peaks 4.85 Å and 2.38 Å (Fig. 23).

site was very rare and was only found in sample 10. A frequent constituent was clay minerals – kaolinite, identified in samples 5, 7, 10, and 13 and smectite, found in samples 5, 7, 8, 11, and 13 (Fig. 23).

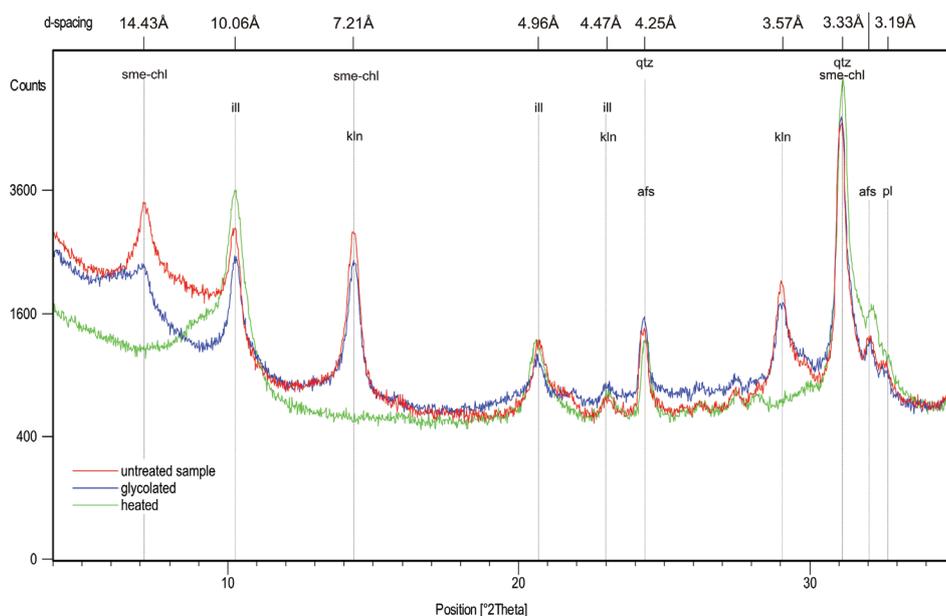
Fig. 24. Results of XRD analysis of oriented clay fraction mounts. Mineral abbreviations: sme-chl – smectite-chlorite, ill – illite, qtz – quartz, kin – kaolinite, afs – alkali feldspar, pl – Ca-Na feldspar (elaborated by W. Bartz)

The clay fraction of the local clay material that could potentially be used for restoration is a mixed-layer mineral – chlorite-smectite, kaolinite, and illite (or structurally similar muscovite; Fig. 24). Illite was identified on the basis of peaks at 10.06 Å, 3.33 Å, and 4.96 Å that remained unaltered by ethylene glycol saturation and heating to 550 °C. Kaolinite peaks were found at 7.21 Å, 3.57 Å, and 4.47 Å in the untreated sample and disappeared when the material was heated to 550 °C. The mixed-layer smectite-chlorite was recognized on the basis of peaks at 14.43 Å, 3.33 Å (overlapping with the most intense quartz peak), and 7.21 Å. The small shift of peak 001 ( $d = 14.43$  Å) after ethylene glycol saturation, visible in the form of a wide peak at 15.5–17.5 Å, confirmed the presence of the smectite layer. This particular peak shifted to 8–10 Å when the sample was heated (Fig. 24).

As smectite is known to increase in volume many times when watered and shrink when it dries, local clay is completely unsuitable for conservation purposes. Other clay deposits need to be found, and their properties need to be examined before using.
