**Michał Kwasek\***

## *Conservation aspects of cast-iron platform shelters on the example of Vistula Pomerania railway stations*

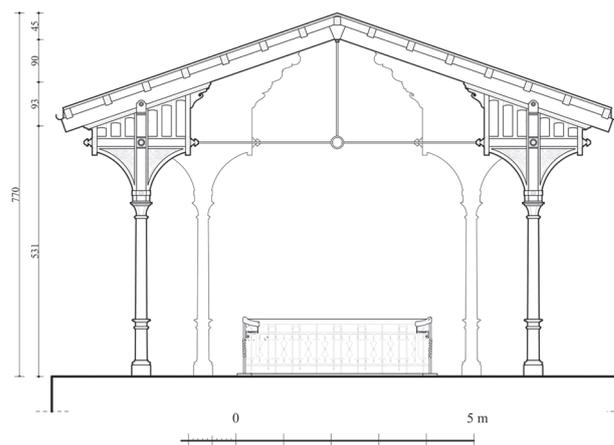
Fig. 1. Gdańsk Główny railway station, cross section through a cast-iron shelter on platform No. 2, inventory 2014 (source: collections of KTPPA, WA PG, elaborated by: A. Urbańska, M. Wachowiak, A. Wyźlic, M. Kwasek)

The standard type of shelter for double-edge platforms is the gable roof (Fig. 1). It is a self-sufficient structure. Cast-iron pillars contain decorative capitals and bases. At the top, they are provided with endings that lengthen the support of the wooden rafters. This also leads to an increased stiffening of their connection with the pillars. The form of this part of the columns imposes the angle of the roof inclination. The cast-iron supports are paired to form load-bearing frames, usually set rhythmically at 6–7.5 m intervals. The elements that bind the pillars together are the wooden rafters. They are the supports for the roof purlins laid perpendicularly on them. The frames are reinforced with metal ties attached above the heads of the columns. To reduce the deformation of these horizontal bars, they were hung to the rafters at mid-span. Such a construction solution was used at least as early as 1850 [12, p. 211] and is representative of the 2<sup>nd</sup> half of the 19<sup>th</sup> century. It was applied at many stations of the railroad line connecting Königsberg with Berlin. They were also made in Gdańsk Główny and Sopot.

At the main station of Pomerania’s capital city, the canopies of platforms 2–5 are historical examples of cast-iron shelters with a large, as for such objects, roof angle. It is about 20 degrees (the slope of the shelters used on this railroad route was usually about 6 degrees) and may derive

from the large width of the platforms and thus the long span (distance between the pillars) of the frame, which is as much as 8.2 m<sup>12</sup>. Consequently, these shelters reach 7.7 m in height, and the horizontal ties are also fixed in a non-standard way – at 2/3 of their height (Fig. 1). These canopies range in length from less than 100 m to just over 200 m. On platform two (the most extended authentic shelter), the decorated cast-iron columns are unusually arranged in four rows. The vast majority of them are situated at a standard distance from the platform’s edge<sup>13</sup>. However, in places where stairs lead to the platform, the cast-iron pillars were moved 1.3 m further from the platform’s edge (Fig. 2). The purpose of this was to create more space for travellers to move around where, due to the location of the stairs, there was less space. The use of the same cast-iron pillars (of equal height) while maintaining the same roof plane required additional elements to raise the rafter support line. For this purpose, a set of wooden beams was used (Fig. 2).

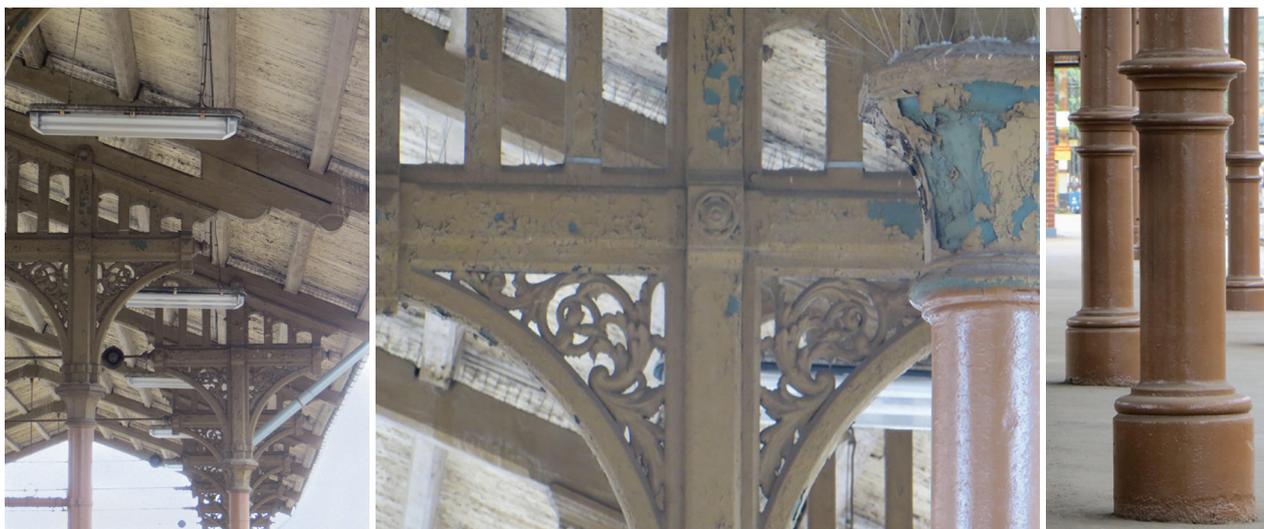
Fig. 2. Gdańsk Główny railway station, platform No. 2 roofing, 2012 (photo by M. Kwasek)

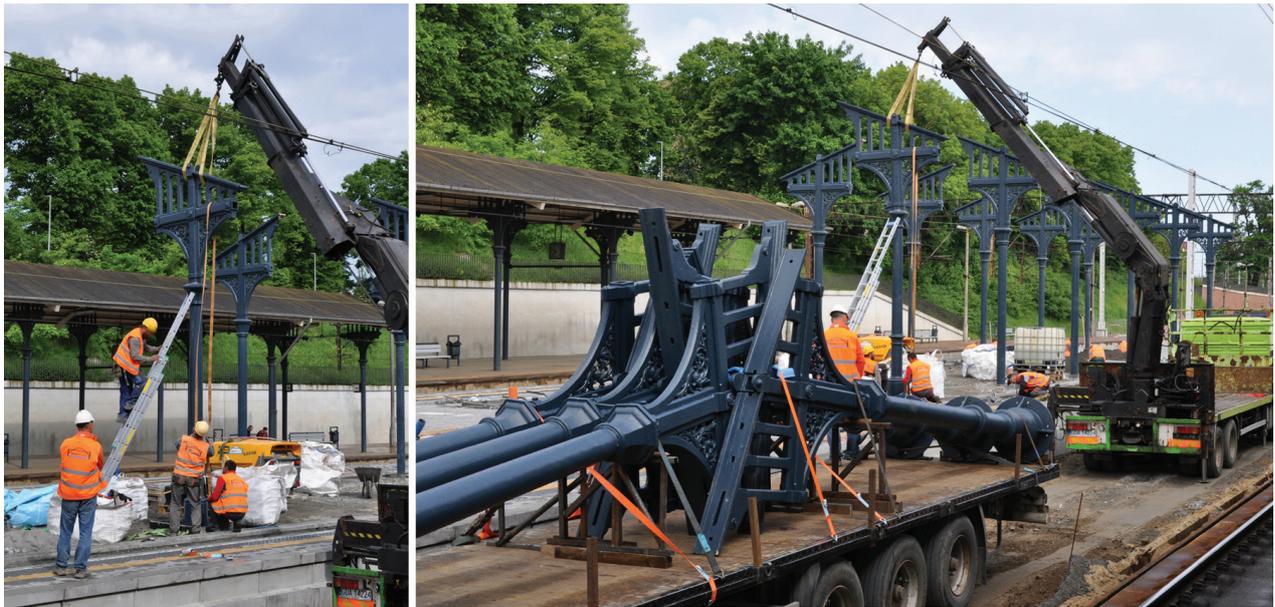
Fig. 3. Gdańsk Główny railway station, works of reassembly of the renovated cast-iron pillars of platform No. 2, 2018 (photo by M. Kwasek)

The pillars have been subject to conservation works. They were thoroughly cleaned of all paint coatings, the original colours were restored, and areas of pitting caused by corrosion were filled in. In 2018, the pillars were repositioned to their former places (Fig. 3), and the wooden elements were replaced with new ones. These were conservative measures, enabling the continuation of such a unique structure, restoring their original appearance from the turn of the 20<sup>th</sup> century. The shelter of platform 1 is a contemporary implementation from the early 1990s. As with the added pillars of platform 3, their upper parts refer to the

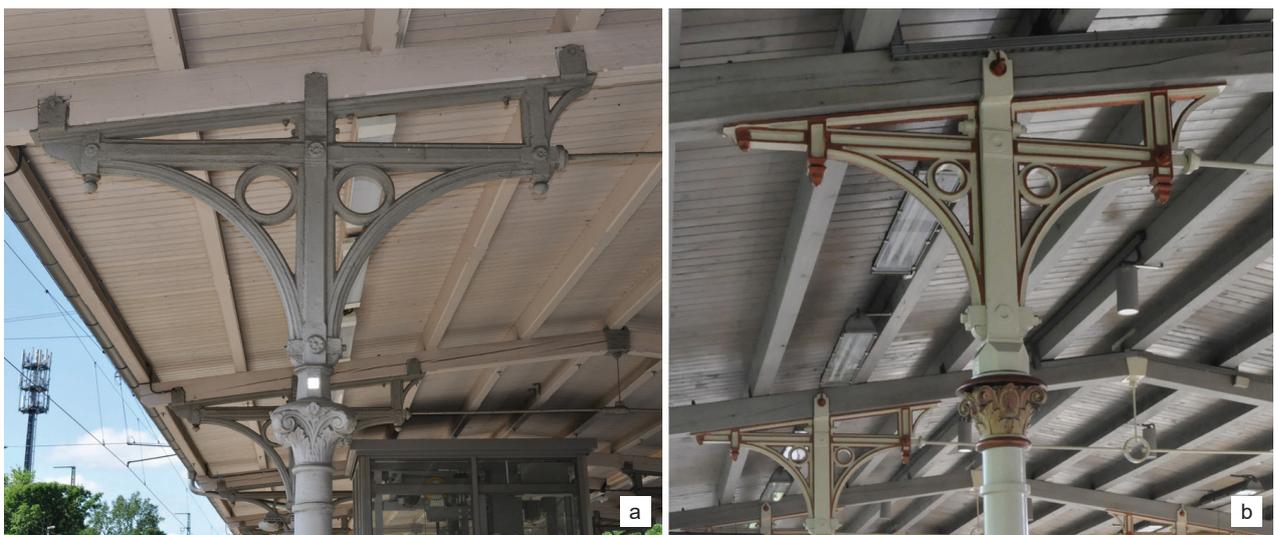
Fig. 4. Comparison of the upper parts of cast-iron columns supporting platform shelters: a) Berlin S Wannsee Bahnhof, 2019, b) Sopot, 2020 (photo by M. Kwasek)

At the Sopot railroad station, there are about 200 m long cast-iron platform shelters. Their form is resembling the ones implemented in numerous S-Bahn stations in Berlin, among others in Yorkstraße, Ostkreuz, Schönhauser Allee, S Wannsee Bahnhof, Potsdam Griebnitzsee and many others (Fig. 4). Occasionally they differ in dimensions, details – the form of decorative capitals or bases, the way of suspension, and the fastening of metal ties<sup>16</sup>. However, structurally and architecturally, they are similar solutions. As in the Berlin's stations mentioned above, the Sopot shelters are characterized by a significantly reduced roof inclination compared to the later construction in Gdańsk – only about 6 degrees. These structures are much lower than in Gdańsk (4.5–4.7 m) and have a shorter span of the metal and wooden frames (5.2–5.5 m). Nonetheless, only one of the presented Sopot shelters is an original structure (Fig. 5). It is located on the platform currently used by suburban trains (SKM). During the 2008–2010 modernization and restoration works, the cast-iron pillars were repositioned, the historic character of the floor was reconstructed, and based on the stratigraphy examination of the pillars, their cream-golden coloration, dating back to the 1870s, was restored<sup>17</sup>.

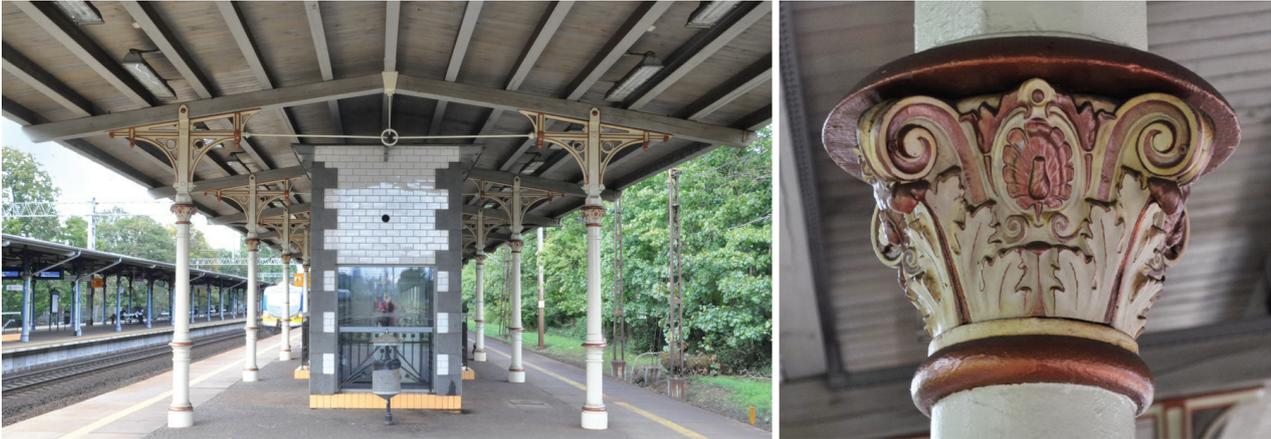
Fig. 5. Sopot railway station, general view and construction detail of the 19<sup>th</sup>-century cast-iron platform shelter on the platform of the SKM (Rapid Urban Railway), 2020 (photo by M. Kwasek)

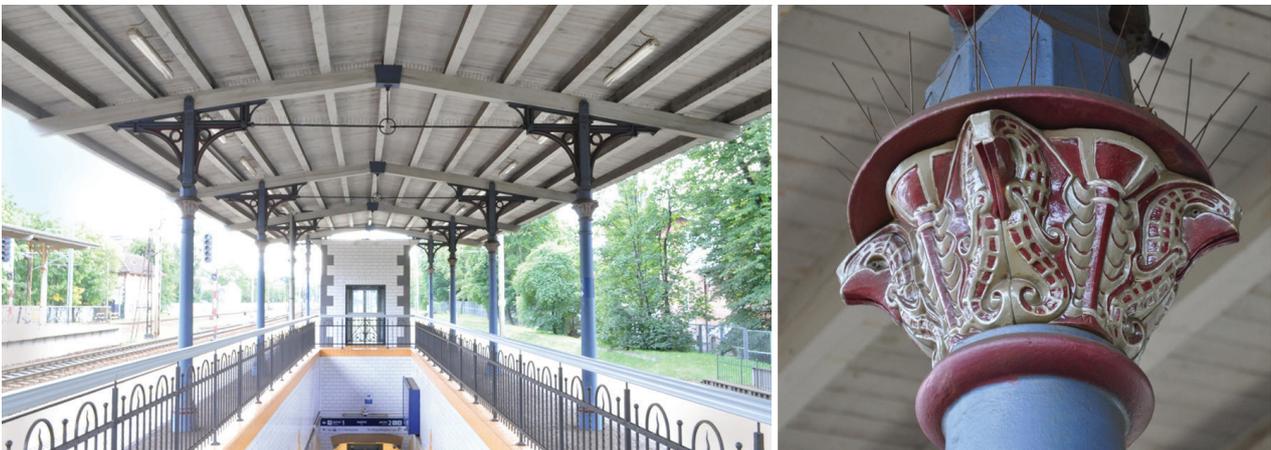
Fig. 6. Sopot railway station, general view and construction detail of the platform shelter on the long-distance platform created about 2011, the state in 2020 (photo by M. Kwasek)

A nearly identical shelter, located on the long-distance platform, is a structural and architectural copy of the 19<sup>th</sup>-century cast-iron construction (Fig. 6). It also applies a similar colour palette, which makes its contemporary

origin hardly recognizable at present. It is distinguished only by individually designed details of the pillar capitals containing maritime motifs. This platform was covered by a double-braced shed of riveted steel construction until ten years ago, presumably dating from the early 20<sup>th</sup> century. It was demolished in 2011. At the same time, the city authorities acquired the historical structural elements from the railroad company. Some of them have been recently renovated and installed as small architecture in front of the Sopot railway station building. Solutions in which authentic elements of railroad infrastructure are used in ur-

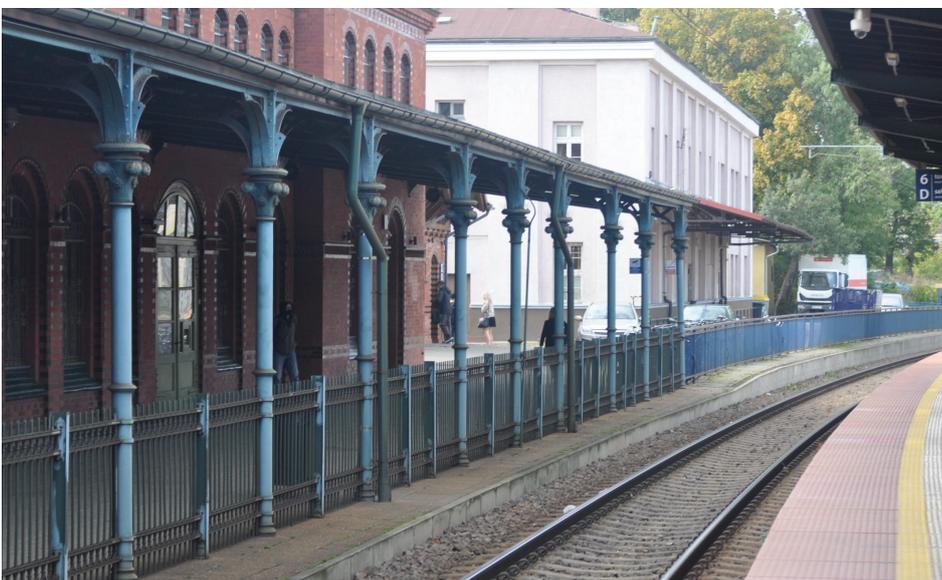
Fig. 7. Malbork railway station, single-pitched platform shelter with cast-iron pillars, the state in 2020 (photo by M. Kwasek)

The railroad station in Malbork presents an intermediate approach between the conservative works in Gdańsk and the Sopot creation, with a strong reference to historical forms. In this facility, a row of cast-iron pillars supports a pent roof, added to the station building from the platforms' side (Fig. 7). During the renovation works carried out in 2014, all elements of this structure were cleaned and painted. Additionally, the pillars were provided with

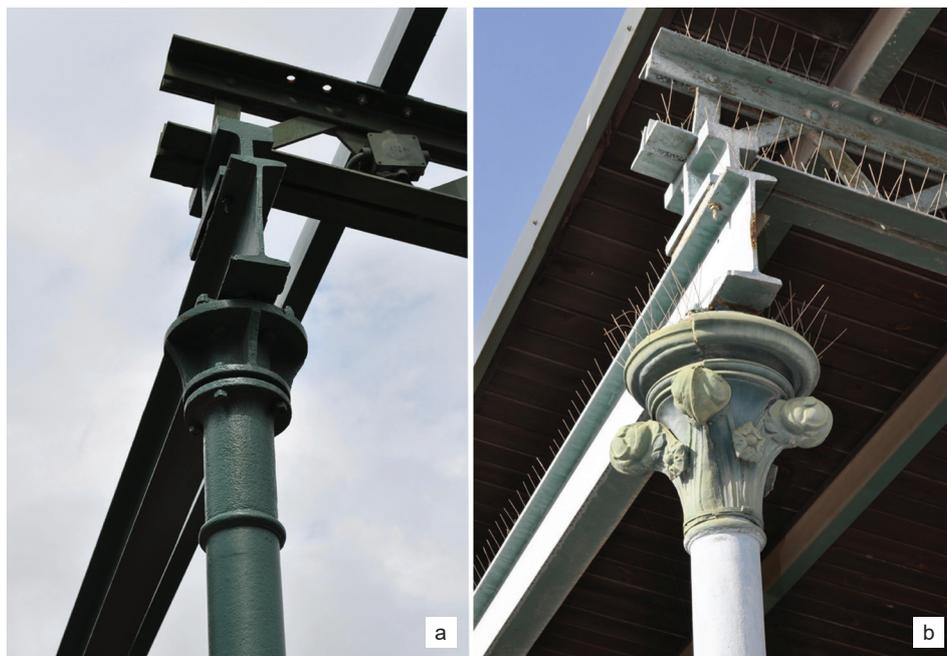
Fig. 8. Malbork railway station, detail of the head of the cast-iron pillar of the platform shelter before and after the installation of the decorative overlays: a) the state in 2014, b) the state in 2020 (photo by M. Kwasek)

decorative capitals bonnet (Fig. 8). They replaced the originals, which presumably were present here and were deteriorated over the decades<sup>18</sup>. The contemporary form of the overlays applied is a relatively liberal reference to those used in 19<sup>th</sup>-century capital realizations, and its contemporary origin is recognizable without difficulty. Nevertheless, the material and quality of workmanship are not of the highest standard. They were made of plastic or thin sheet of non-ferrous metal<sup>19</sup>. These materials have aged differently from the painted surfaces of the metal pillar (Fig. 8). While the fastening systems of the cast-iron capital elements remain in most cases invisible, the described bonnets in Malbork were attached to the column using steel clamps. Undoubtedly, such a method of assembly is exposed to easier destruction and may also have a negative impact on the aesthetics of the solution. Commendable in this realization is the decision to restore the pillars' incomplete form and the use of patterns indicating their non-authentic origin. To some extent, the selection of material applied may be justified by the nowadays difficulty of replicating a historic building fabric – in preference to a readily available plastic. Nevertheless, as the examples illustrate:

<sup>18</sup> The form of the upper part of the column (Fig. 8, condition as of 2014), with an isolated section (with the use of a minor, simple band), indicates that cast-iron decorative bonnets have initially been mounted there, which were usually attached around the shaft to form decorative capital.

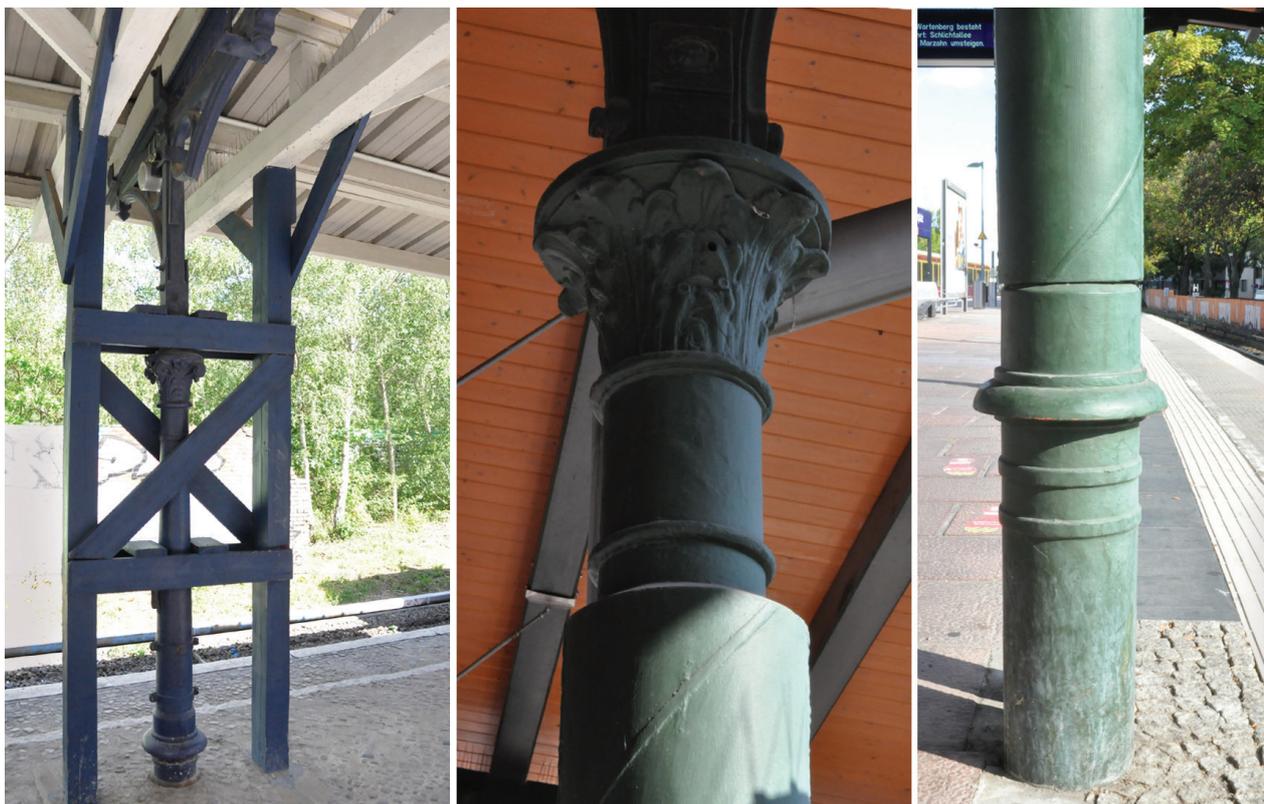
Fig. 9. Berlin, examples of repair work on cast-iron columns of platform shelters in S-Bahn stations, the state in 2019 (photo by M. Kwasek)

Potentially the most serious difficulties that may occur during the exploitation of a cast-iron structure may be generated by possible reparatory works. As indicated by unsuccessful attempts to repair cast-iron pillars [22, p. 58], identifying an adequate intervention method is then crucial. Similarities in the applied forms, material, and construction solutions of cast-iron platform shelters in Poland and abroad permit analogous and proven repair means. In Germany, techniques have been developed that allow for the temporary or permanent strengthening of such damaged pillars, using additional external metal jackets or an auxiliary wooden structure (Fig. 9). The conducted experimental studies indicate that cast-iron columns' reinforcement is also possible using composite fibres, which does not significantly affect the columns' aesthetics [23].
