**Anna Bojeś-Białasik\*, Agnieszka Luboń-Radwańska\*\***

## *Research and conservation of the so-called Studentate at the Dominican Priory in Krakow*

The topic of the article is architectural and conservation research in one of the rooms of the so-called studentate in the Dominican priory in Krakow, which brought very interesting and unexpected results. In a small room that served as a kitchen, elements of late-Gothic decoration were discovered, e.g. beamed ceiling, portal and large fragments of polychrome. The article describes the course of research and subsequent discoveries, each of which required individual decisions regarding the method of conservation and exposition. An important issue was the interpretation of the iconographic program of the polychrome and the analysis of the entire decoration in the context of architectural transformations and the supposed historical function of the room. Reference was also made to conservation and technical procedures related to, among others, the need to introduce a new load-bearing ceiling above the room.

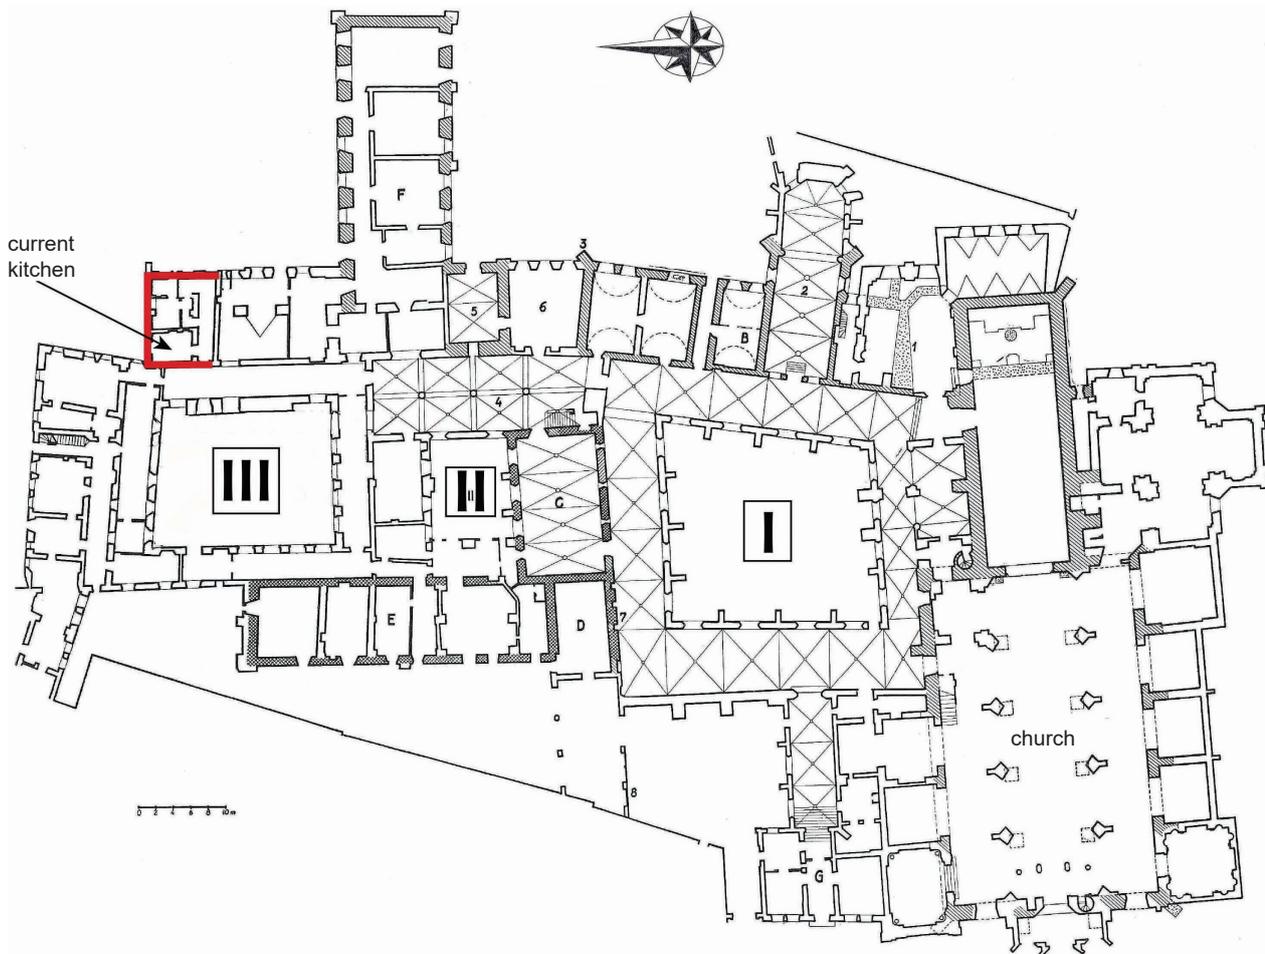
Fig. 1. Plan of Dominican priory in Krakow; the range of supposed 13<sup>th</sup> century building marked in red; I, II, III – cloisters (elaborated by A. Bojęs-Białasik)

the distant third garth, the spaces were usually not included in the most urgent development plans, and therefore also research plans (Fig. 1). The first research in this area was conducted by Maria Filipowicz in 1996 and identified a stone and brick wall of a building with a brick portal, with a lintel in the form of a broken arch, located in northern section of the eastern wing's eastern wall [5, p. 299]. At the time, Filipowicz dated it to the 14<sup>th</sup> century. In the vicinity of the spaces, in the adjacent arm of the cloister that had been remodeled into six cells, research and conservation work was conducted in stages in the years 2012–2015 (Agnieszka Luboń-Radwańska, Anna Bojęs-Białasik), which found that the oldest parts of the cloister walls (the outer walls) date back to the 15<sup>th</sup> century, and their net vaults – with a complex rib figuration – refer to the 1<sup>st</sup> half of the 16<sup>th</sup> century. In the years 2018–2019, the spaces adjacent to the rooms under study from the south were studied (Dariusz Niemiec, Maria Filipowicz), but the results have not been published. However, it is known that that the above-mentioned stone and brick structure was re-dated to the 1<sup>st</sup> half of the 13<sup>th</sup> century.

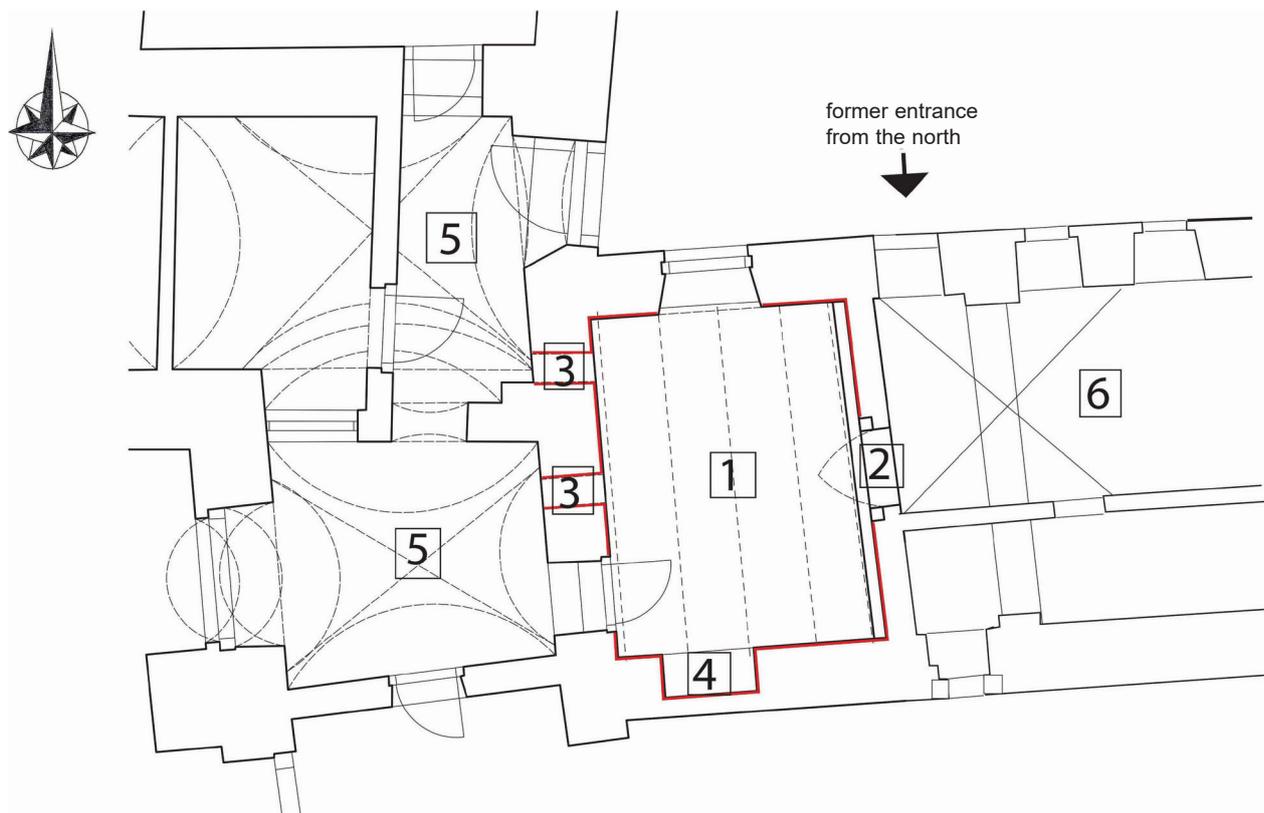
Fig. 2. Dominican priory in Krakow – plan of rooms researched in 2017–2018. The kitchen and ducts in western wall marked in red; 1 – kitchen covered with Late Gothic wooden beam ceiling, 2 – Gothic portal of 15<sup>th</sup> century, 3 – duct in the western wall, 4 – former entrance to the kitchen from the south (bricked up), 5 – rooms separated from the former cloister, 6 – adjoining cell (elaborated by A. Bojęś-Białasik)

a small vestibule, it was a part of the research performed in just one of them – the kitchen – that resulted in the most interesting findings (Fig. 2). The two other spaces were created as a result of partitioning a former cloister that was erected around the turn of the 15<sup>th</sup> and 16<sup>th</sup> centuries. The kitchen was created by partitioning an older building, probably the stone and brick structure found by Filipowicz. The structure may have originally been detached and, over time, became absorbed into the priory. The peripheral walls of its cellars were erected using limestone, with large relieving arches built with large blocks of this stone. This quite archaic structural system allows re-dating it to the 13<sup>th</sup> century [6]<sup>1</sup>. The surviving remains of the composition of the northern façade of the ground floor, with a portal with an arched archivolt and probably two windows on both of its sides, are slightly off the axis of symmetry of the presumed building (Fig. 3). The dearth of data does not allow for wider conclusions on the original

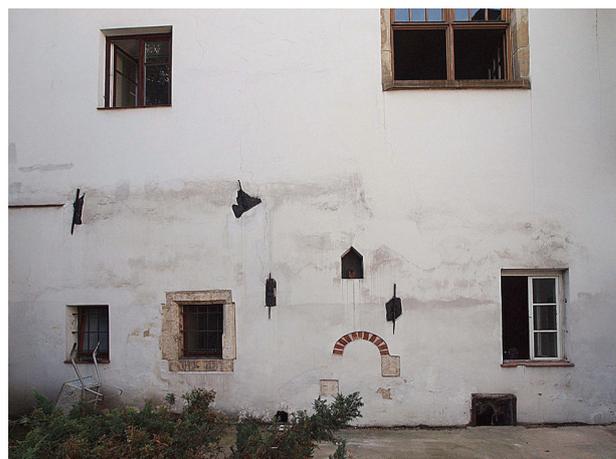
Fig. 3. Dominican priory in Krakow – the northern elevation of the eastern wing of monastery located at the 3<sup>rd</sup> cloister, relics of the façade composition at the ground floor: portal with semicircular brick archivolt and windows, partly rebuilt (photo by A. Bojęś-Białasik)

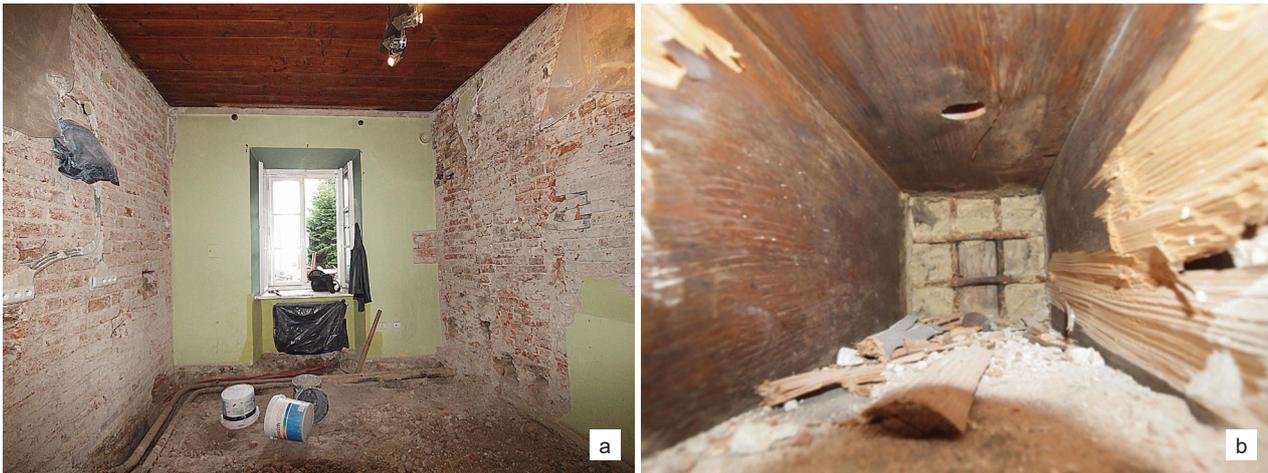
Fig. 4. Dominican priory in Krakow – the kitchen interior at the preliminary stage of work:

a) view of the northern side of the kitchen, b) view of the southern timber boarded duct with grate (photo by A. Bojęs-Białasik)

potential with hope of future exposition. Before the research in the kitchen began, it had featured a plank floor and a flat ceiling made of boards, while the walls were covered with contemporary plaster and the interior was illuminated by a single window in the northern wall. The research of all the interior’s elements – the walls, ceiling and floor – was conducted simultaneously (Figs. 4a, b).

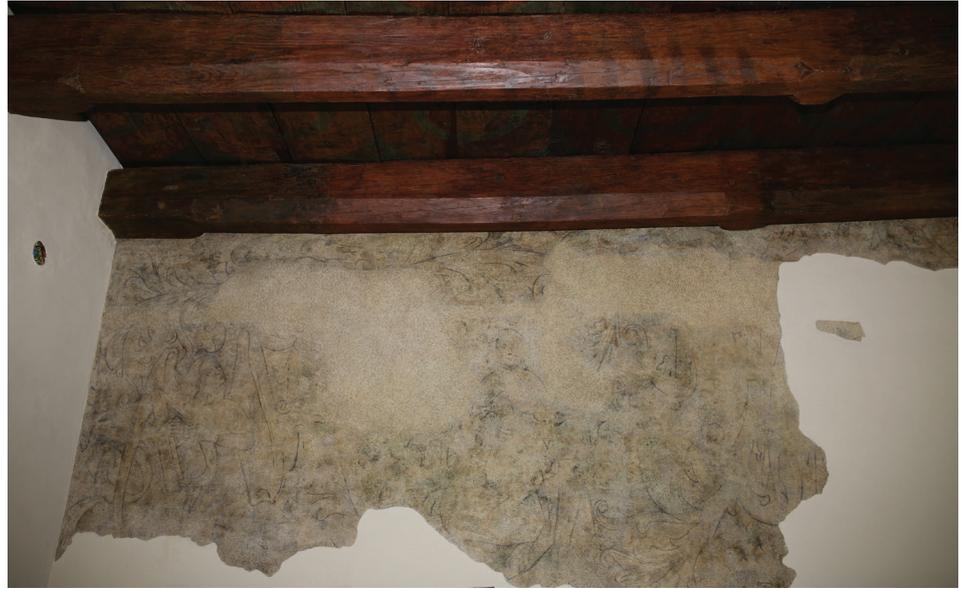
Fig. 5. Dominican priory in Krakow – view of the western kitchen wall with revealed fragments of polychrome – after conservation work completion (photo by A. Luboń-Radwańska)

element, although gaps in the painting's continuity may lead to erroneous interpretations of the whole (Fig. 5). The painting's context appears to suggest that the central figure may be Mary adored by a group of angels that play music<sup>6</sup>. The scope of the missing elements was extensive enough to prevent a clear confirmation of these observations. During the removal of contemporary plasters, a continuation of these motifs up to the ceiling boards was discovered, along with individual traces of them in other places. These traces show that the polychromy formed a complete decoration of the interior, reaching the central, most important scene painted on the opposite (eastern) wall and separated by a bordure (discussed further in the paper).

The architectural research on the western wall also brought interesting results. It was built using bricks that measured 7.5–8 × 13–14.5 × 28–29 cm, in an irregular brick bond, with a predominance of the Polish bond, while at a height of ca. 80 cm above the floor, there were two ducts (tunnels) with square-shaped cross-sections that measured 35 × 35 cm, which ran along the entire width of the wall<sup>7</sup>. The interior of one of the ducts was deliberately lined with boards and fitted with an iron woven gate, placed in the external opening of the duct<sup>8</sup>. The ducts were built at the same time as the wall, but traces show that they were later slightly enlarged/widened (there were visible hack marks on the side walls), perhaps in association with the boarding of their interior, only to brick them up from both sides after some time (Fig. 4b). The brick and brick bond parameters indicate that it can be dated to the late 15<sup>th</sup> century.

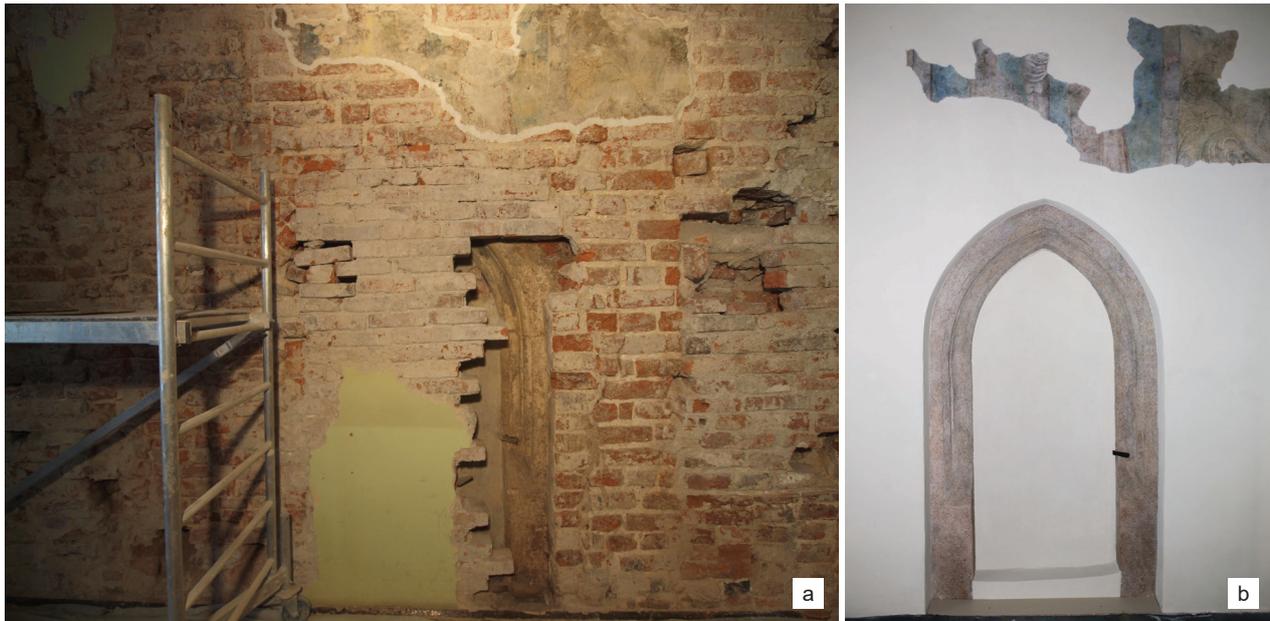
On the opposite (eastern) wall, another fragment of the painting had survived, but in a vestigial form. Apart from the linear drawing of acanthus leaves, it also featured a vertical strip of colorful bordure that framed a figural scene with three figures presented on a blue background. Only fragments of these figures have survived, but the attributes and the placement of the central figure suggest the depiction of the Crucifixion of Christ<sup>9</sup>. Notably, the painting was placed on a thin brick coat that probably covered the entire face of the eastern wall and was made very poorly. The brick coat that covered the wall showed signs of frequent interference; one of these was the creation of a shallow recess with a bottom lined with a wooden board, but without a lintel, which resulted in a wide crack in the layer above the recess. During research, underneath the lower, very loose portion of this coat, there was a Gothic portal built of Jura limestone (secondarily bricked up) with stylistic features typical of the 15<sup>th</sup> century (Fig. 6a).

Traces showed that up to the point of being covered by the coat with the polychromy, the portal had functioned as a passage between the present-day kitchen and the nearby cell (located from the east). The construction of the wall was associated with bricking it up and covering it with a layer of brick coat with polychrome.

At an unspecified time, a part of the coat was removed from the aperture of the portal, once again allowing for passage to the adjacent space. The toothing of the coat was then evened out using brick, with the construction of lintel above the portal, made from brick with a header bond. After some time, the portal aperture was once again bricked up and later – probably in contemporary times – the opening in the coat was also sealed. Due to a lack of access

Fig. 6. Dominican priory in Krakow – the eastern wall with a brick covering and a fragment of polychrome above it (Crucifixion?):  
a) gothic portal while uncovering, b) gothic portal and polychrome after conservation work completion  
(photo by A. Luboń-Radwańska)

to the load-bearing wall located deeper, it was difficult to date it and ascertain whether the portal was its original part or a later addition. The portal survived along with a sill, located 8 cm below the previous level of the kitchen floor.

The revealing of the complete form of the Gothic portal contributed to the decision to exhibit it. As part of conservation work, a carefully made ogival brick arch was built above the portal in the brick coat, while the portal itself was subjected to technical, preservative, aesthetic and visual conservation, with the gaps in plaster and monochromies filled in (Fig. 6b). The surviving fragments of wall polychromy were cleaned and subjected to conservation, i.e., gaps were sealed and the content of the painting was highlighted using pointing, preserving the subtlety of the original modeling. Decorative motifs and forms and the calligraphic character of the polychromy appear to be typical of the late 15<sup>th</sup>- and early 16<sup>th</sup>-century Late Gothic aesthetic, which attached great significance to sophisticated form and artistic elegance of the final product.

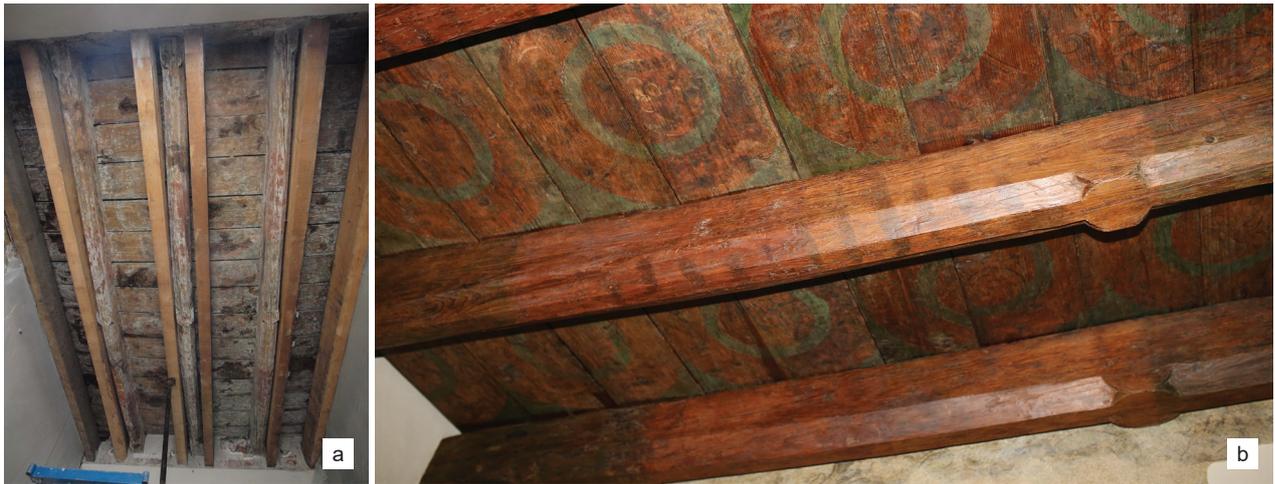
The distinctive motif of acanthus leaves vines – which weaved in semicircular patterns – was also present on the beam ceiling that was uncovered after the removal of the contemporary soffit boards<sup>10</sup>. The beam ceiling structure consisted of five beams with chamfered edges, which ended on both sides with interpenetrating convex molding so-called curtain-crystal (converging stop), as from wide straight deck boards laid perpendicularly with scarf joints.

All the ceiling beams had central moldings (with curtain-crystal edges at intersections with chamfers), whose location correlated with the tip of the pointed arch of the eastern wall's portal. The faces of the moldings were painted with coats of arms whose content was impossible to read. The longitudinal – not transverse – arrangement of the beams relative to the space's plan and the two-sided profiling of the beams near the walls indicated either the reuse or relocation of the ceiling deck, with an intent to correlate it with the portal's position (Figs. 2, 7a). The contact between the furthestmost ceiling beams with the plaster featuring the painting, fragments with technological plasterwork underneath the contemporary soffit and the uniform decorative motifs of the ceiling and walls show that they were components of a chronologically coherent décor.

Fig. 7. Dominican priory in Krakow – Late Gothic wooden beam ceiling (“lower” one):  
a) while uncovering, b) after building and conservation work completion (photo by A. Luboń-Radwańska)

chite pigment with plant-based black, which also covered the beams. Due to the small amount of data, the latest coat of paint on the deck was dated in a very general manner to the early modern period (Fig. 7b).

The technical condition of the beam ceiling elements was good, but the structural members showed very pronounced bending, which required urgent intervention, especially in terms of the planned structural reinforcement and emergency support, which was in effect for the entire period of work. The conservation of the Late Gothic beam ceiling followed two ways. The beams were left in place and subjected to in-situ conservation, while the deck boards were dismantled and transported to the workshop. Prior to the conservation, a fragment of the polychromy was subjected to a macro X-ray fluorescence (MA-XRF) analysis to mark the content of each element in the pigments. Afterwards, infrared images of all boards were taken, highlighting the outline of fragments of the linear drawing of the vines. The boards were cleaned from the remaining bits of clay plaster and impregnated, the gaps in the wood were filled in, and pointing was applied (linear, watercolor), enhancing the surviving polychromy fragments from both historical periods. The basis for this decision was the similarity between the circular motifs, which did not cancel each other out in terms of aesthetics. Afterwards, the surface of the boards was covered with shellac and proofed with wax.

The Late Gothic lower deck, with painted beams and boards, was left in its original position in a complete state, and subjected to thorough conservation. Its beams were also strengthened using rods suspended from the steel beams of the new ceiling, thus relieving it from all of its previous load and giving it a purely aesthetic function (Fig. 7b). Another unexpected discovery was made during

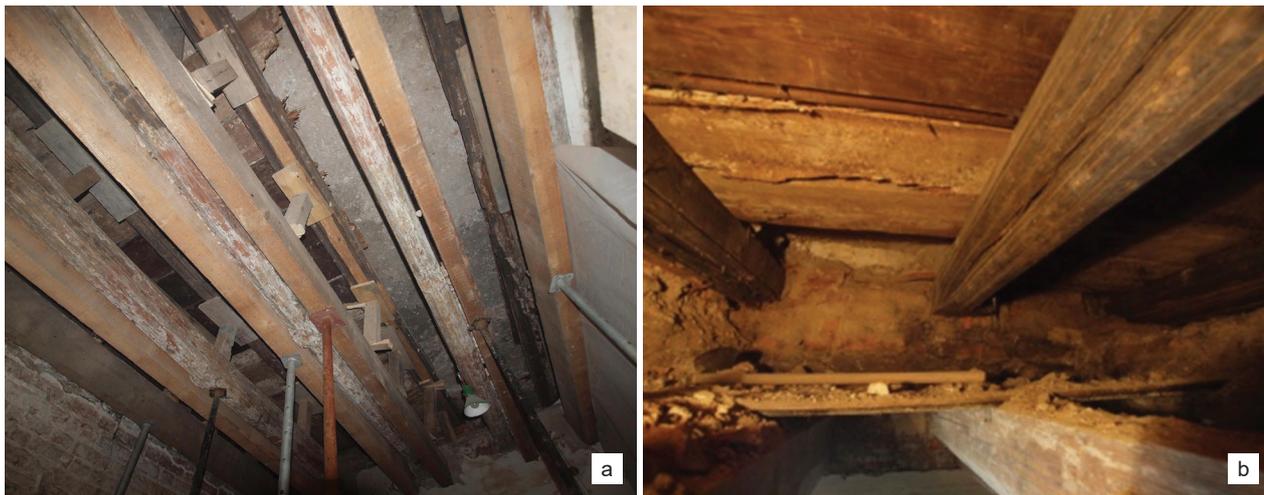
The dismantlement of the boards unexpectedly contributed to yet another discovery. Around 80 cm above the board deck (let us call it the lower deck), another wooden beam ceiling with the same structure was discovered (beams and transverse deck boards), but that also spanned the adjoining cell, or at least a part of it. This higher beam ceiling consisted of evidently secondary elements, but these were largely sourced from a uniform cover, which had been dismantled and used here as a technical ceiling to lighten the load applied to the lower deck. The notches in the ends of the beams and traces of cut elements indi-

cated that it had featured dense beams ceiling with fasciae and a central molding on one beam, with the beam edges molded using a combination of rollers and undercuts, which was very popular in Krakow both in the 16<sup>th</sup> and in the 17<sup>th</sup> century [7], [8] (Figs. 8a, b). The vast majority of the beams were in a state of nearly complete decay (dry rot), and they were anchored into the walls in a makeshift and amateurish manner, without adherence to the logic of construction of both the beams and the entire ceiling. Some of the beams featured secondary trimming and were left without original endings. The ceiling surface was formed by all sorts of boards, with some featuring surviving molding, which suggests they may have been sourced from a dismantled deck or from other structures, such as furniture, while others were simple unworked boards, used without deliberate intent. The elements of the upper ceiling that could be accessed for research showed no signs of polychromy. The space between the two ceilings was filled with rubble with fragments of brick and pieces of broken up clay plaster. In that area, in the south-eastern corner of the space, we observed signs of the extensive application of clay putty in the beams and wall, with the applications connected to the chimney vent – located inside the wall – of a furnace located in the cellar [9, pp. 142–144]<sup>11</sup>.

The catastrophic technical condition of the upper beam ceiling (which supported a layer of rubble, grout and the flooring of the first-floor hallway!) first required a decision to be made concerning the structure of the new ceiling above the kitchen so as to prevent structural failure and collapse. The assembly of this ceiling was an extraordinarily difficult task, which was performed in stages and with the application of due caution<sup>12</sup>. The new deck,

Fig. 8. Dominican priory in Krakow – wooden beam ceiling (“higher” one) – “technological”:  
a) both ceilings while exploring with intervention support, b) rubble charge filling the space between the ceilings  
(photo by A. Bojęs-Białasik)

<sup>12</sup> The dismantling of the upper historical deck and the installation of a new structure with steel beams was done without compromising the thin flooring of the 1<sup>st</sup> floor.

supported by steel beams, anchored directly underneath the first-floor flooring layers, took over the function of a horizontal load-bearing and fire barrier element. Underneath it, only a single beam of the upper beam ceiling was left in place, which was proofed and disinfected, while other beams had disintegrated completely and had to be removed.

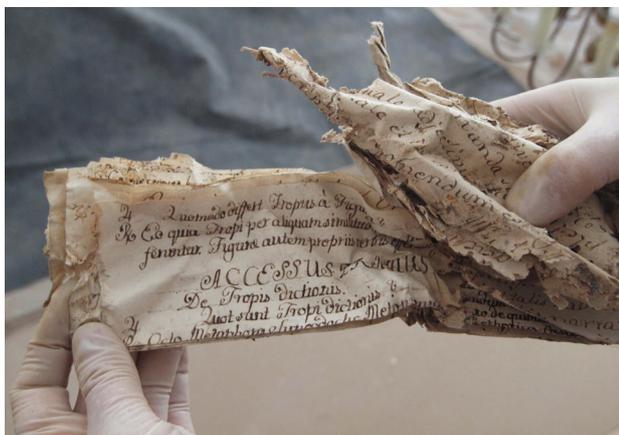
the work. During the dismantlement of the deck boards of the lower ceiling, manuscripts in Latin were found in a narrow opening between them, probably used as a makeshift sealant. The cut-up strips of paper, covered in handwritten text, were formed into spirals like oakum, which was typically used to seal gaps like this. The manuscripts were secured and given over to the Dominicans (Fig. 9).

Fig. 9. Latin manuscripts found during disassembling of the Late Gothic ceiling in Dominican priory in Krakow  
(photo by A. Bojęs-Białasik)

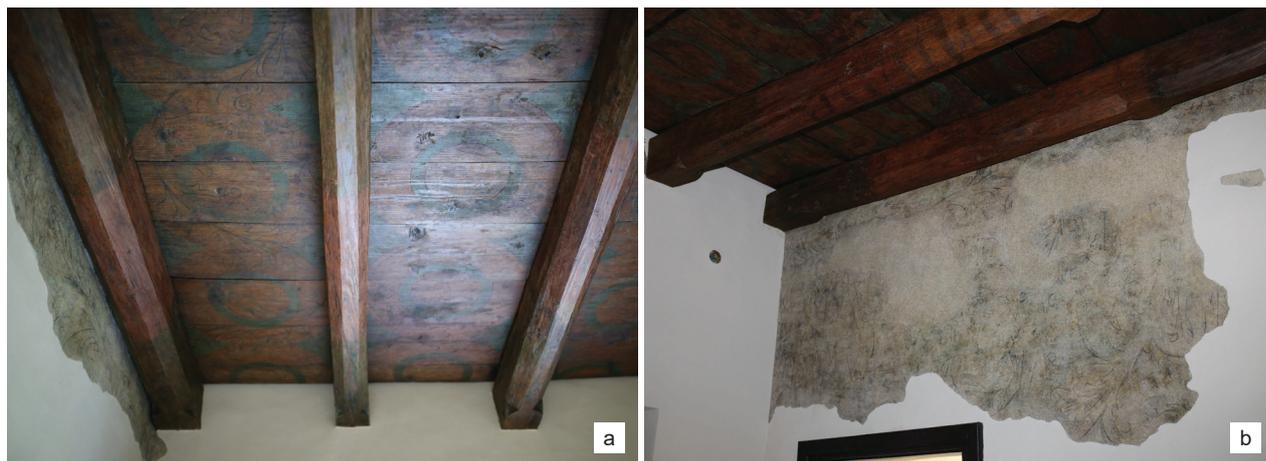
After the research and conservation work was concluded, the kitchen space received a previously unknown, stylistically coherent aesthetic expression from the late 15<sup>th</sup> or early 16<sup>th</sup> century. The surviving remains of the décor indicate that the acanthus vines “weaved up” both the walls and the ceiling, stylistically unifying the entire interior. The supposed interpretations of the two fragmentarily surviving scenes of the painting link it with religious themes, but the wealth and intensity of the décor require us to explore the function of the space and its user (users). In previous studies of the part of the priory in question, the presence of lay people in this space was considered, and it had been attested not only by the 19<sup>th</sup>-century descriptions of the complex, but also the distinctive spatial layout of the northern wing, located near the third garth, which had doubled circulation spaces that were separate from and ran parallel to each other. This atypical situation could be justified by the necessity to separate the friars from the lay people present there, whose presence may have resulted from the relocation of the priory gate to this

Fig. 10. Dominican priory in Krakow – kitchen views after completion of research and conservation works:  
a) view of the ceiling and polychrome on the eastern wall, b) view of the ceiling and polychrome on the western wall  
(photo by A. Luboń-Radwańska)
