Architectus

DOI: 10.37190/arc240207 Published in open access. CC BY NC ND license

Historical windows and their impact on the energy balance of the building

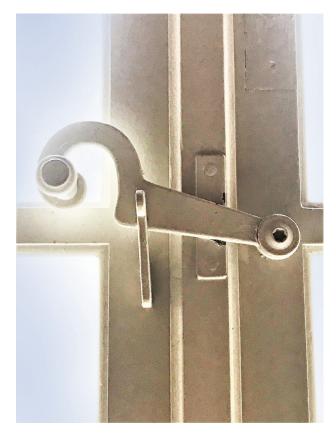
Fig. 3. Cracow, Poselska 7, a deadbolt after renovation (photo by D. Strzałka-Rogal)

Assessing the significance of the window or windows and their contribution to the overall character of the building is the first step in deciding on the appropriate course of action [7]. The preservation of a historic original façade is an irreplaceable heritage resource that should be left and repaired whenever possible [8]. The significance of a historic building, both as a whole and in terms of its component parts, can be assessed by considering its heritage value [9]. Historic window systems are typically built with great attention to detail (such as weather protection) and with good quality materials (such as heavy-duty wood) [2]. Problems associated with the passage of time – peeling paint, cracked glass and missing putty – can look unsightly, but they are easily repaired (Fig. 3) [10].

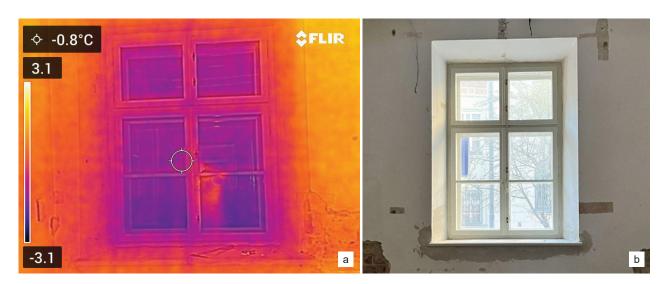
Fig. 4. Cracow, Poselska 7, historic window joinery:

a) photo taken with a thermovision camera showing heat loss within the window, b) existing condition of the window (photo by D. Strzałka-Rogal) II. 4. Kraków, ul. Poselska 7, zabytkowa stolarka okienna:

The age of a building's windows can affect the energy balance, primarily in terms of energy efficiency [14]. Over time, gaps or cracks can develop in the windows, allowing air to enter or leave the building (Fig. 4). This air infiltration can lead to drafts, loss of conditioned air and increased energy consumption as heating or cooling systems compensate for temperature changes.
