Results of the latest interdisciplinary research conducted in the Church of St. James in Sandomierz

The article is a summary of interdisciplinary research conducted in the 13th-century Dominican Church of St. James in Sandomierz in May 2022. The research included an archaeological survey located at the junction of the presbytery and the nave, followed by an architectural and historical-artistic analysis of the discovered walls and architectural details. The aim of the work was to obtain new materials regarding the beginnings and subsequent transformations of the church of St. James. In addition to traditional research and documentation methods, digital technologies were used, i.e. digital photography, laser scanning and photogrammetry. The stages of archaeological work recorded in this way could be incorporated into the existing digital 3D model of the entire monastery complex. Archaeological methods, as well as preserved source materials (textual and iconographic) were used to date individual structures. Due to later excavations (related to reconstructions and burials), the relationship between the layers recorded in the excavation did not create a clear sequence and cannot be th

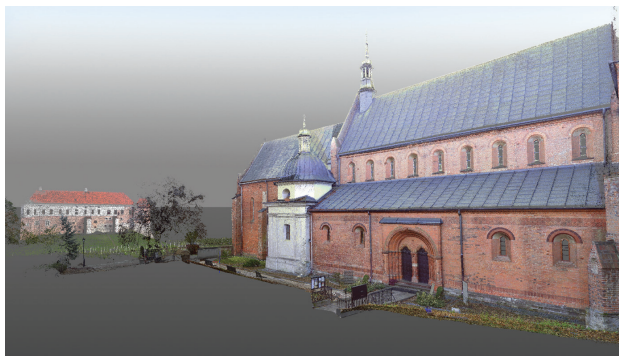
Fig. 1. The orthophotogrammetric projection
– Church of St. James in Sandomierz
– displaying the northern elevation (elaborated by A. Gołębniak)

until the present day. The structure contrasts against other medieval brick churches preserved in Poland, given its exceptionally intricate ceramic adornment, which is particularly evident in the main portal. It is widely recognised as one of the most exquisite examples of late Romanesque architectural design (Fig. 1). The monument has been the subject of numerous studies, however many issues pertaining to its architecture – including the medieval construction stages as well as subsequent modifications – are yet to be conclusively resolved. This particular circumstance constituted the impulse for the initiation of new investigations, executed within the years 2021–2023 under the two scientific projects, financed by the Jagiellonian University. The research was conducted by: Justyna Kamińska (History of Art and Project Manager), Małgorzata Doroz-Turek (Architecture), Andrzej Gołębniak and Kamil

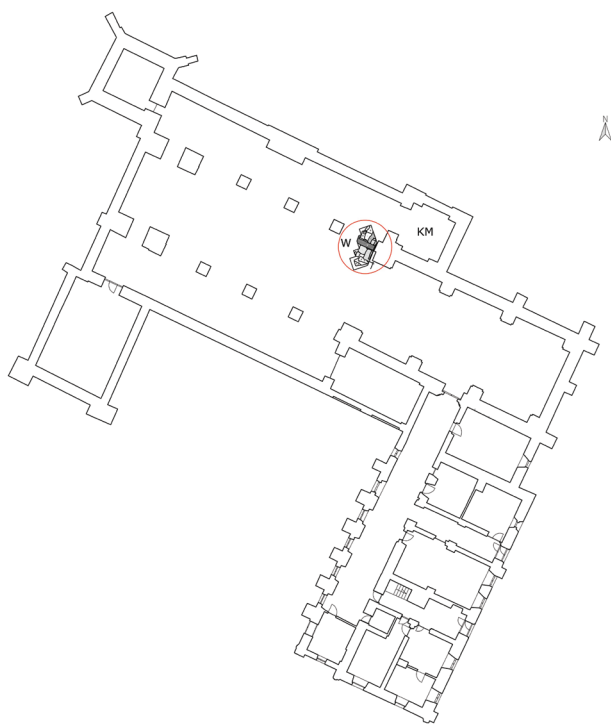
Fig. 2. Sandomierz, plan of the Church of St. James
and the preserved monastery wings, location of the excavation site.
W – excavation, KM – Martyrs' Chapel
(elaborated by M. Doroz-Turek)

The archaeological research was conducted in May 2022 in an excavation site situated at the intersection of the chancel and the east end of the northern aisle of the church. The discovered results laid the groundwork for an architectural, as well as artistic-historical analyses (Fig. 2). The non-uniform outline of the excavation site, approximately 4 × 1.5 m in size, depended on the structure of the existing floor of the church and the technical feasibility associated with the removal of specific tiles. In the east, the area was delineated by the structural pillar of the chancel arch, inclusive of its foundational base, in conjunction with the chancel. The excavation's northern perimeter extended up to the crypt vestibule's vault located

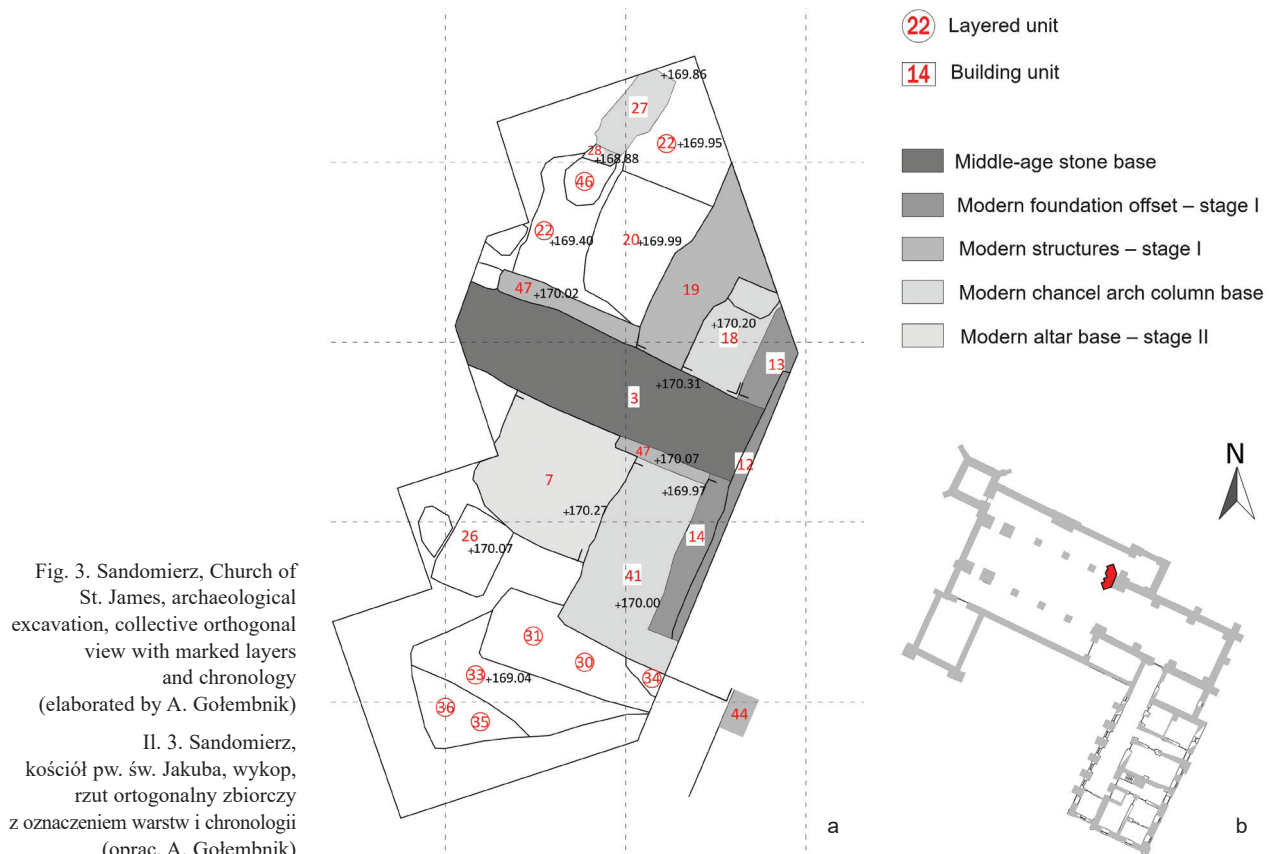
Fig. 3. Sandomierz, Church of St. James, archaeological excavation, collective orthogonal view with marked layers and chronology (elaborated by A. Golembnik)

In total, 48 stratification units were documented during the studies, including 8 solid masonry structures and 4 accompanying structures, as well as 36 layered units (including structural soil reinforcements)². Stratigraphy was made up of backfill layers (the material used to fill construction trenches) and levelling layers (even spreadings

beneath the flooring) (Fig. 3a). The outline of a burial pit was discovered on the eastern side at the bottom of the excavation. Works on smaller areas were carried out up to the apex of the natural layers, reached on the southern (+160.15 m above sea level) and northern (+159.82 m above sea level) extremities of the excavation (Fig. 4a, b).

a ceramic tile with dimensions of 3.5/3 cm in thickness and 13.6 cm in width, potentially serving as a compensatory layer. Moreover, a brick with a thickness of 8.5 cm was discovered on its northern façade. The finial of the wall was ancillary, constructed of bricks with dimensions of 14 × 25 × 8/8.5 cm, similar to those employed in the construction of the foundation k. 7 (Figs. 3, 4a, b).

At the level of +170.07 m, beneath the layer unit k. 8 and the structural component – wall k. 9, nearly regularly shaped limestone slabs were revealed on the southern side; they were identified as part of the flooring (Figs. 3, 4a, b). The dimensions (width × length × thickness) of the three revealed plates (k. 26, V, VI) were: 30.5 × 67.1 × 7–15 cm, 41.80 × 47.50 × 14 cm, 29.50 × 43.00 × 10–18 cm. The plates were positioned beneath the modern brick altar's base (k. 4, k. 8, k. 9), situated 32 cm below the current floor level, solely loess (k. 46) was found below them, burial sites were also discovered (k. 35, item +168.90).

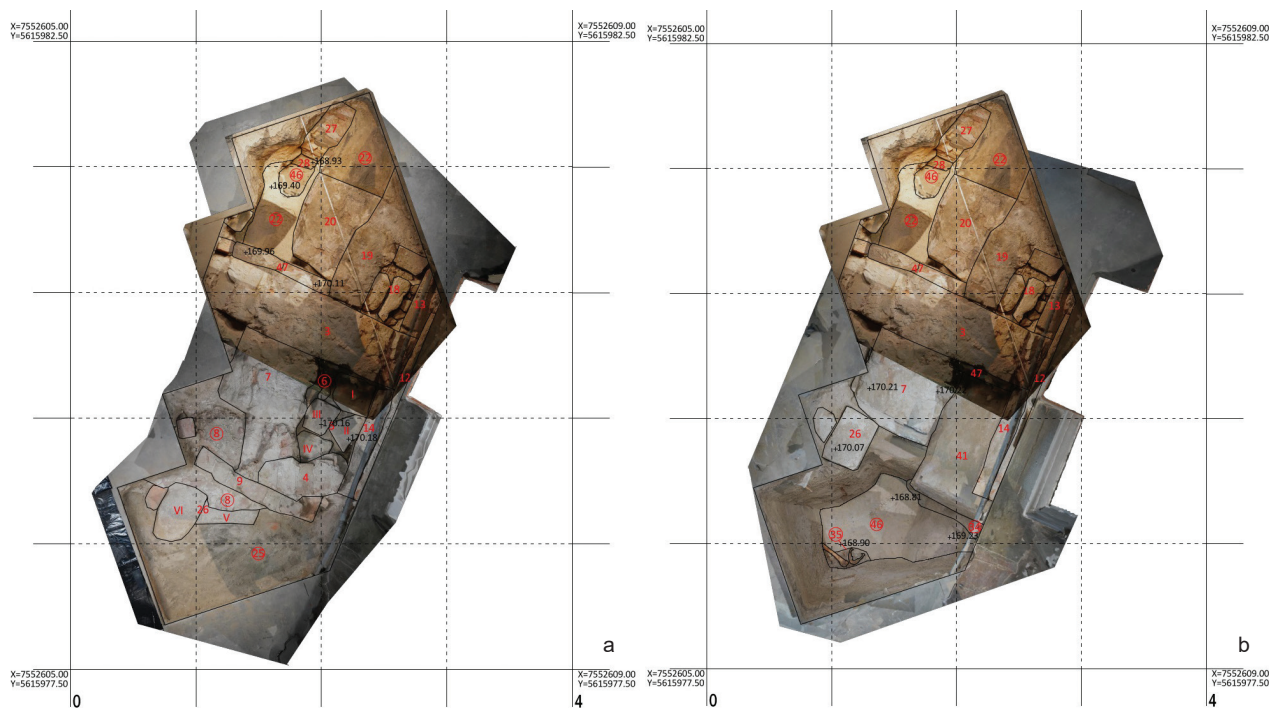
Fig. 4. Excavation: a) horizontal level +170.16/+170.18/+169.96/+169.40, b) horizontal level +170.07/+170.21/+169.90/+168.81 (elaborated by A. Golembnik)

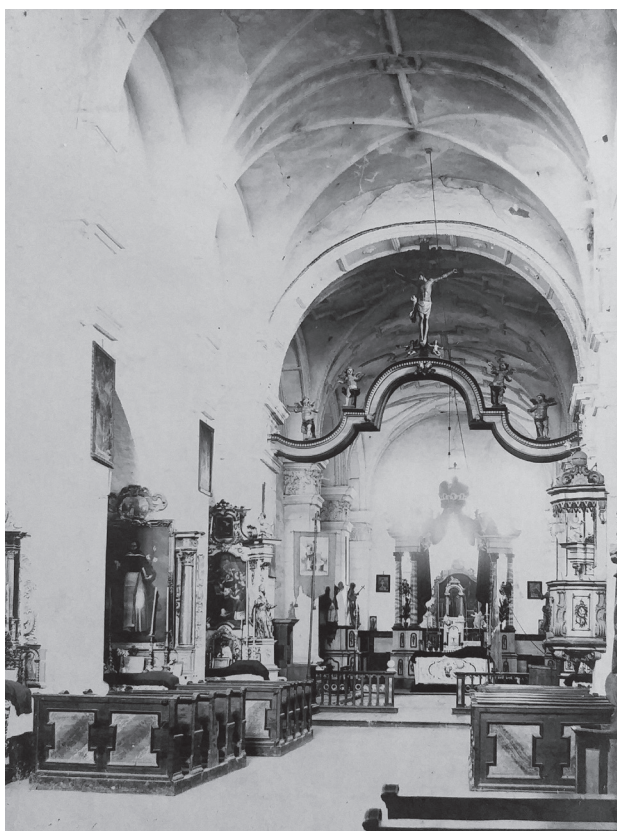
Fig. 5. Sandomierz, interior view of Church of St. James prior to 1905, with a visible altar by the northern half-pillar of the chancel arch (photo by N.N., source: Sandomierz monastery's archive)

During the archaeological excavation, the research group discovered remnants of the foundation of a modern altar, which had been present until the church underwent renovation in the early 20th century, as evidenced by archival photographs (Fig. 5). The foundation remained in the form of a broad belt adjacent to the face of the chancel corner foundation, with an additional chancel arch pillar expanded from the south. The altar was partially set on a previously unknown older wall (k. 3), extending in an East–West direction towards the first pillar between the naves from the east, retained at a length of approximately 175 cm, with a depth of ca. 140 cm and a width of 45–50 cm, including offsets. The wall starts 27 cm beneath the level of the contemporary floor and narrows as it descends. In the lower section, it has been erected using haphazardly selected blocks of stone (limestone and granite³), joined with lime mortar. The wall's foundation foot, positioned in a confined-space excavation penetrating the floor of loess layers, was registered at the depth of +168 m above sea level. The wall construction involves

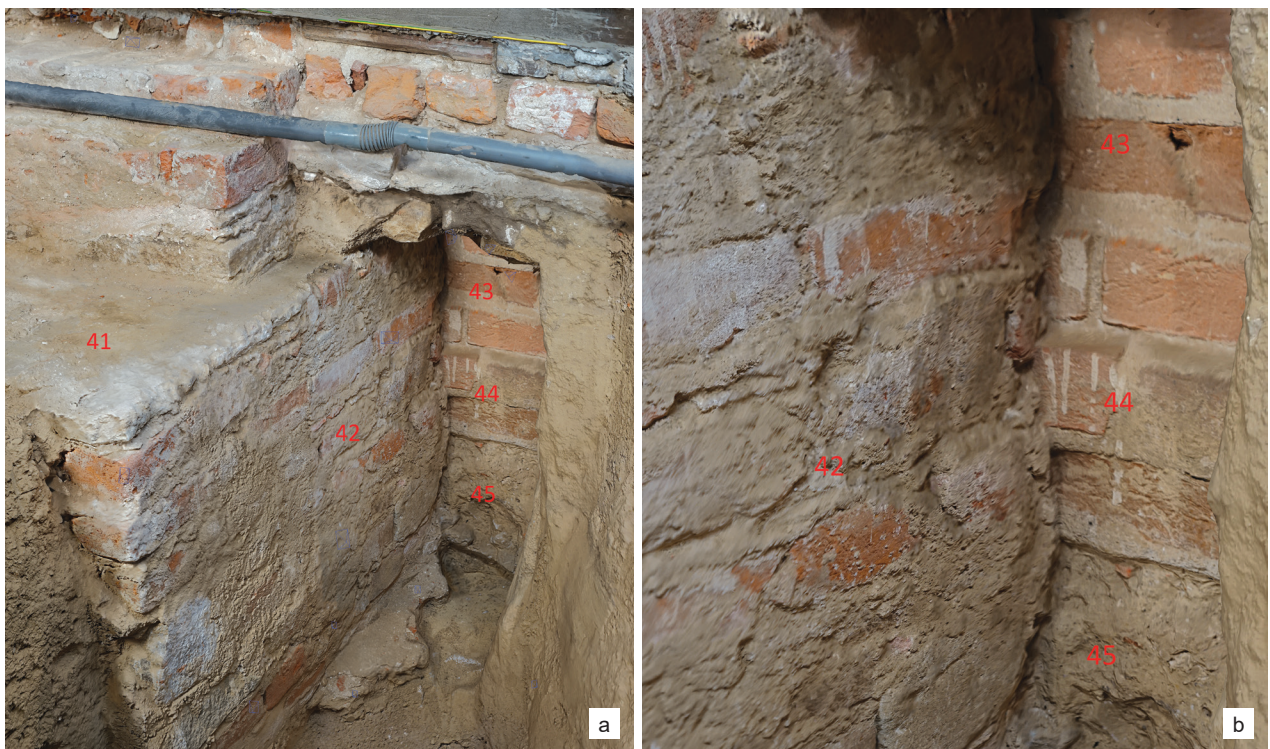
Fig. 7. Sandomierz, Church of St. James, east section of the excavation (SW-side view):
a) relation between constructions k. 41/42 (newer, appended), b) k. 43/44 (older) (elaborated by A. Gołębnik)

the excavation (Figs. 6, 7). The foundation, running in the North-South direction, was positioned on a limestone debris bonded with lime mortar and constructed using bricks. Due to the small area of the uncovered wall made up of five lines of bricks, the brick pattern could not be identified, allowing us to determine solely the thickness (7.5 cm) and length (25.5 cm) of the used bricks. The dimensions correspond to those of the bricks which were used in the construction of the church's chancel, specifically 12/12.5 × 25.5/25 × 7.5/7 cm (Kamińska et al. 2023, 107).

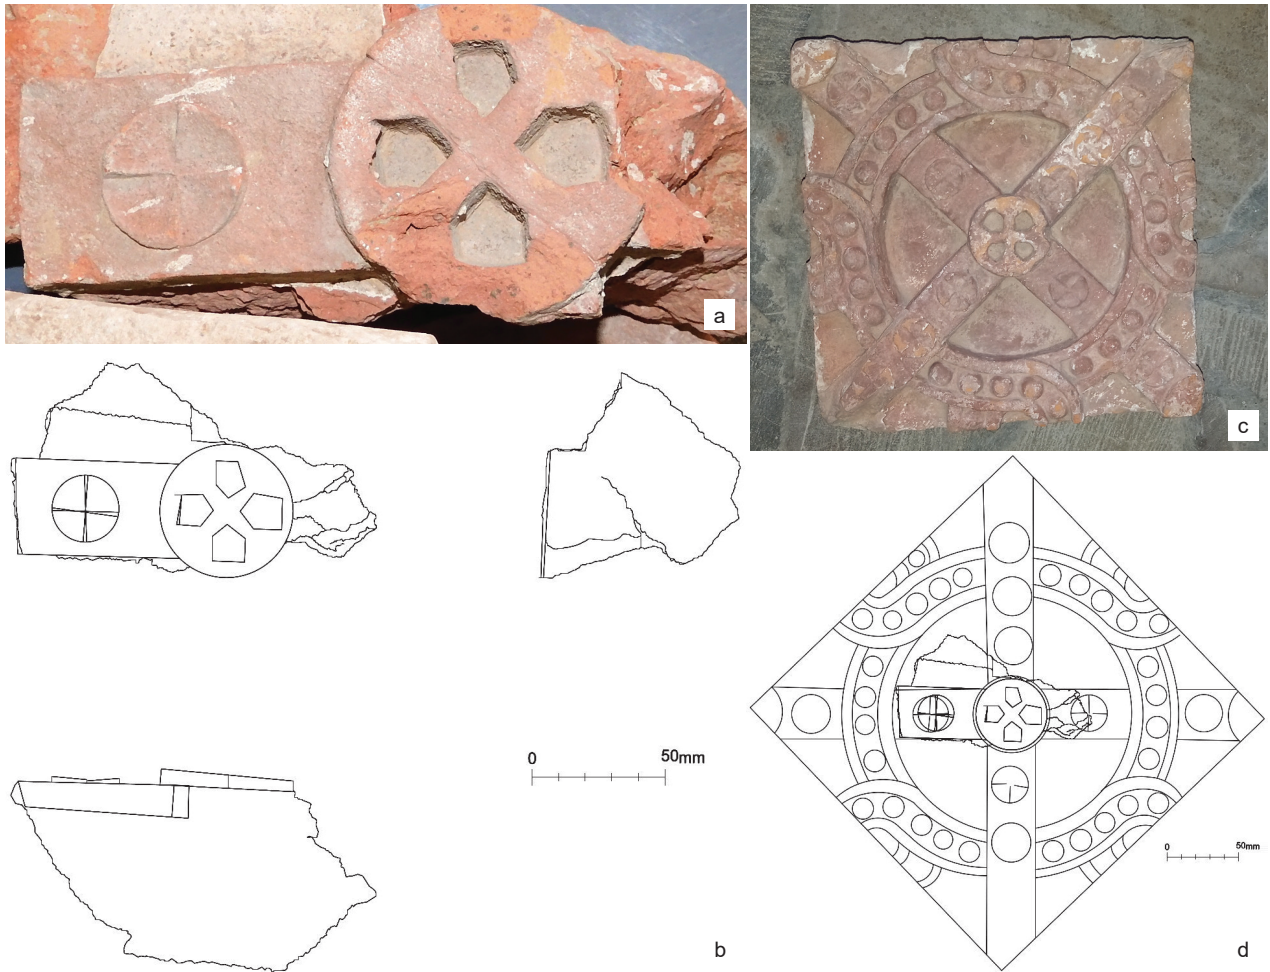
Fig. 9. Sandomierz, Church of St. James, a ceramic tile with a motif of braided pattern and a cross:
 a, b) a fragment of a ceramic tile discovered in the excavation, c) an intact copy of the tile, d) a reconstruction diagram
 (photo and elaborated by M. Doroz-Turek)

An intriguing ceramic block was uncovered during the excavation, positioned inside the mixed backfill layer, which unfortunately translates into the lack of proper dating (Fig. 9a, b). The artefact in the form of a block with dimensions of 7.69–8.03 × 13.73 cm, seems to be a fragment of a ceramic tile identical to those known from the frieze found on the facade of the northern aisle. Currently, 20th-century replicas are placed there, reconstructed by Jarosław Wojciechowski based on the fragmentarily preserved frieze (Fig. 1). The uncovered fragment was matched against a similar loose tile preserved in the church (approx. dimensions 26 × 26 cm), corresponding to its pattern and size, although slight differences are visible (Fig. 9c, d).

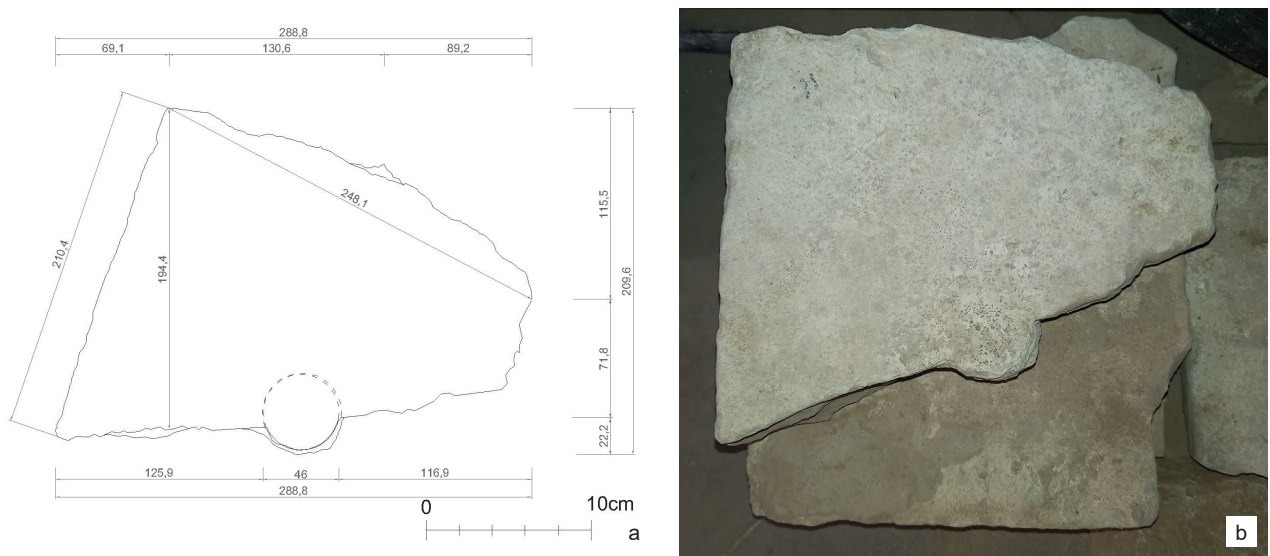
Fig. 10. Sandomierz, Church of St. James, stone slab found during the excavation: a) drawing, b) photography
 (photo and elaborated by M. Doroz-Turek)

Apart from these elements, three additional, irregularly shaped stone plates were uncovered 11 cm above (coordinates +170.16, +170.18). These elements were arranged loosely, serving as filling (k. 5, I–IV); one featured a distinctive circular indentation (Fig. 10). Marek Florek revealed similar plates during his archaeological works carried out inside the church between the years 1991–1992. Three usable levels of flooring were identified at the time at excavation site number 4 – apart from the contemporary and “late Romanesque” (dating back to the period when the church was constructed, second quarter of the 13th century, situated directly on the pillar foundation), also the modern one (originating from the 2nd half of the 17th century, around 1670, preserved as a stone slab and bricks with traces of engove on the pillar’s eastern face) (Florek 1993, 136, 127, 132). Stone slabs were also uncovered at excavation site 9, documented 17 cm below the current flooring’s level (the researcher believes the flooring dates back to the 2nd half of the 19th century, supplemented with early 20th-century fillings) (Florek 1993, 131, 133, 135).
