**Piotr Marciniak\*, Ireneusz Wyczalek\*\*, Zdzisław Pawlak\*\*\***

*Methods for measuring and evaluating deformation  
in conservation work on wooden structures:  
an interdisciplinary case study  
of the parish church in Domachowo*

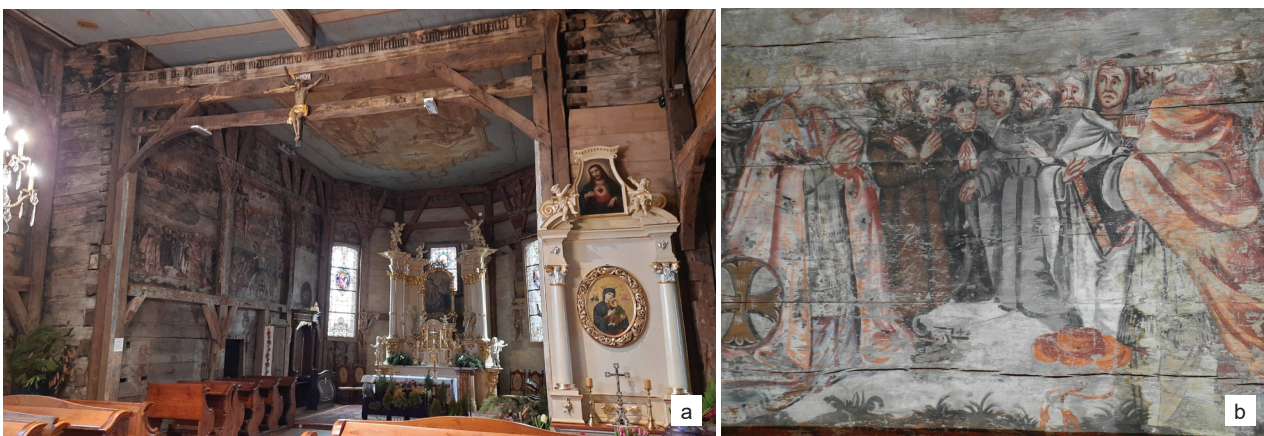
Fig. 2. Uncovered interior of the church with visible paintings on the wooden structure showing clear figural and ornamental themes:

a) view of the nave towards the chancel (photo by P. Marciniak),

b) figure detail of the paintings in the chancel (source: [http://parafia-domachowo.pl/wp-content/uploads/2020/10/SAM\\_6014.jpg](http://parafia-domachowo.pl/wp-content/uploads/2020/10/SAM_6014.jpg))

During a conservation project between 2019 and 2020, the church's inner frame was uncovered to reveal the existence of paintings on the log structure (Fig. 2). The form and style of the paintings cast doubt on the previous dating of the church. The uncovered paintings, which also featured descriptions of the particular representations, were made on the log section with timber framing. In the beginning, the authors assumed that the additional framing was built simultaneously with the formwork during renovation in 1775 (Jankowski 2009, 193). The discovery led to an initial examination of both the structural systems. Among other things, it showed that the logs were connected at the

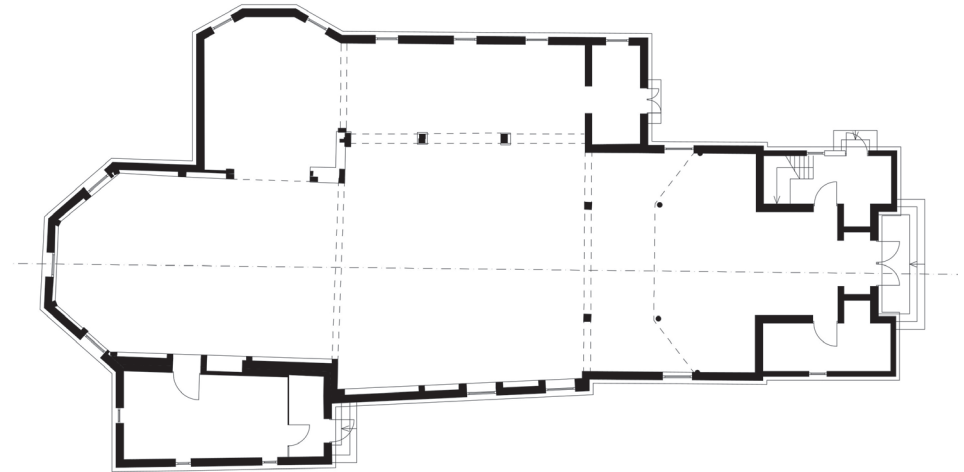
Fig. 3. Ground plan of the Church of St. Michael the Archangel in Domachowo (drawing by J. Jura, A. Rosa)

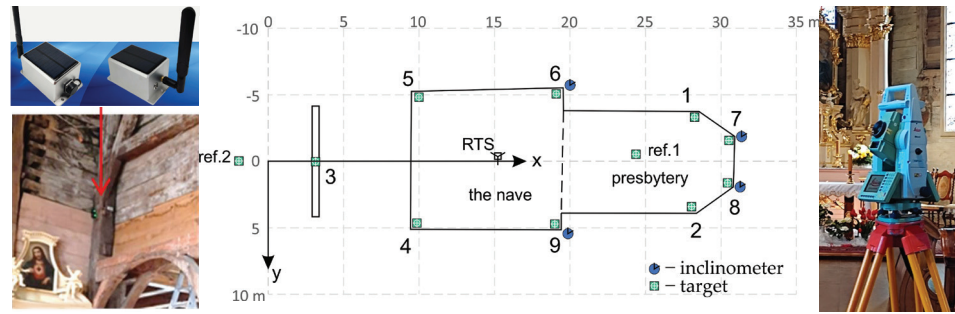
Fig. 5. Measurement diagram using a tachymeter and inclinometers (elaborated by I. Wyczałek)

In the basic version, four inclinometers powered from the power grid were installed on the site. The readings were collected synchronously every 2 seconds via a local Wi-Fi server, saved to disc and then remotely downloaded via the Internet. After an initial test, the authors set the frequency of recording the readings at every 10 seconds. Based on the analysis of the observations, the authors concluded that the records of inclinations in one point changed up to  $\pm 15$  mm during intense winds in October 2021, taking into account the adjustments resulting from the absence of plastic transformations within the investigated structure (Fig. 5).

set of data which provided a point of departure for further assessment of the building's condition and the necessity to provide protection measures, as required. This disrupted the order of works, for which the monitoring of the structure was of key significance. Figure 6 shows changes in the displacements across and along the building (axis  $Y$  and axis  $X$ , respectively) determined from readings of inclinometers situated in the higher part of a pillar in the corner of the nave, at its junction with the chancel (Fig. 5, point 6).

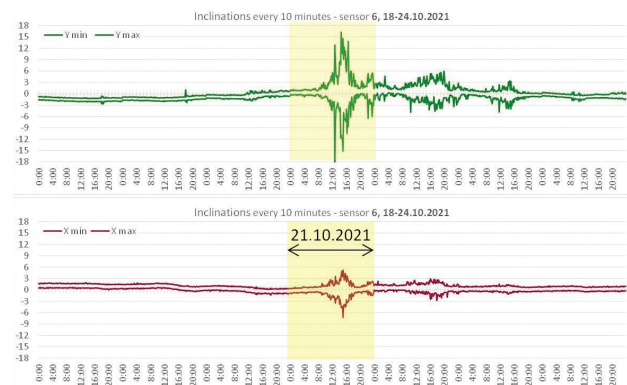
Fig. 6. Section of inclinometer readings with displacements of the wooden structure (18–24.10.2021) (elaborated by I. Wyczałek)

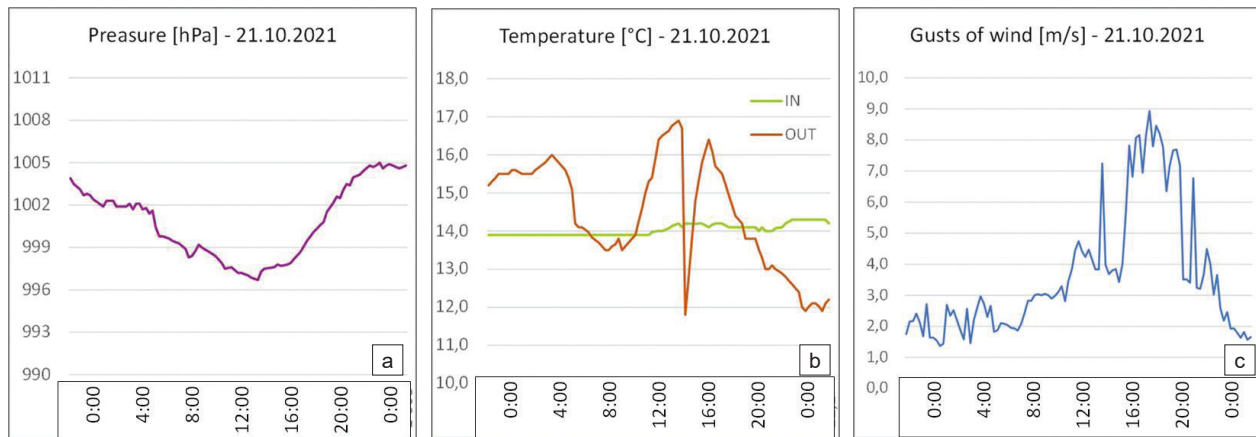
Fig. 7. Recording weather conditions and synchronization of data: parameters of weather station readings on 21 October 2021: a) pressure, b) air temperature and c) gusts of wind (elaborated by I. Wyczałek)

In order to compare the results of the inclination measurements with the weather conditions, the latter were recorded. To do so, a SENCOR 12500 Wi-Fi weather station was set up near the buildings. This comprised a base with a thermometer (inside the building) and a set of sensors: two thermometers, a barometer, an anemometer, and a rainfall meter. With access to the Weathercloud website, it was possible to remotely view the measurements of the station in a 10-minute cycle. The measured data was also collected within the same cycle. It was then remotely downloaded to a \*.csv file and subsequently processed and analyzed using the authors' own methods and software. Afterwards, this data was compared to the inclinometer readings.

The monitoring of historic buildings that are susceptible to dynamic deformation is of particular importance. The aforementioned DSM can be useful for analyzing structural deformations not only in wooden churches, but also in other historic buildings that are exposed to this type of deformation during, for example, vibrations or minor earthquakes. DSM can also be used in particular applications of the Internet of Things and in transmitting data in real-time (Fig. 7).

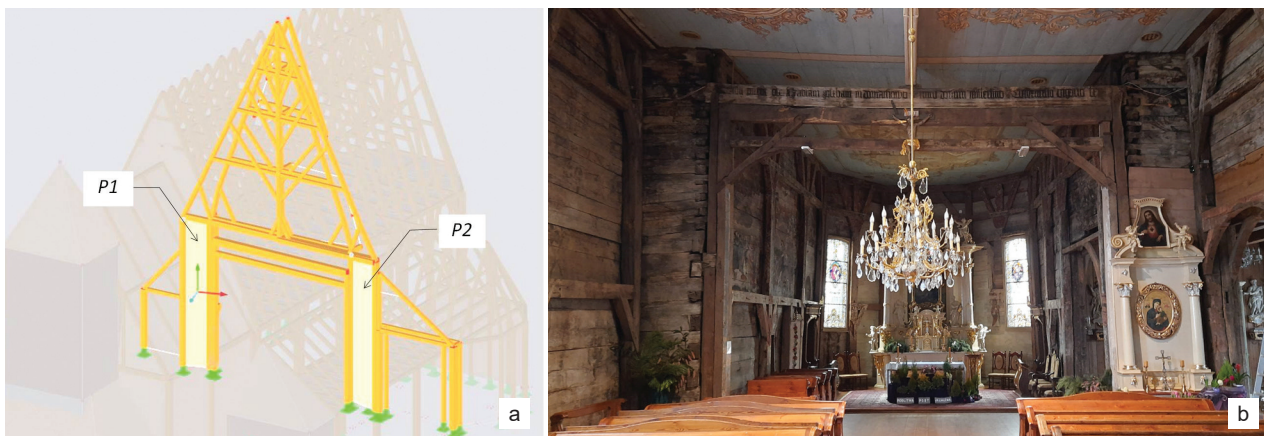
Fig. 8. View of transverse wall at the junction of the nave and the chancel: a) numeric model of the structure – diagram (elaborated by Z. Pawlak), b) view towards the interior of the chancel (photo by Z. Pawlak)

The numerical model of the structure confirmed the measurement results, in addition to identifying a considerable inclination within the structure of the church and its elements. The authors also conducted comparative analyses to investigate the impact of stiffening plates, namely floors, ceilings and wall cladding on the structure's static and dynamic response. The analyses showed that the structure of the building had insufficient lateral rigidity. The weakest element was the lateral system at the junction of the nave and the chancel (Fig. 8).

The junction was the point where the greatest lateral displacement occurred during windy weather, in both the numerical model and in the actual building. Especially weakened was the wall on the right side, where the rood beam connecting the opposite walls was broken. The authors also analyzed the impact of impairments in the structural elements, as well as the impact of the specific interconnections of post branches, on the behavior of the entire system. In addition, they conducted a dynamic analysis of the structure during both high and extreme climatic pressure (including strong gusts of wind). The objective of the dynamic analysis was to validate the calculation model and to determine if strong gusts of wind caused excess vibration in the building's specific elements. In a modal analysis of part of the structure the authors compared its dynamic parameters with and without the impairments in the nodes,
