**Małgorzata Chorowska\*, Roland Mruczek\*\***

## *What did Książ castle look like around 1300?*

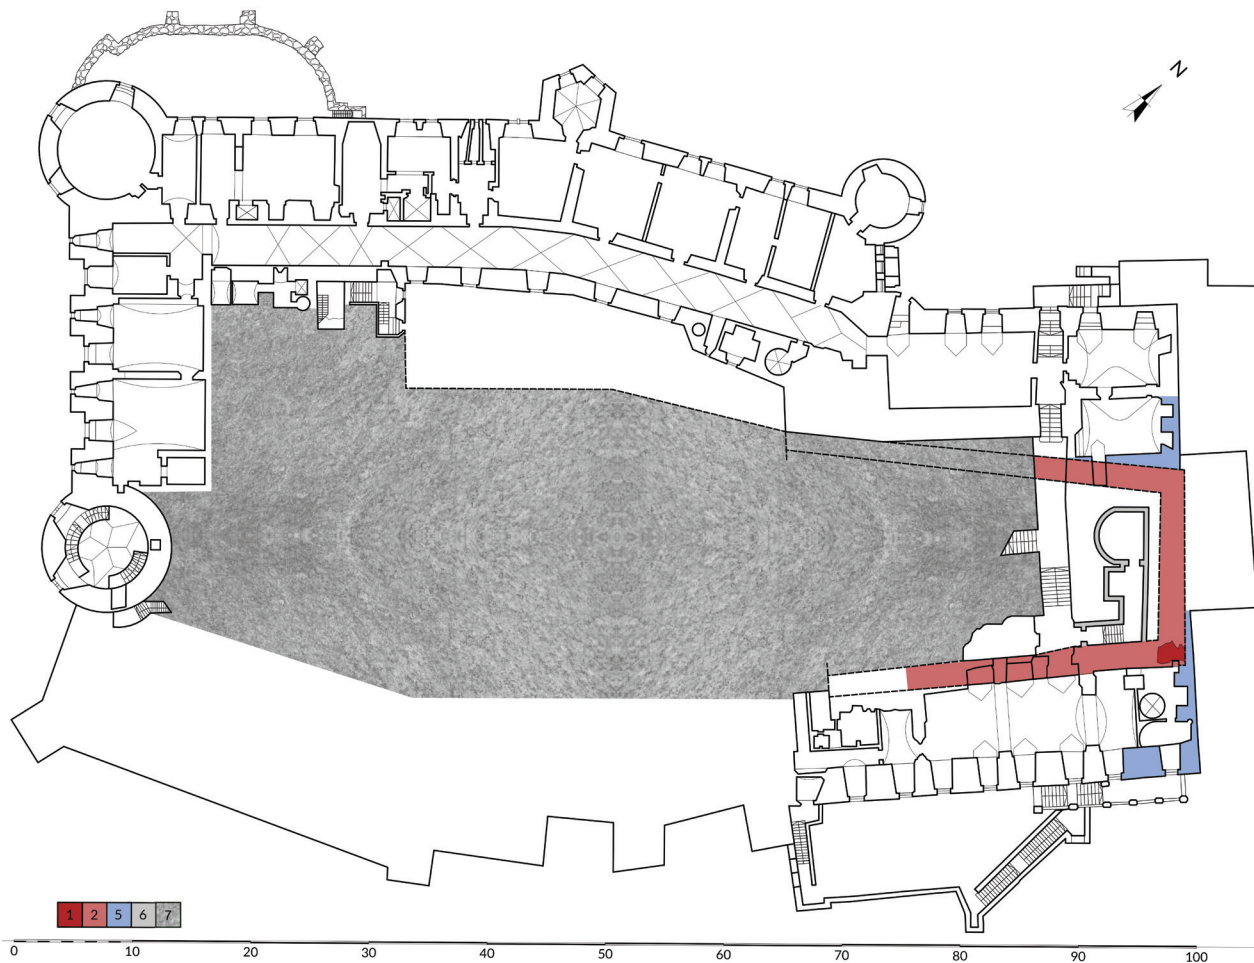
Fig. 3. Książ Castle – basement projection (storey –1) with chronological stratification of walls within the range of the baroque front tract: 1 – preserved wall from the last decades of the 13<sup>th</sup> century, 2 – reconstructed course of this wall, 5 – walls from the 17<sup>th</sup> century, 6 – walls from 1860–1945, 7 – rock (elaborated by M. Chorowska, drawing by M. Noszczyk, source: Chorowska et al. 2023, 6)

The purpose of the prospecting of the eastern cellar rooms, located on storey –1, was to find the remains of the upper castle perimeter wall (Fig. 3). This wall was characterised by a stone construction bonded by lime mortar with an admixture of clay sand, which was the reason for its characteristic yellow-brown colour. The medieval mortar in the Książ castle differed from modern mortars by its much darker colour, the presence of large lumps of lime and its greater cohesiveness. It was therefore easily

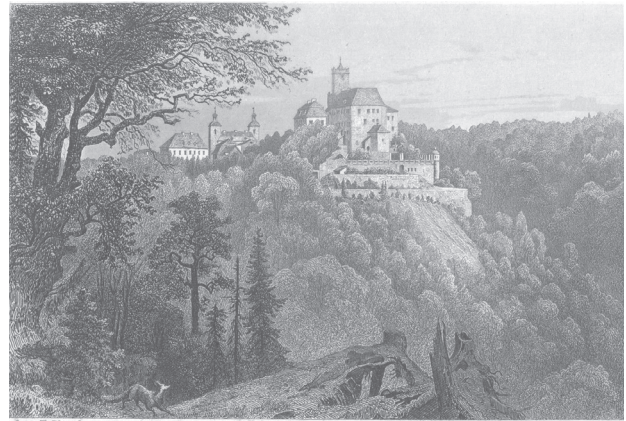
II. 9. Książ Castle in view from the north-west, intaglio by Huber according to a drawing by Theodor Blätterbauer (published by Carl Flemming, 1885–1888; source: from the collection of P. Siemko)

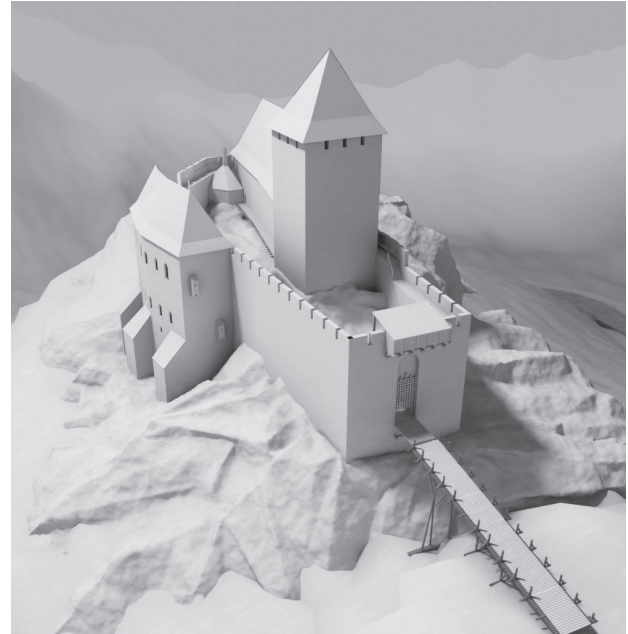
Fig. 11. Książ Castle visualised circa 1300.

View from the south-east
