Ronow Castle in Trzciniec – interdisciplinary research on a medieval stronghold at the Czech-Lusatian borderland

Abstract

Key words: LiDAR, Middle Ages, castellology, Upper Lusatia, Ronow castle

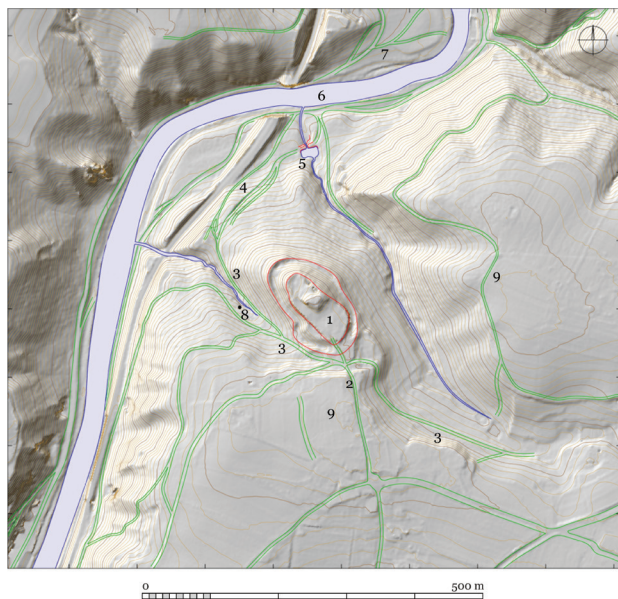
Fig. 1. Plan of the broader surroundings of the castle:

- 1 – castle, 2 – main access road,
 - 3 – additional medieval road,
 - 4 – ravines, 5 – dam of the smaller pond,
 - 6 – ford on the Lusatian Neisse River,
 - 7 – roads ascending to the north-east,
 - 8 – well in the western valley,
 - 9 – two proposed locations of the 1399 siege camp (elaborated by P. Hlavenka, M. Sýkora, J. Vidman)
- II. 1. Plan szerszego otoczenia zamku:
- 1 – zamek, 2 – główna droga dojazdowa,
 - 3 – dodatkowa droga średniowieczna, 4 – wąwozy,
 - 5 – grobla mniejszego stawu,
 - 6 – bród na Nysie Łużyckiej,
 - 7 – drogi wznoszące się na północny wschód,
 - 8 – studnia w zachodniej dolinie,
 - 9 – dwie sugerowane lokalizacje obozu oblężniczego z 1399 r. (oprac. P. Hlavenka, M. Sýkora, J. Vidman)

Within Zone I, to the east of House No. 18 (Fig. 5: 3), a trapezoidal terrace measuring approximately 40×37 m has been preserved (Fig. 5: 4). Additional terraces (Fig. 5: 5–10) and remnants of retaining walls (Fig. 5: 11–13) extend along the zone's western section. While their chronology remains uncertain, superficial survey suggests they may represent early modern modifications of the terrain, possibly related to the regulation of road routes. In the western valley, below the zone, a well is also visible (Fig. 1: 8).

The hill south of the castle and the eastern slope opposite it (Fig. 1: 9) have been proposed as the location of the siege camp during the 1399 assault. These locations were suggested based on topographic suitability and accessibility, though current research has yet to produce evidence confirming this hypothesis.

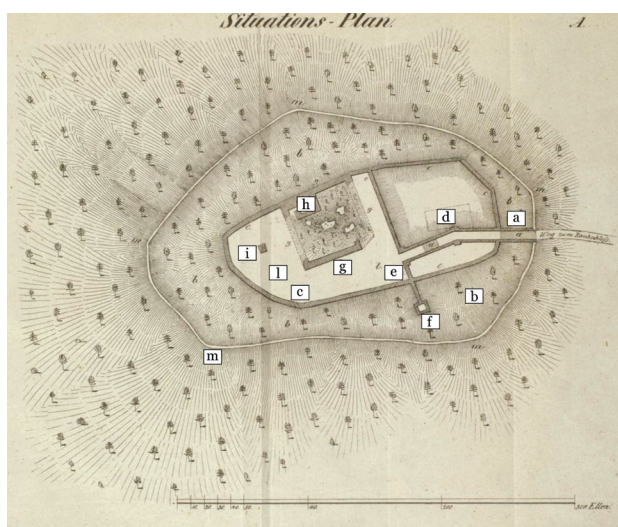
Fig. 2. Plan of Ronov Castle from 1844 (source: Eschke 1844, appendix, modified by R. Biel)

A particularly detailed description of the castle and its surroundings, with many new observations, was published by Karl Christian Eschke in 1844 (Eschke 1844, 269–276). According to his account, the castle was surrounded by a rampart with a wall measuring 1 to 1.5 *Ellen* in thickness, and a moat crossed by a drawbridge. The outer bailey was enclosed by perimeter walls measuring 2 to 3 *Ellen* thick. He also described a wall (Fig. 2e) separating the first bailey and descending along the western slope, terminating in a watchtower (Fig. 2f). The upper castle, laid out as a square with a truncated southern corner – where the gate was presumably located – was surrounded by a wall 12 *Ellen* and 18 *Zoll* high. Eschke also recorded a cellar featuring a channel cut into the floor, interpreted as a drain, with an opening height of 1 *Elle* and 6 *Zoll*. He noted that the second bailey contained a well concealed within a small building, while the first bailey likely housed stables (Eschke 1844, 269–276). Although he stated that these stables were marked with the letter “k” on the accompanying plan, no such marking is present (Fig. 2).

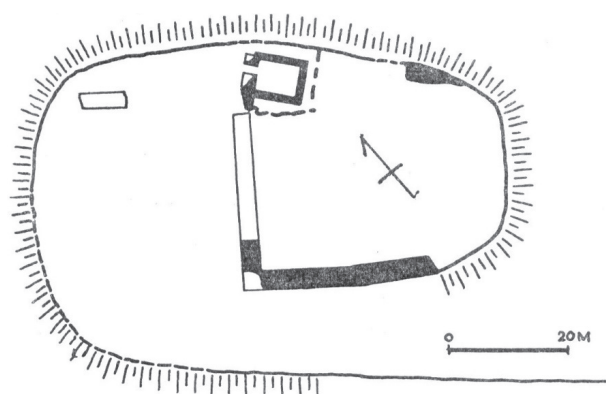
Fig. 3. Plan of Ronow Castle from 1957 (source: Guerquin 1957, 79)

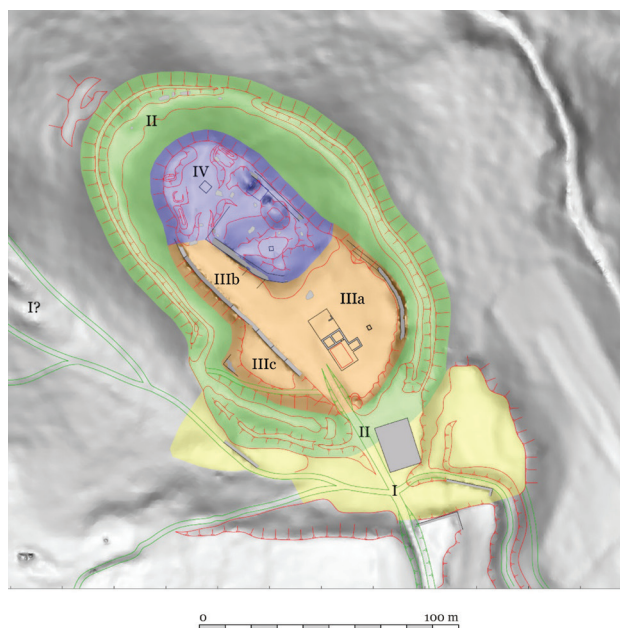
Fig. 4. Delineated functional zones of the complex:

- I – outer bailey,
 - II – outer fortifications,
 - III – lower ward with subdivisions a, b and c,
 - IV – upper castle
- (elaborated by P. Hlavenka, M. Sýkora, J. Vidman)

Based on topographic features and distinct separating elements (walls, moat, embankments), the castle complex can be divided into four spatial zones (Fig. 4). Zone I comprises the outer foreground of the castle and has the most ambiguous boundaries. It is located at the southern edge of the castle area, beyond Zone II, though its extension into the western valley below the castle remains possible. Zone II includes the outer fortifications, consisting of an embankment and a moat that surround Zones III and IV. Zone III is interpreted as the outer bailey, with clearly defined boundaries in the southeastern part of the hill. Zone IV is considered the original residential core of the castle, occupying the northwestern portion of the hilltop.

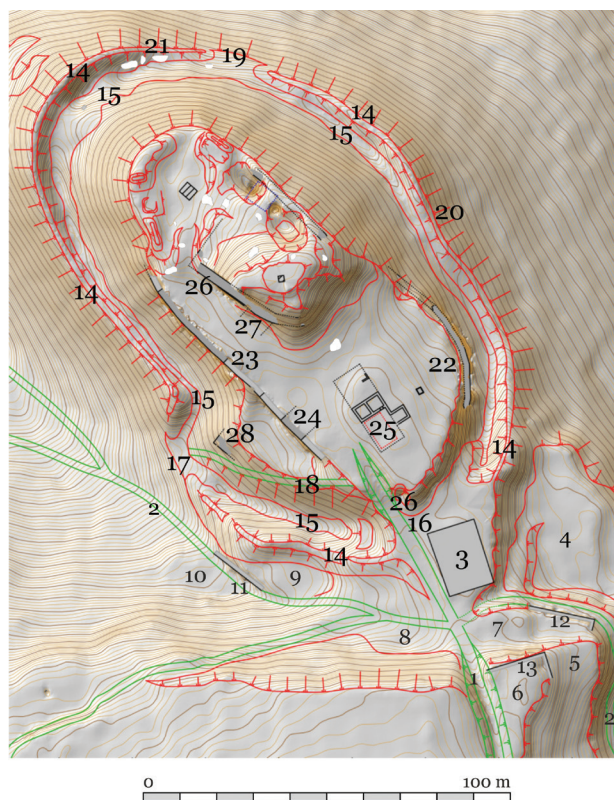
Fig. 5. Plan of the entire castle area (contour interval 25 cm):

- 1–2 – roads, 3 – House No. 18, 4–10 – early modern terraces,
 - 11–13 – segments of retaining walls, 14 – outer embankment, 15 – moat,
 - 16 – deformed moat section after the construction of the forester's house,
 - 17 – interruption of the rampart,
 - 18 – former road along the southwestern slope,
 - 19 – interruption or unfinished section of the rampart,
 - 20 – S-shaped bend of the rampart,
 - 21 – rubble of destroyed stone blocks in the moat,
 - 22 – eastern perimeter wall of Zone III,
 - 23 – southwestern wall of Zone III,
 - 24 – medieval wall interpreted as a building façade,
 - 25 – foundations of the forester's house (18th–19th c.),
 - 26 – quarry, 27 – hypothetical gatehouse,
 - 28 – corner of the perimeter wall or guard tower
- (elaborated by P. Hlavenka, M. Sýkora, J. Vidman)

(Fig. 5: 1), leading from the village and the former manor of Unter-Ronaw, and likely crossed the moat of Zone II via a bridge. This route is supported by field observations and analysis of terrain morphology, particularly a clearly defined cut in the slope of the Działoszyn Ridge. A second,

regionally significant road (Fig. 5: 2) ran from the south-east and descended into the western valley, likely as part of a route between Reichenau and Marienthal.

Zone II comprises the outer defensive structures of the castle, consisting of an external embankment (Fig. 5: 14) and a moat (Fig. 5: 15), which enclosed Zones III and IV, forming an additional defensive perimeter. The entire system takes on an approximately oval form measuring about 160×100 m. The embankments reach an elevation between 270 and 275 m a.s.l., and their course, generally continuous along the western, northern, and eastern flanks, adapts to the natural topography of the hill. On the south-eastern side, both moat and embankment rise to about 280 m a.s.l., indicating intentional adaptation of the defences to terrain features and potential threats. The most substantial segment of the embankment is preserved along the southern and southeastern portions of the site, underscoring their heightened defensive importance. In the area of the former gate (Fig. 6: 16), however, both moat and embankment were significantly altered due to the construction of the forester's house in 1794 and, later, House No. 18 (Fig. 5: 3).

In the northern part of the moat, massive stone blocks were recorded (Fig. 5: 21), interpreted as collapsed material from the upper portions of the castle (Zone IV), likely resulting from deliberate demolition or destruction during the 1399 siege. No traces of foundations, mortar, or masonry rubble were found on the crest of the embankment. Although Karl Christian Eschke (1844) and later authors mention a wall 0.6–1 m in width running along the embankment, no material remains confirm its existence.

The eastern boundary of the outer bailey is defined by a massive curtain wall preserved over a length of 34 m and up to 5.4 m in height (Fig. 5: 22). The wall runs in a markedly polygonal course, and its facing has been damaged by later erosion. Its construction consists of medium-sized stones carefully laid and interspersed with smaller fragments, displaying a tendency toward regular coursing. Five distinct layers are visible, each between 0.7 and 0.85 m in height. Three wall openings have been preserved: from left to right, the first measures 12 cm in diameter and 1.4 m in depth; the second is square, 11×11 cm, and 1.3 m deep; and the third, 23×22 cm and at least 1.53 m deep, is set at an oblique angle ($\sim 20^\circ$) relative to the wall face, likely serving as a water drain. At this point, the wall's thickness exceeds 1.5 m and is probably closer to 2 m. The mortar is a light ochre-coloured lime binder with a high content of quartz aggregate and traces of mica.

The southwestern wall (preserved length: 70 m; height up to 4.5 m) displays evidence of multi-phase construction (Figs. 5: 23; 6: 7; 8; 8a). Eschke (1844, 270) and Moschkau (1891) treated it as a monolithic defensive wall; however, the variation in mortars and construction techniques confirms the existence of at least two building phases. In the medieval walls B and F (Fig. 6), a light ochre lime mortar with up to 70% washed quartz aggregate (grain size 3 mm to 1.5 cm) and a minor presence of mica was used. In contrast, the early modern walls feature a similar light ochre lime binder with a higher admixture of river sand and fine, dark stones, but without mica. The segments labelled A, C, D, E, and G (Fig. 6) were likely added during 19th-century adaptations for an inn. Notably, wall E was secondarily joined to wall F (at the joint), and wall F retains visible corners at both ends (Fig. 6: 13, 14), suggesting it originally formed a standalone, enclosed construction element, likely a building façade (Fig. 5: 24). Only in the later walls (C, D, E, G) were various niches and technological conduits identified. These are arranged in two vertical tiers and vary in size – e.g., $7 \times 9 \times 65$ cm; $6 \times 9 \times 85$ cm; $13 \times 10 \times 30$ cm – with some set at an angle to the face, likely for drainage purposes.

The largest part of the outer bailey, sub-zone IIIa (52 × 50 m), served as a courtyard. Its surface is nearly level, with slight slopes to the north-east and south-west. Within this area is the foundation of an 18th-century forester's lodge, later converted into a 19th-century tavern (Fig. 5: 25). According to Eschke's plan (Fig. 2), the southern part of the courtyard may have housed the gate and bridgehead; however, extensive alterations due to road construction and the operation of a small quarry (Fig. 5: 26) now complicate the reconstruction of the medieval building layout.

Sub-zone IIIc (11 × 44 m), situated at a lower elevation than IIIa, may have originally formed a single continuous space with it. This is suggested by the fact that sections of the southwestern perimeter wall (Figs. 5: 23; 7: 8), which today separate IIIa and IIIc, appear to be of early modern origin. A road leads to IIIc from the west, descending from the outer fortifications along the slope (Fig. 5: 18); although partly destroyed by later alterations, it is still visible. Above this road lies the foundation of a rectangular structure (preserved dimensions: 2.5 × 5.5 m), traditionally interpreted as a guard tower (Fig. 2: f), though it might also represent a wall corner (Figs. 5: 28; 8d). The construction

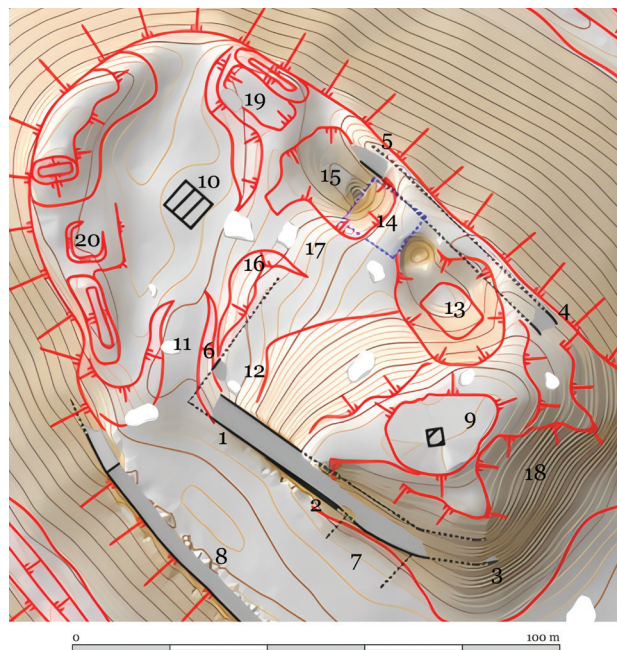
Fig. 7. Plan of the castle – Zone IV (contour interval 25 cm):
1–6 – fragments of the perimeter wall, 7 – hypothetical gatehouse,
8 – fragment of the southwestern wall of the lower ward,
9 – elevation with concrete reservoir,
10 – concrete slab covering the well in the castle courtyard,
11 – presumed location of the former entrance,
12 – hypothetical two-storey building,
13 – largest depression interpreted as a cellar,
14 – preserved vaulted cellar,
15 – depression with a partially preserved corridor,
16 – topographic edge, 17 – possible passageway,
18 – erosion trace of the elevation (building?),
19 – remains of an above-ground structure, 20 – rectangular depression
(elaborated by P. Hlavenka, M. Sýkora, J. Vidman)

The best-preserved section of the castle's curtain wall is located on the southwestern side, where it measures 2.5 m in width (Fig. 7: 1). The outer face of this segment

is 17.5 m long and partially retains a two-stepped plinth, projecting 0.18 m at the upper and 0.14 m at the lower level (Fig. 8b). The inner face is preserved over a length of 9.5 m (Fig. 9). At an elevation of 287.83 m a.s.l., the lower edge of a socket for a beam plate was recorded, measuring 20 cm in height and 30 cm in depth (Fig. 9: 1). Directly above are five beam pockets (Fig. 9: 2–6), originally embedded in the wall. Each is about 30 cm deep, with spacing intervals of 0.84 m, 0.99 m, 1.06 m, and 0.99 m. Although the wall face is not preserved, the impressions suggest the beams had a cross-section of approximately 20×20 cm. This structure indicates the presence of a multi-storey building (Fig. 7: 12), with the upper floor situated at around 288.25 m a.s.l. Within this wall, mortar joints corresponding to 11 nearly horizontal construction layers were observed, sloping slightly in accordance with the terrain. A short wall fragment, 0.9 m in length, is set perpendicular to this segment and likely formed part of the same building (Fig. 7: 6).

Three depressions interpreted as cellar remains are located in the northeastern and eastern part of Zone IV (Fig. 7: 13–15). The largest measures 9×12 m and contains a flat-bottomed area of 2×4 m (Fig. 7: 13). Two large blocks of the perimeter wall, 7 m and 3.3 m long respectively, collapsed into this space, suggesting that the majority of the depression is filled with rubble. From here, a passage leads into a second preserved cellar measuring 5.4×6.6 m (Fig. 7: 14), which features a barrel-vaulted ceiling and a ventilation opening in its southwestern side. The third chamber (8.5×7 m), located farthest north (Fig. 7: 15), contains a partially preserved narrow entry corridor leading towards the central cellar. All three cellars likely belonged to structures abutting the northeastern section of the curtain wall. Based on a clearly defined terrain edge (Fig. 7: 16), it may be inferred that a gap or passage existed between two parallel wings (Fig. 7: 17). Alternatively, the layout may have followed an L-shaped plan, with a transversely oriented two-storey building.

A further building relic, this time above ground, is located in the northeastern part of Zone IV near the northern corner (Fig. 7: 19). This rectangular feature (5×9 m) is surrounded by a small earthen rampart; on the courtyard side, a 2 m-long, 1.2 m-wide wall segment without a preserved face projects from it. The final feature is a slight depression along the western edge of the zone (Fig. 7: 20), rectangular in plan (3×4 m). Scattered across the entire

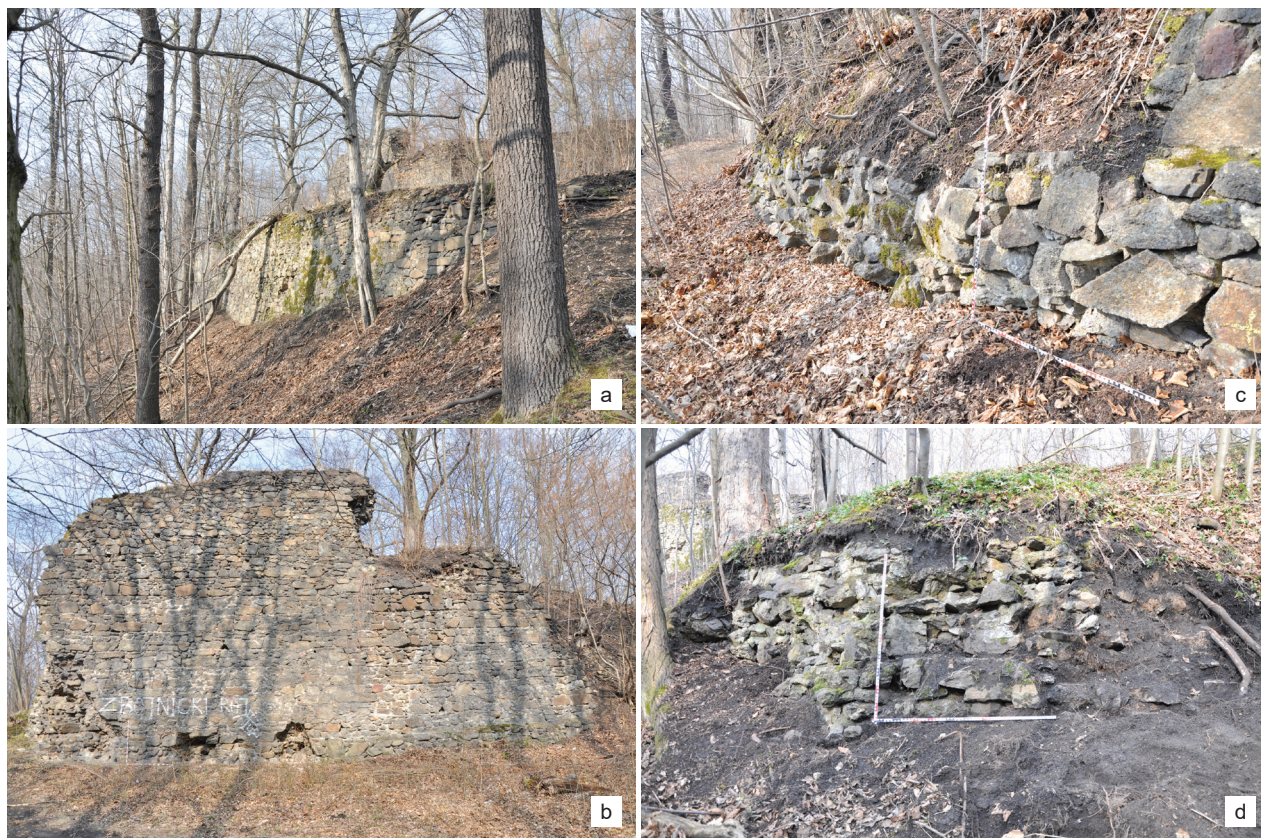
Fig. 8. Ronov Castle in 2022:

- a – preserved section of the southwestern perimeter wall of Zone IV, corner near the hypothetical entrance,
 - b – perimeter wall of Zone IV from the south, at the site of the presumed dismantled gate,
 - c – tower or corner of Zone III, view from the south-west,
 - d – southwestern wall of Zone III, view from the south-west
- (elaborated by M. Sýkora)

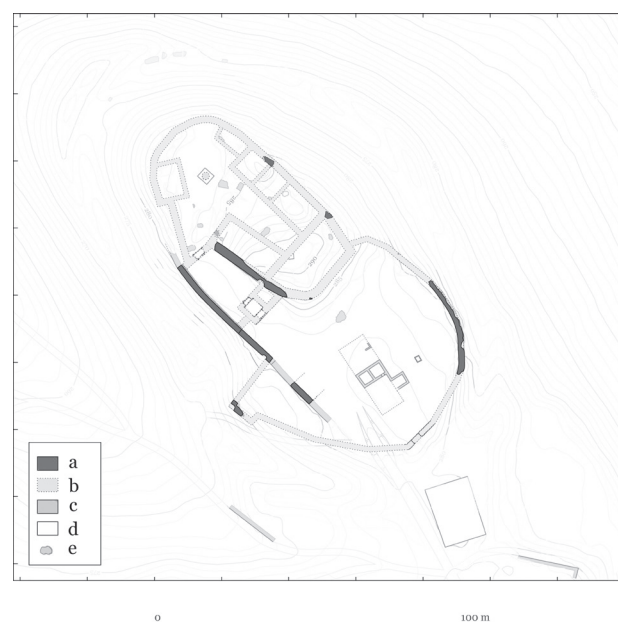
Fig. 10. Hypothetical reconstruction of the ground plan of Ronow Castle:

- a – preserved medieval walls,
 - b – reconstructed course of medieval walls,
 - c – preserved early modern walls, d – contemporary buildings,
 - e – fragments of destroyed walls
- (elaborated by M. Sýkora)

distribution of architectural elements enables the hypothetical reconstruction of their functions and, to some extent, their chronological development (Fig. 10).

The castle (Zone IV), enclosed by a massive perimeter wall with a clearly defined gate and remnants of interior buildings, likely constituted the original residential core, to which additional fortifications were subsequently added in response to the evolving needs of its owners. The layout of the defensive system suggests that its individual components underwent multiple phases of reconstruction. The configuration of ramparts and ditches points to their phased development, and parts of the outer circuit (Zone II) may be associated with late 14th-century extensions, potentially in reaction to the advent of gunpowder weaponry.
