## *Written in architecture... St. James' Church in Toruń – the Gothic pearl of Pomerania discovered by archaeologists*

The article is about the Church of St. James in Toruń, which underwent archaeological research between 2008 and 2020. The author's goal was to present the most important findings and the conclusions drawn upon them.

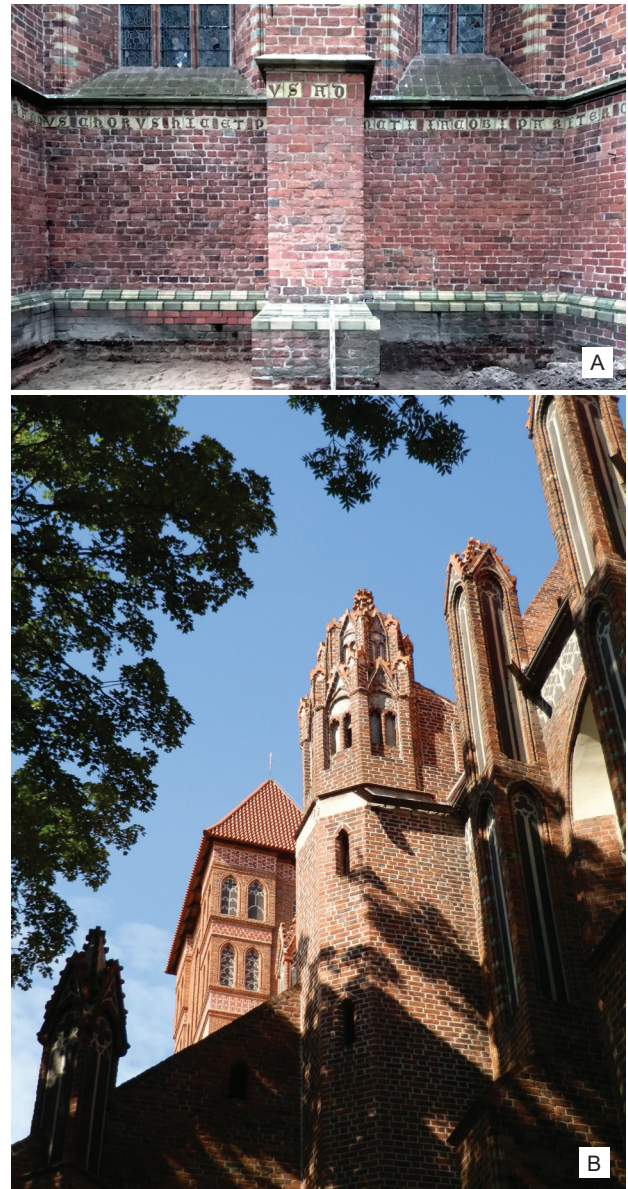
Fig. 3. Toruń, St. James' Church:

A. View of the chancel from the south.

Fragment of the inscription is visible (photo by A. Cicha),

B. View from the southeast of the stair tower and western tower (photo by K. Sulkowska-Tuszyńska)

In the second stage, a new presbytery was built – the second one (after 1309 until about the 3<sup>rd</sup> quarter of the 14<sup>th</sup> century; phase II) (Figs. 2B, 3A, 5II).

pression of a polygonal closure (Fig. 3A). Perhaps the need to accommodate the old foundations' varying lengths and widths meant that the pairs of diagonal buttresses are not parallel to each other and have slightly different dimensions. The third and fourth pair of straight buttresses were left unchanged (Figs. 2B: 2 i 9, 1 i 10). Of the fifth pair, right next to the nave, the southern buttress was erected perpendicular to the chancel (Fig. 2B: 11), resting its low foundation on the great foundation from phase IA, and a side portal was built next to it. Between this entrance and the eastern wall of the southern nave, a slender, polygonal stair turret was "inserted", partly resting on the great foundation of the phase IA (Sulkowska-Tuszyńska 2014). Much older bricks were used to build this turret, probably from the demolished wall of the first structure (Pawlak et al. 2025). On the northern side, by the 3<sup>rd</sup>–4<sup>th</sup> quarter of the 14<sup>th</sup> century, a sacristy was built or extended (?) with an external pillar for the supporting arch (Figs. 1A, 2B), inside which stairs lead to a small gallery, from where there is a view of the main altar<sup>18</sup>.

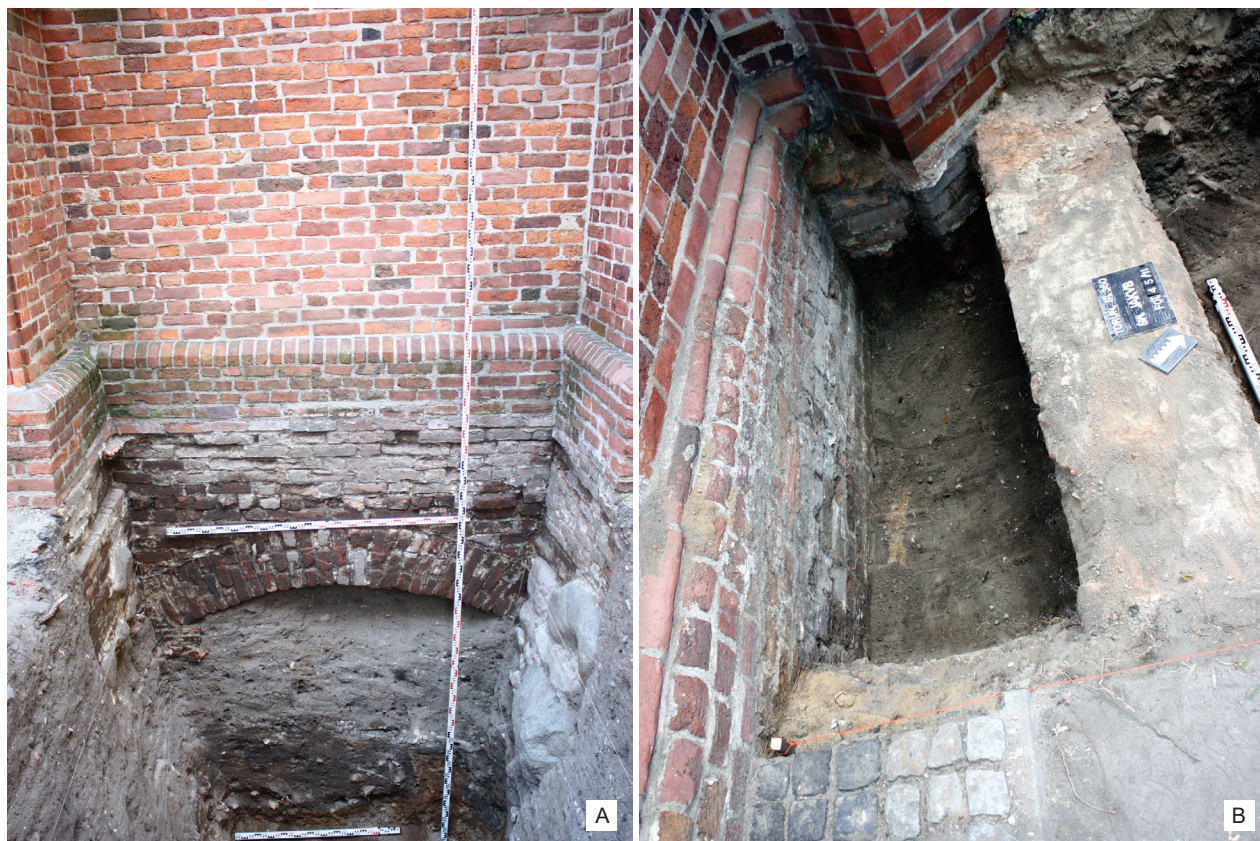
Fig. 9. Toruń, St. James' Church. St. Valentine's Chapel:

- A. View of the eastern part of the arcaded foundation and the foundation of buttress P-13 (Fig. 2),  
 B. Western foundation of the passage between the chancel and the monastery (see Fig. 5IV)  
 (photo by J. Struwe)

built, rested on an arcade foundation supported by a new buttress on its axis (Fig. 9A). Its medieval furnishings are unknown. The only known information about its interior decoration is that the eastern wall and the vaulting were decorated with plant motifs<sup>24</sup>. It is very likely that a grave marked with a limestone slab, with a majuscule inscription around the “head” and a maker mark on the axis, was located in this chapel as early as 1435. The slab lay over the supposed grave, as indicated by the inscription, of Toruń alderman Mikołaj Rumpeler<sup>25</sup> (Krantz-Domasłowska, Domasłowski 2001, 90; Jurkowlaniec 2015, 318). This is one of the few medieval tombstones that is fully preserved and legible<sup>26</sup>. At that time, the church was floored with tiles decorated with flour de lis (Sulkowska-Tuszyńska 2022a, 74–78, ryc. 56–58, Kat. 78–79).
