History of the crypt in the Eastern wing of the post-Cistercian monastery in Krzeszów

Abstract

The article presents the results of architectural research concerning the identified underground spaces of the Krzeszów monastic complex.

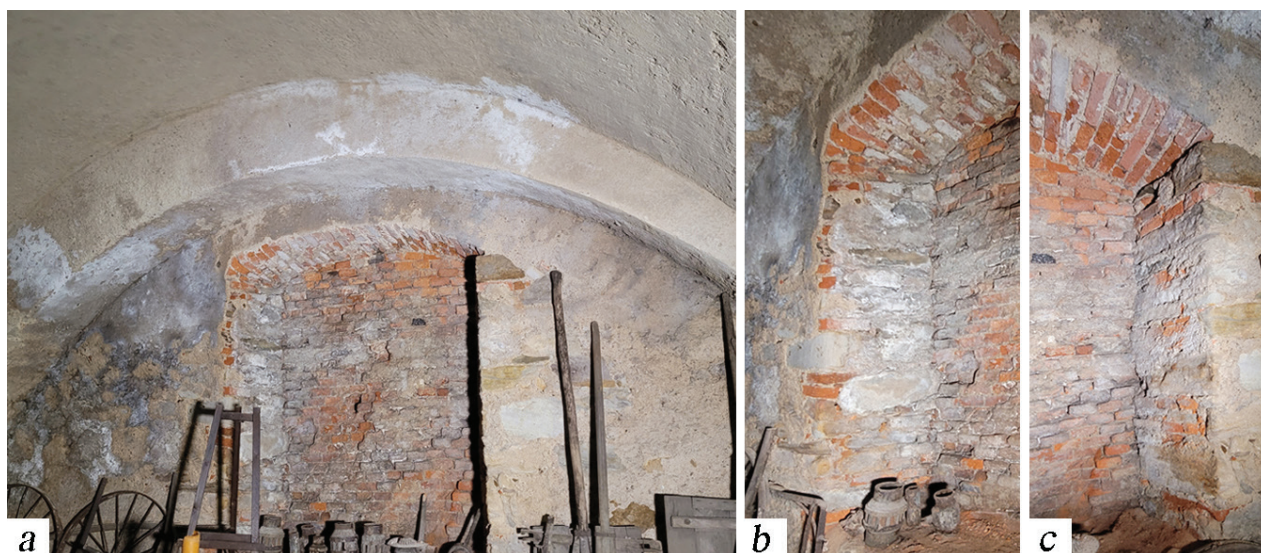
Fig. 2. South wall of part A of the crypt with two arches (wall and added) and a bricked-up exit to the monastery grounds, 2023:
a) general view, b) eastern glyph, c) western glyph (photo by A. Piwek)

The stone and brick south wall in part A of the crypt features a recess in the middle (Figs. 1c, 2a), the rear wall of which is composed of bricks measuring 14.5–15.0 × 6.3 cm. The height of 10 layers of bricks (and joints) laid with their headers is 80.5 cm. The side walls are inscribed with a glyph, and the upper structure comprises a segmental arch that is integrated into the wall, resulting in the visibility of only one side (the wall arch). Since the background of the recess is not connected to its side walls (Fig. 1c: A3, A4), it can be hypothesised that it should be considered as a brick-ing up of a previously existing wide passage. Two distinct categories of material can be identified in the eastern wall of the recess: a layer of bricks (with a width of approximately 15–20 cm) and rows of stones situated behind it (see Figure 2b). This phenomenon can be attributed to the construction of the wall in two distinct phases. The stone segment can be regarded as a remnant of an earlier stage, while the brick element represents a subsequent addition. The western wall of the recess contains worked stone blocks, indicating the remains of an older, narrower passage (Fig. 2c).

Adjacent to the wall under examination is another arch, measuring approximately 60 cm in width and 65 cm in depth. However, its course is not parallel to that of the wall arch, a discrepancy that is probably attributable to the different times of their construction. This arch is undoubtedly later than the wall arch. The subject begins approximately 40 cm in front of the eastern wall and is aligned flush with the opposing wall. As demonstrated in Figure 1c: A1, the junction between the eastern wall of the crypt and the protruding arch is of particular interest. Analysis indicates that this junction is likely secondary to the visible face of the wall. This hypothesis can be substantiated by the almost vertical attachment of the arch to the eastern wall, which results in a width of only approximately 40 cm at ground level. Conversely, the alignment of the arch with the western wall suggests that

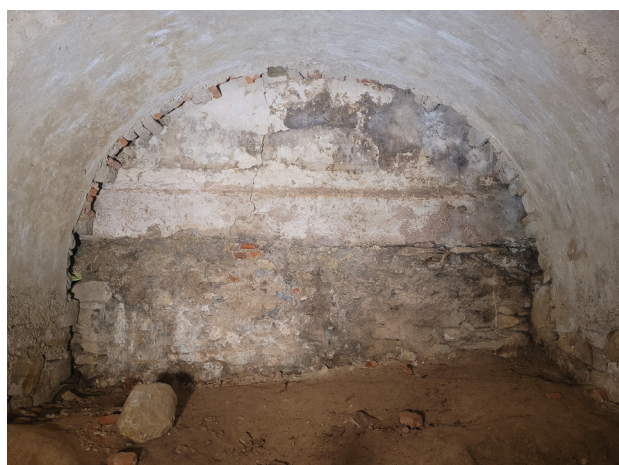
Fig. 3. South wall of part B of the crypt containing plasterwork from the medieval period and three different floor levels, 2023
(photo by A. Piwek)

The upper half of the south wall surface consists of white-washed lime plaster, while the lower half (built of stones and a few bricks) consists of roughcast with fragments of plaster (Fig. 3). This distinction can be attributed to the differing purposes of the two types of use. The lower part of the structure was originally part of the wall foundation, and was later incorporated into the usable interior of the basement. In contrast, the upper part was part of the wall that formed the usable ground floor room from the beginning, extending northwards (towards the church). The plaster in the upper part exhibits several layers of whitewash, suggesting that the interior, which has not been preserved, was in use for a considerable duration. Furthermore, three levels are still visible on their surfaces – traces of previously laid floors. The lowest of these (–1.97 m), corresponding to the inception of the eastern wing's construction, traverses approximately halfway up the observable portion of the wall, the second is situated approximately 50 cm above it, and the

third (marked with a pencil) is positioned around 70 cm. An examination of the 290-centimetre segment of the wall revealed that the ground along this section slopes at a considerable angle. The structure's perimeter is delineated by a transverse wall measuring 46 cm in height, constructed from five layers of bricks with dimensions 29,0–29,3–29,5 × 15,0 × 7,0 cm, laid alternately in a row of headers and a row of stretchers. Between the wall and the eastern wall of the room, there is a masonry structure measuring 88 cm in width, 58 cm in depth, and 18.5 cm in height (considered a step). This structure consists of four layers of similar bricks, with the second and fourth layers (counting from the top) being half the height of the other layers. The ground level is much more leveled from the low wall with the step. It is evident that the low partition serves to protect the south wall and its foundations from losing stability. Such concerns must have arisen because, with the deepening of the northern part adjacent to the wall (the final phase of changes made during the Baroque period), previously invisible parts (medieval foundations) were exposed. It was therefore imperative to expose only the minimum of the building structure when creating the underground passages under the corridor, even at the cost of excluding part of the newly built basement from current use. Moreover, the construction of the wall impeded the ground from slipping into the area designated for the newly created passageway between the crypts. The construction of the wall (and the steps) is related to the construction of part B of the crypt.

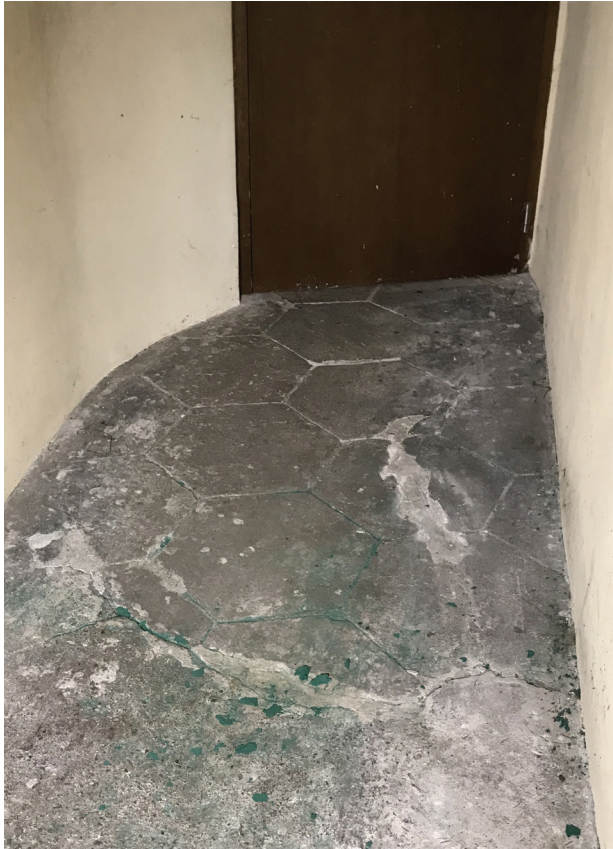
Fig. 5. Outline of the semicircular staircase (also marked by the curvature of the south wall) in the passageway of the eastern wing of the monastery leading to the added pavilion, 2023 (photo by M. Kwasek)

of the church, whose form differed significantly from the medieval layout⁶. Between the newly constructed transept and the preserved part of the east wing, only two interiors were planned on the ground floor. While maintaining proportionality with the width of the sacristy and the passageway, they were displaced in an eastward direction (Fig. 4). The first of these was constrained by a newly constructed section of the south wall. The construction of a subterranean level beneath the sacristy was planned. The structure was overhung by a ceiling, and it was hypothesised that it was illuminated from the east by a single window. Access to the crypt was provided by a narrow passage in the south wall and a round staircase built into the south-west corner, which also functioned as a connection to the individual floors of the monastery. The dimensions and positioning of the corner pass-through are known, inter among other things, from the monastery plan drawn by J.G. Feller circa 1770. The location has been specifically identified on the basis of preserved traces in the floor of the corridor on the ground floor (connecting the interior of the eastern wing with the pavilion added from the east) and is visible in the distortion of its wall (Figs. 1c, 5). A space that was both inaccessible and

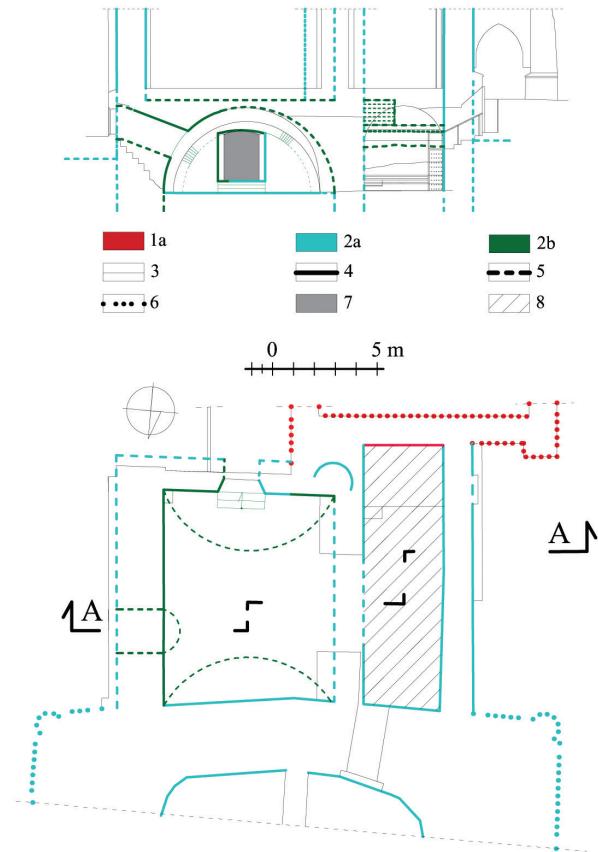
Fig. 6. Reconstruction of the plan and cross-section through the monastery crypt of stage 2 of phase b. Markings: 1a – 1st half of the 14th century, 2a – approx. 1730, 2b – approx. 1731, 3 – current state, 4 – visible course of basement walls, 5 – invisible course of walls below ground level, 6 – ground floor walls, 7 – passageway, 8 – part without basement (elaborated by A. Piwek, M. Kwasek)

The second phase (2b) involved the introduction of further significant changes (Fig. 6). These were a consequence of the construction of a new Baroque church. The commencement of construction work on the church necessitated the temporary closure of the presbytery crypt. The function of the crypt was temporarily assumed by the basement under the sacristy (now part A of the crypt). The interior was adapted by widening the existing entrance towards the east. The resultant cavities in the wall face were filled with bricks on this side. The construction work on the wide passageway may have instilled apprehensions regarding structural integrity. In order to circumvent this issue, a substantial arch was constructed within the designated wall, with the central portion subsequently becoming the element closing the wide passageway from above (Figs. 2, 5). The construction works entailed the removal of access to the circular staircase in the basement. One of the beneficial outcomes – unless it was another reason for the bricking up – was the separation of the residential and burial functions. The interior was vaulted with a longitudinal barrel vault, and illuminated by a small window in the eastern wall. The brick covering thickened the existing eastern wall. This was also used to reinforce it, which, as subsequent modifications demonstrated, was not the final construction measure of this nature, presum-

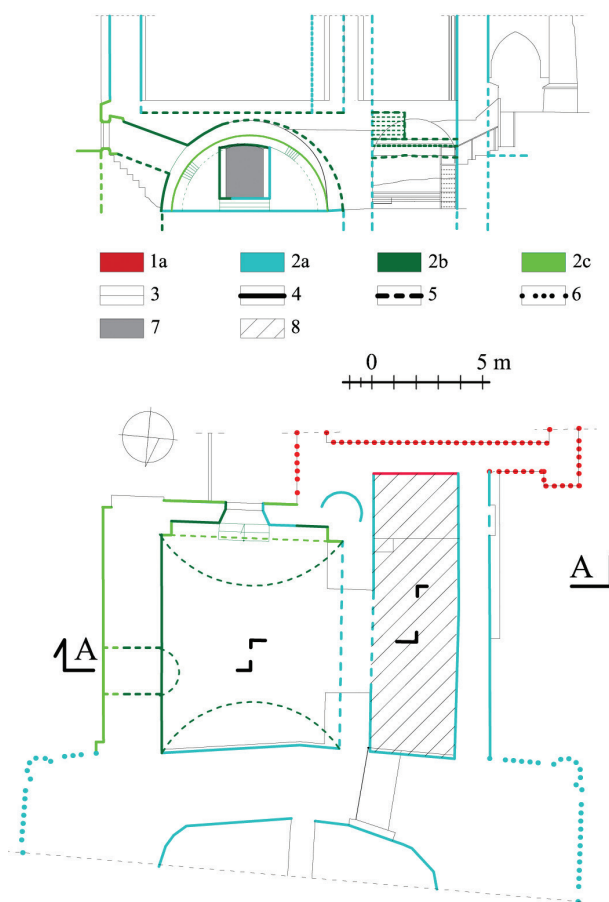
Fig. 7. Reconstruction of the plan and cross-section through the monastery crypt of stage 2 of phase c.

Markings: 1a – 1st half of the 14th century, 2a – approx. 1730, 2b – approx. 1731, 2c – approx. 1735, 3 – current state, 4 – visible course of basement walls, 5 – invisible course of walls below ground level, 6 – ground floor walls, 7 – passageway, 8 – part without basement (elaborated by A. Piwek, M. Kwasek)

In phase three (2c), the southern wall of the basement underwent a process of thinning on the outer surface, while an internal arch was introduced to ensure stability (Fig. 7). In the upper levels, this approach enabled the construction of an additional section of wall on the arch, thereby increasing its thickness beyond that of the basement levels. This resulted in the wall achieving the requisite thickness, equivalent to that of the earlier phases. It is indisputable that this measure was implemented for structural reasons. This phase of the construction of the monastery crypt was completed around 1735.

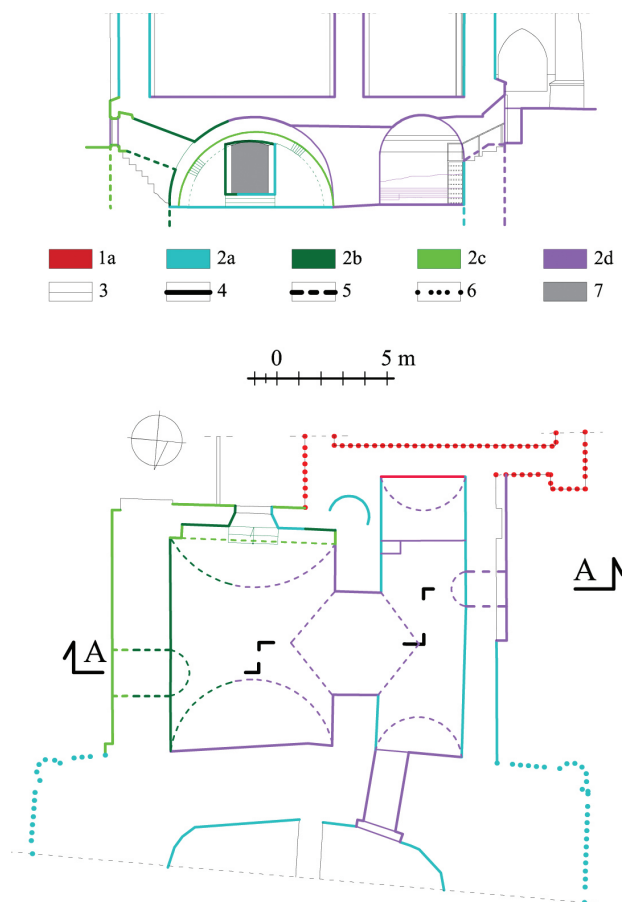
Fig. 8. Reconstruction of the plan and cross-section through the monastery crypt of stage 2 of phase d.

Markings: 1a – 1st half of the 14th century, 2a – approx. 1730, 2b – approx. 1731, 2c – ca. 1735, 2d – ca. 1738, 3 – current state, 4 – visible course of basement walls, 5 – invisible course of walls below ground level, 6 – ground floor walls, 7 – passageway (elaborated by A. Piwek, M. Kwasek)

ment A to the external area of the monastery (Fig. 8). Of the two passages of this crypt that reach the transverse wall of the transept, only the western one was suitable for creating a passage, as it was the only one from which it was possible to freely access every underground part. However, the implementation of this plan necessitated the construction of a basement beneath the corridor. The soil was removed in such a manner that a passageway could be created⁷, which was established in the narrowest part, i.e., as close as possible to the axis of the convex transept. Consequently, the construction efforts were primarily concentrated on the northern sector of the basement, while the southern sector was only partially cleared and secured with a low wall. In addition, a section of the eastern wall of part B of the crypt had
