The issue of structural failures at St Elizabeth's Church in Wrocław in the light of architectural surveys

Abstract

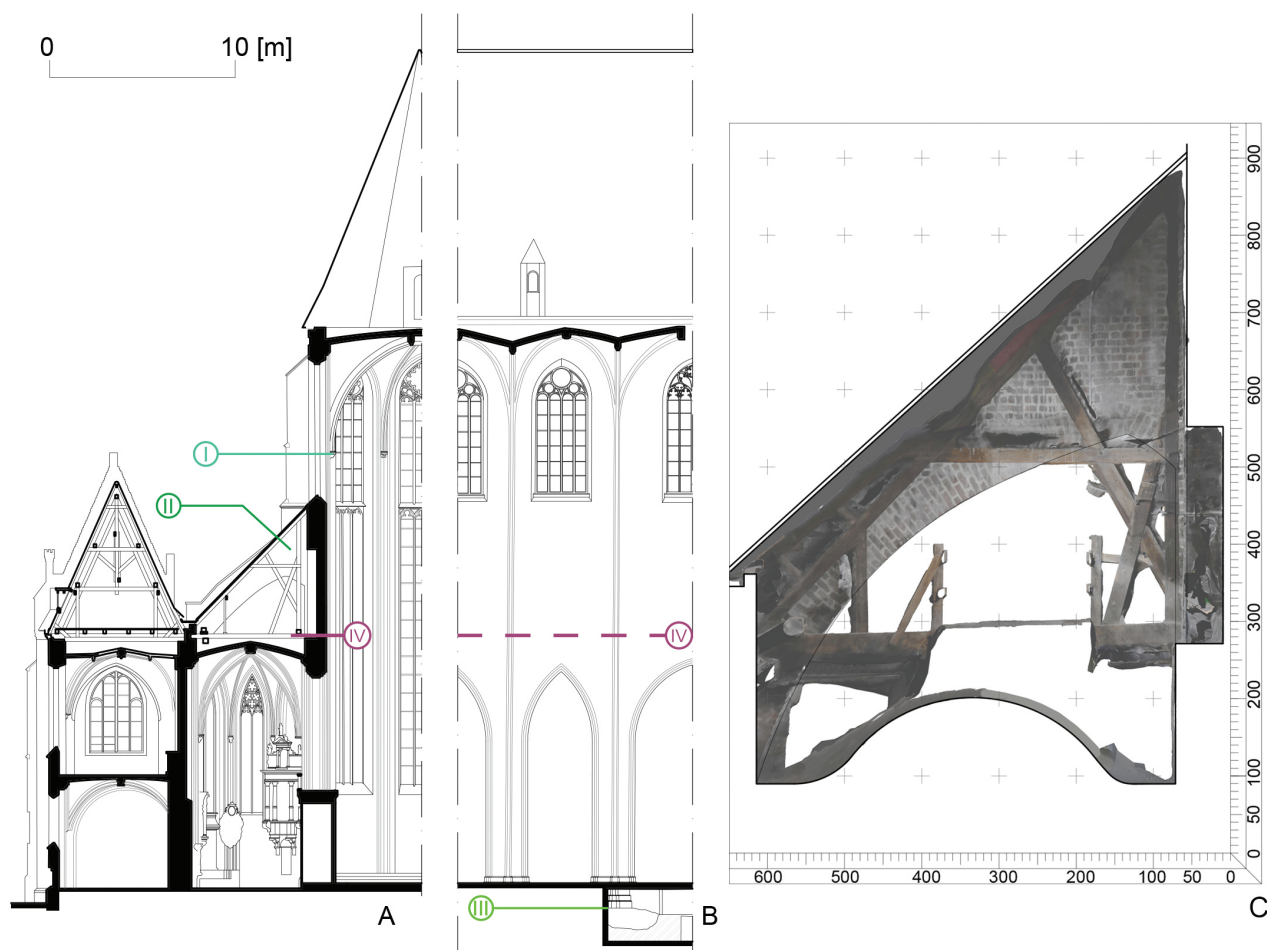
Fig. 2. Cross-sections of St Elizabeth's Church in Wrocław: A – transverse (eastward through the eighth bay from the west), B – longitudinal in the northward direction, C – flying buttress between the seventh and eighth bays from the west on the north side. I – main nave vault corbel, II – flying buttress, III – original floor level (nave), IV – probable height of the walls established as part of the hall concept (orthophotography generated from a photogrammetric model; compiled by F. Hackemer)

by excessive load on the supports. The foundations of the nave (at least in large part) were most likely built as part of the initially planned hall or pseudo-basilica structure. They were designed to bear much smaller loads than those resulting from the construction of the enormous height of the nave (Fig. 2 IV). After the modification of the design, the load on the foundations more than doubled. The collapse of the church was caused by the insufficient load-bearing capacity of the foundations, not by the low setting of the flying buttresses.

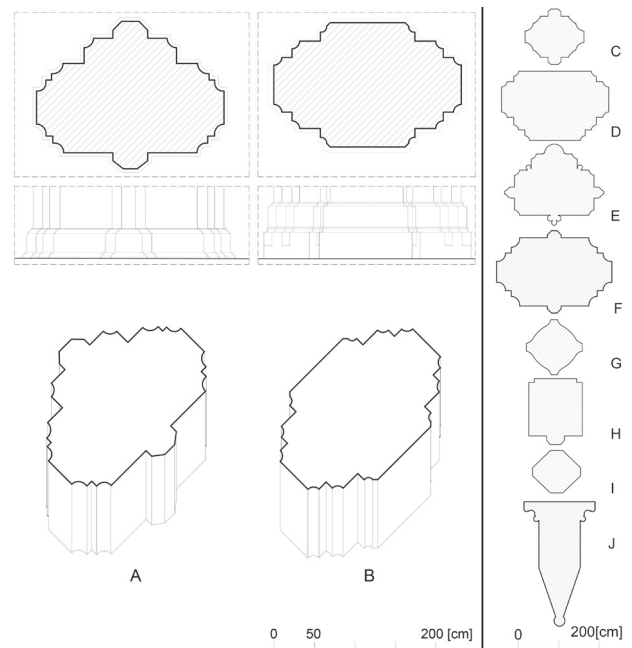
ply (quarter-circular) profiled pilaster strips. In contrast, there are no responds in the chancel. Instead, the pillars are flanked on both sides by pilaster strips, and the vaults rest on corbels at their apex (Fig. 4).

Fig. 4. Pillars of St Elizabeth's Church in Wrocław, plan, side view of the plinth, and axonometric view of the shaft: A – nave, B – chancel. Plans of pillars of formally similar churches: C – Cistercian church in Złota Korona, D – Cistercian church in Lubiąż, E – Our Lady before Tyn church in Prague, F – parish church of St Peter and Paul in Legnica, G – St Maurice church in Soultz, H – Dominican church in České Budějovice, I – Cistercian church in Kaisheim, J – Cistercian church in Salem (body) (compiled by F. Hackemer)

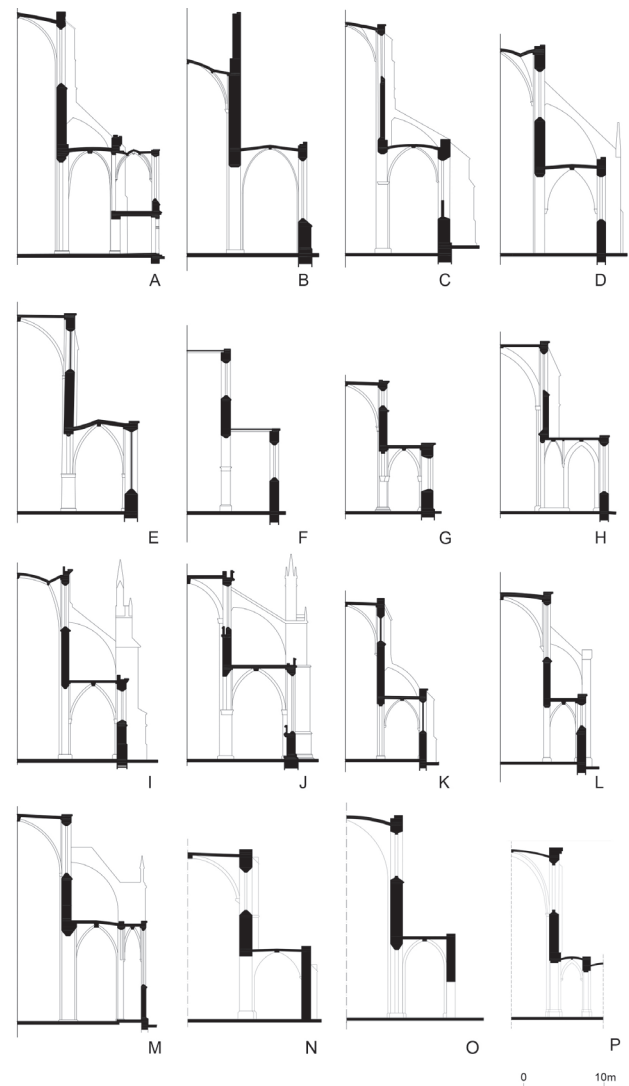
Most of the monastery churches mentioned here have a conventional design (Fig. 9). Although usually hidden, the flying buttresses are at the correct height thanks to the lower clerestories. Sometimes (the nave in Salem), a system of

extending the buttresses by adding them to the pillars of the nave so that they reached the floor was used. Such solutions were missing in the Dominican church in Regensburg, which led to visible (more so than in St Elizabeth's church) deviations from the vertical. However, this is a much smaller building. In contrast, in the Franciscan church in the same city, no vaults were built at all, and the majestic basilica was covered with ceilings. The tendency of monastery builders to hide the flying buttresses naturally forced the use of buttresses at the pillars or the reduction of the difference in height between the nave and the aisles and the overall scale, or the abandonment of vaults.

Fig. 9. Sketches of structural systems on cross-sections of the churches discussed: A – St Elizabeth's church in Wrocław, B – St Stanislaus and Wenceslaus church in Świdnica, C – St Nicholas' church in Brzeg, D – St Peter and Paul's church in Strzegom (nave), E – Dominican church in Regensburg, F – Franciscan church in Regensburg, G – Cistercian church in Lahr, H – Cistercian church in Salem, I – St Theobald church in Thann, J – Cathedral in Freiburg im Breisgau, K – Cistercian church in Kaisheim, L – St Pierre-le-Jeune church in Strasbourg, M – St Lawrence church in Nuremberg, N – Dominican church in České Budějovice, O – Cistercian church in Zlatá Koruna, P – Cistercian church in Lübbau (compiled by F. Hackemer)

Extending the clerestory so high that the existing flying buttresses do not balance the pressure of the vault is completely unusual. This should come as no surprise, given its ineffectiveness. Nevertheless, it was repeated in Silesia. We refer here to the parish churches in Brzeg and Świdnica (Fig. 9). In these buildings, the point of embedment of the buttresses is vertically distant from the point of pressure of the vaults (in Brzeg by approximately 6 m). What is particularly interesting is that in the 16th century, the original

Cross-sections of the churches in Brzeg and Wrocław reveal similar proportions and structural design principles (Fig. 9). However, the church dedicated to St Nicholas differs significantly in terms of detail, with particular emphasis on octagonal pillars without profiling, which is why it was rarely mentioned in the context of its Wrocław counterpart. Nevertheless, it seems that the similarity in the design of the external structure as a synthetic form of a basilica without visible flying buttresses, together with the very high clerestory, indicate at least some inspiration from the Wrocław parish church. This is possible because the construction of
