Ulrich Schaaf*, Maciej Prarat**

Carpentry craft at the turn of the 18th and 19th centuries. Case study: the roof structure of the Church of the Holy Cross in Leszno

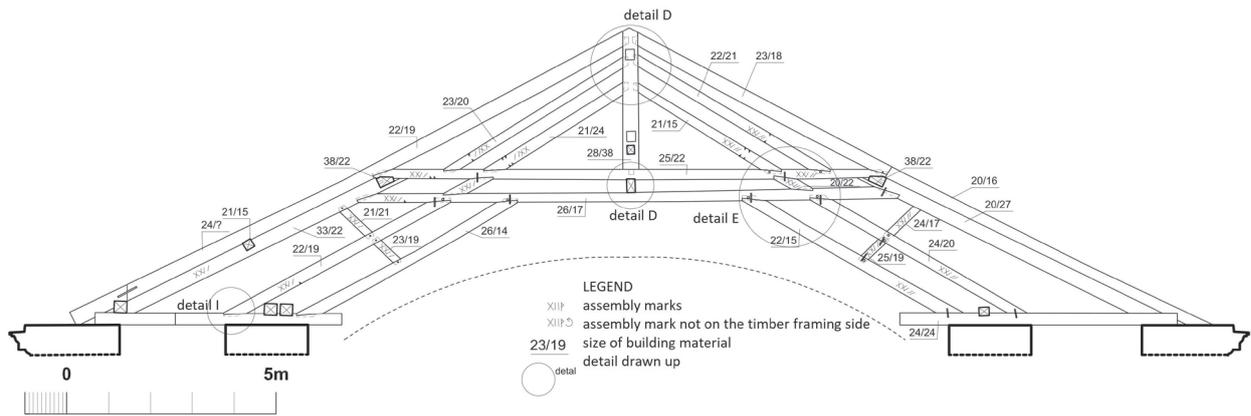
Fig. 1. Leszno, Church of the Holy Cross, roof structure, principal rafter truss (elaborated by U. Schaaf, M. Prarat)

The actual roof structure with a span of 24 m is a collar beam structure, free (within the apparent vault), with inclined standing queen posts on the lower tier and a hanging king post truss on the upper tier. The straining beam for the inclined standing queen posts of a significant length (about 11.00 m) is additionally supported on the lower tier

with two passing braces. Thus, it forms a strut frame. Two passing braces on the lower tier and in their extension, first two short braces between the straining beam and the collar beam, and then two other passing braces on the upper tier additionally support the king post, as in the case of the hanging and strutted frame. In addition, between the pillars of the internal elongated octagon on the southern and northern side, there are hanging king and queen post structure frames, the trusses of which are suspended with

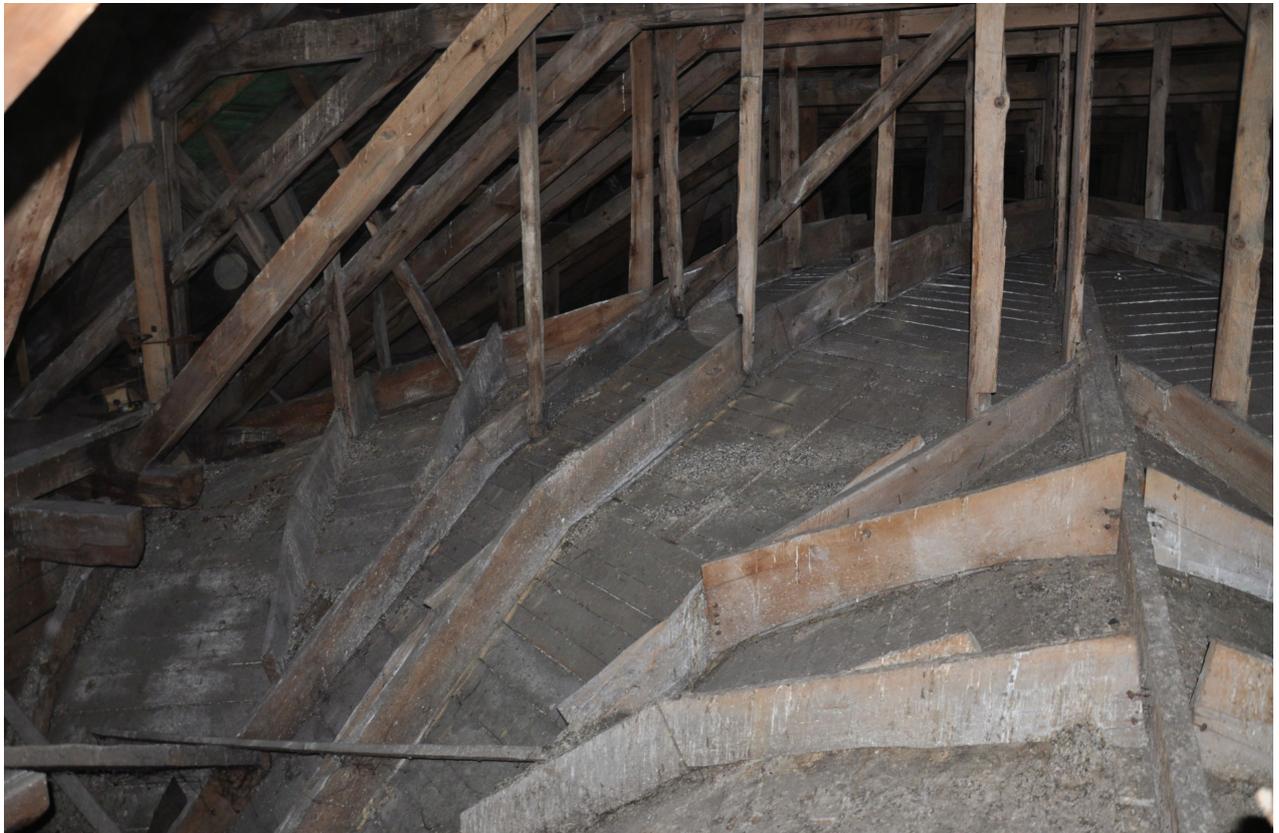
Fig. 2. Leszno, Church of the Holy Cross, roof structure, curved plank roof, curved planks suspended from the structural elements of the roof structure above (photo by U. Schaaf, M. Prarat)

dimension of the arch rise – about 1.5 m, many curved planks were suspended in addition to the various wooden elements of the truss above (Fig. 2).

tudinal, slightly rounded cuts. In this way, beams with the cross-section of the entire tree were obtained. In the whole truss, only some elements are made of the whole tree, processed only with an ax and an adze, and in addition, they are not among the thickest cross-section elements. These exceptions include, for example, some passing braces in the hanging king post structure. On the other hand, most of the structural elements additionally bear traces of slightly oblique cuts resulting from sawing on one, two, or even three sides. Additionally, on the outer surface of some elements, machining with an ax and an adze sometimes turns into machining with a saw (Fig. 12), which shows that the saw was not always used only to divide the whole tree into a half-tree or a cross-tree, as was usually the case. It can be assumed that in this way, efforts were made to obtain as many additional logs and boards as possible, which were used to make the curved plank roof covering the interior of the church (Fig. 2).

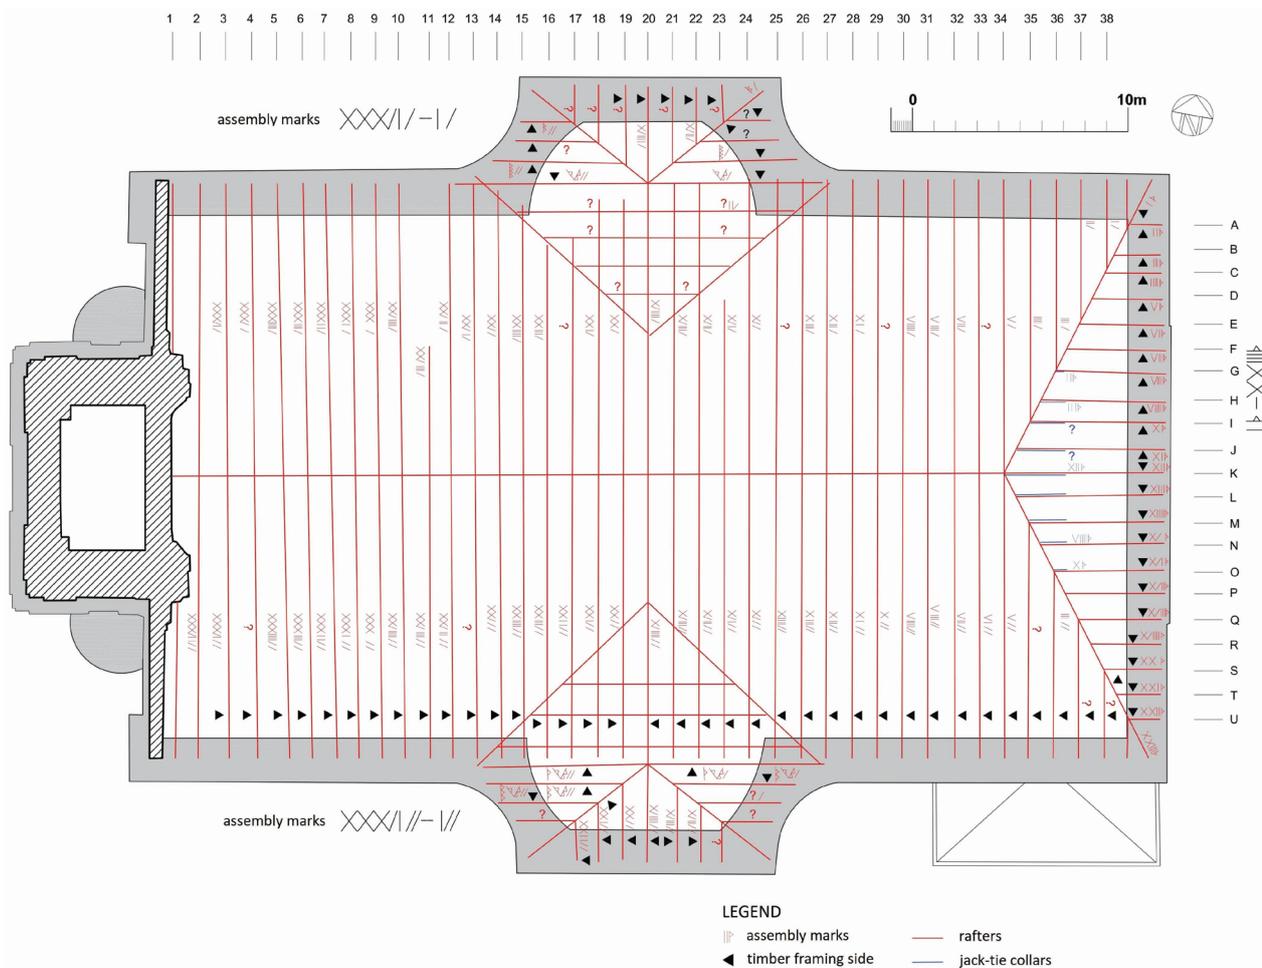
Fig. 3. Leszno, Church of the Holy Cross, roof structure, diagram, top view, arrangement of trusses and system of carpentry assembly marks (elaborated by U. Schaaf, M. Prarat)

The roof structure consists entirely of 38 trusses arranged in the transverse direction of the church and – within the three-sided closure from the east – of two corner trusses and 21 jack ties arranged in the longitudinal direction of the church, marked from A to U (Fig. 3). The solution of the rectangular roofing method in the projection of the body with an elongated, vaulted octagon inscribed in it required, not only the use of a complicated mixed structural system, but also a whole range of different types of roof trusses. Among them, five basic types should be distinguished, i.e., a principal rafter truss in two basic types, a paired common rafter, a corner truss, and a jack tie. Most of these types also come in different variants, which are briefly described below (Fig. 4).

From east to west, all the trusses (principal rafter trusses, paired common rafters, and jack trusses) are marked from 1 to 38 with Roman numerals (see Fig. 3). The timber framing from truss 1 to truss 19 is on the western side, and truss 20 to truss 38 are on the eastern side. In order to distinguish the structural elements on both sides of the axis of symmetry, all elements on the northern side received an additional mark in the form of one oblique incision, and on the southern side – in the form of two oblique incisions. The collar beams and straining beams are partially double-marked – each time with the same numerical mark, but with different markings on the northern and southern sides. By-marks in the form of triangular corner cuts were not always detectable owing to the partial leaving of the wane and the lack of full access to the

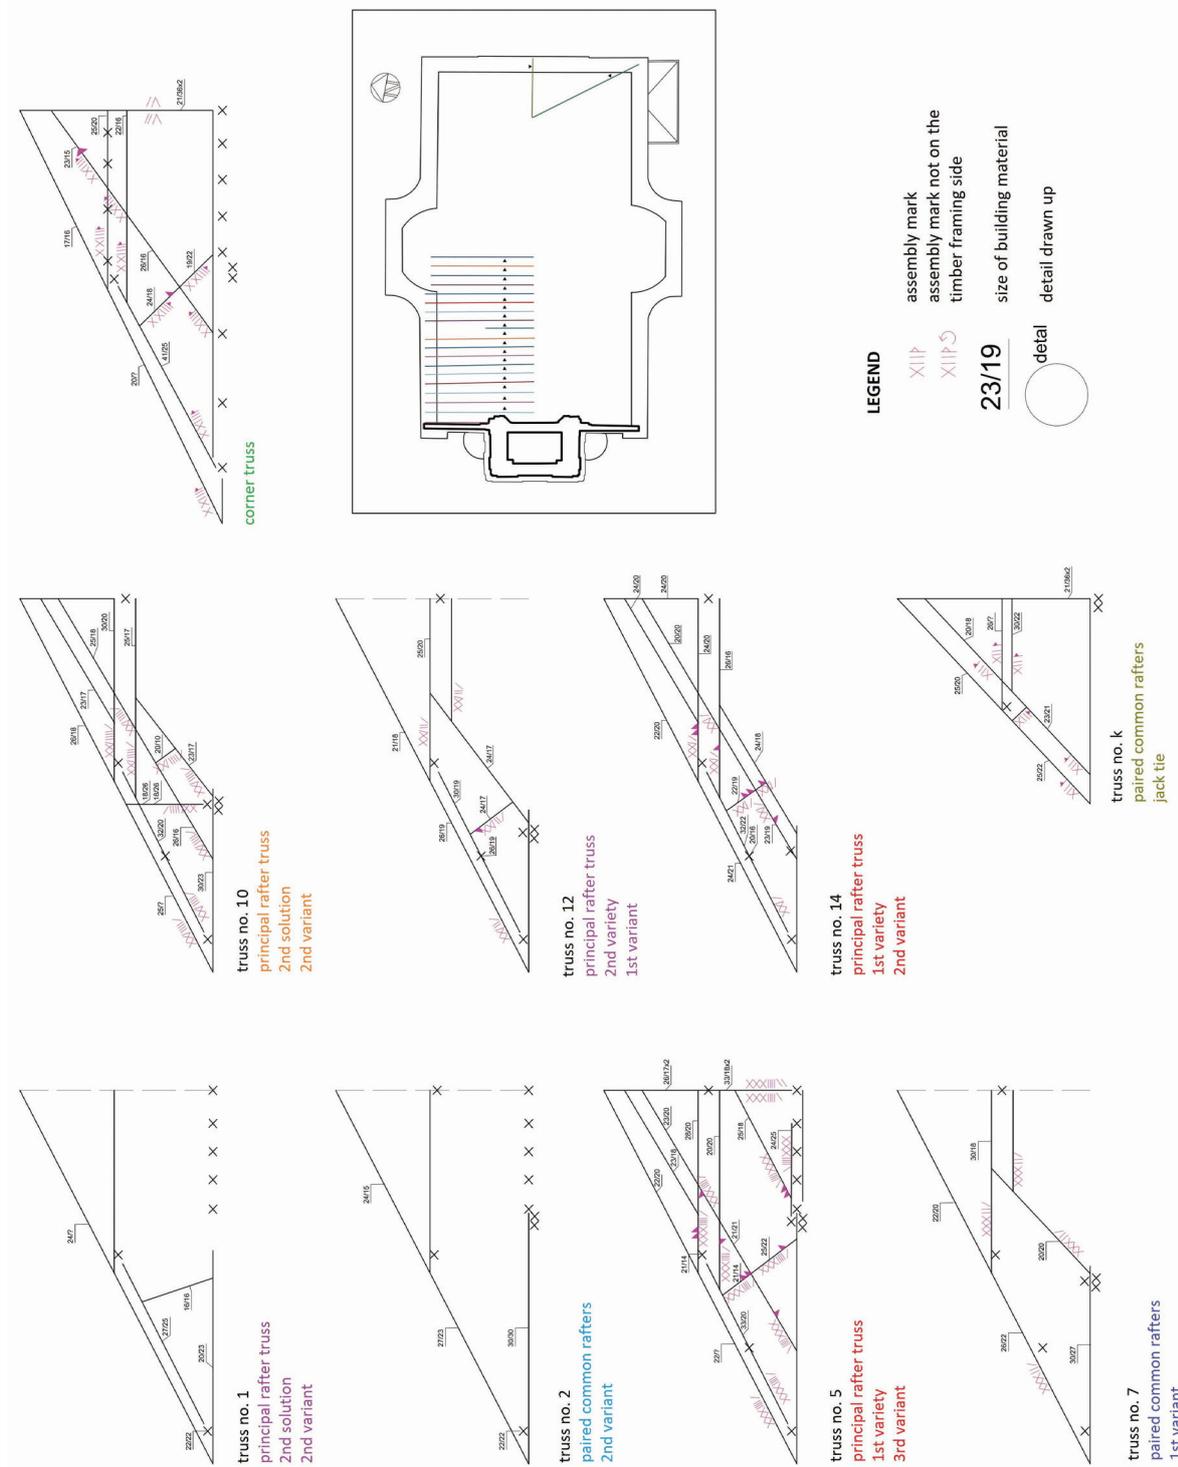
Fig. 4. Leszno, Church of the Holy Cross, roof structure, diagram, types of roof trusses (halves) (elaborated by U. Schaaf, M. Prarat)
 Il. 4. Leszno, kościół św. Krzyża, więźba dachowa, schemat, typy więźbar dachowych (połówki) (oprac. U. Schaaf, M. Prarat)

The principal rafter trusses of the first variety are available in three variants. A typical truss (trusses: 10, 18, 22, 30) consists of the following elements: two short tie beams [17, p. 95] based either on walls/pillars or on double binding beams, two rafters, and one collar beam; on the lower tier, an inclined standing queen post and a straining beam between them, a pair of passing braces supporting the strain-

ing beam, a frame of two queen posts along the inner octagon (in trusses 5 to 34); on the upper tier, it is made of a king post supported by a pair of passing braces. The king post is additionally supported by passing braces and braces on both tiers, and the passing braces on the lower tier are connected with a short brace. The second variant (trusses: 14, 26) is devoid of king posts on the southern and northern sides of the inner elongated octagon. On the other hand, in the 5th and 34th principal rafter trusses, the queen post truss extends across both tiers. On the lower tier, it is additionally supported by a pair of passing braces based on an eaves purlin.

The second type of the principal rafter truss differs from the first type in that it is devoid of a hanging king post structure. It comes in two variants. In the first variant (trusses: 12, 16, 20, 24, 28, 32) it is composed of the following elements: two short tie beams supported on the lateral wall of the church on the outside, and, on the inside, on double binding beams between the pillars of the inner octagon, two rafters and one collar beam, an inclined standing queen post (without a straining beam), a pair of passing braces extending from the short tie beams to the collar beam with a straining beam between them, and a pair of braces stretched between the passing brace and

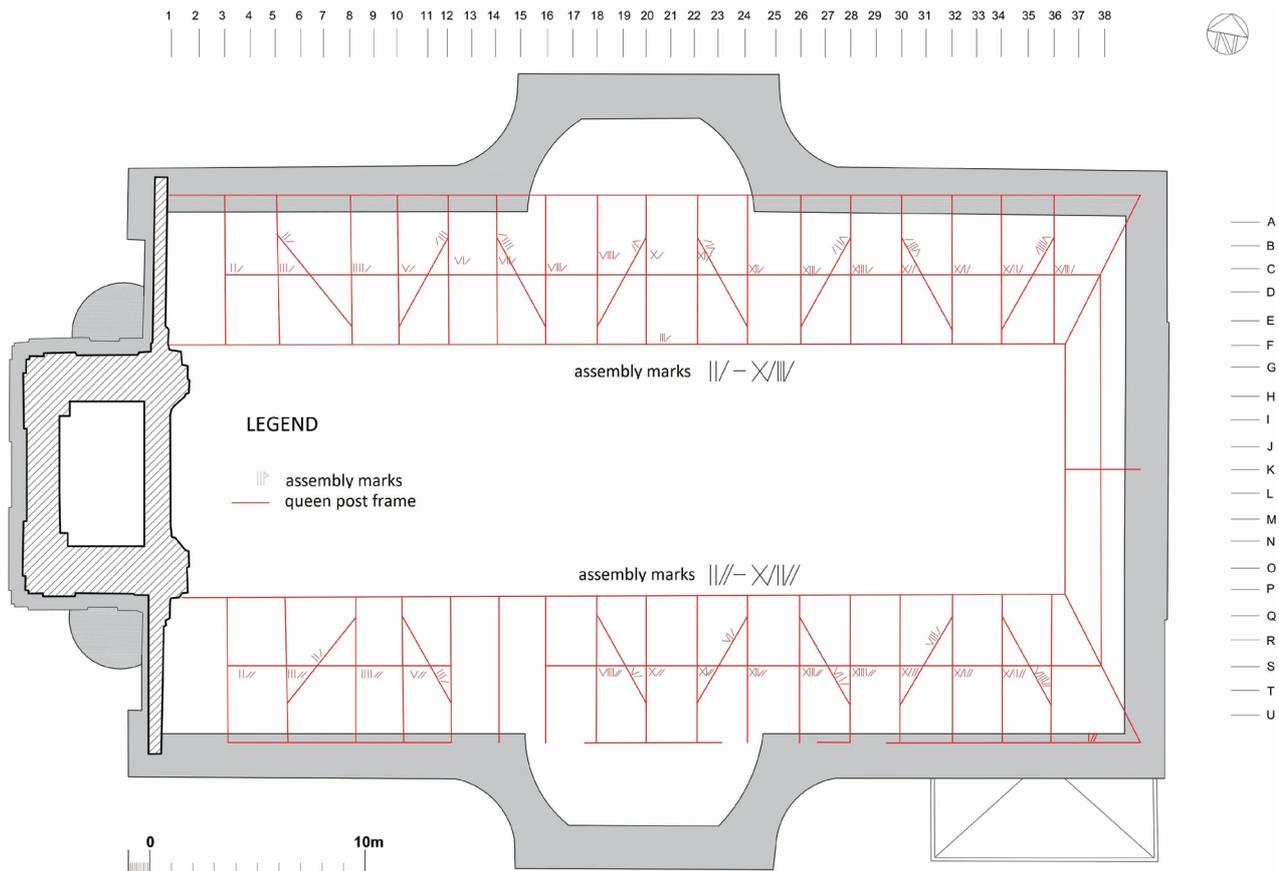
Fig. 5. Leszno, Church of the Holy Cross, roof structure, diagram, inclined standing queen-post frames (elaborated by U. Schaaf, M. Prarat)

In the longitudinal direction, one should distinguish between inclined standing queen-post frames and hanging king post frames. Horizontal inclined standing queen-post frames (Fig. 5) are essentially built of inclined standing queen posts in every other truss, placed on an eaves purlin lying on the trusses and coped with a hip purlin below the collar beams. Between the inclined standing queen posts, slightly below half the height of the frame, there is an additional string of spandrel beams. Inclined standing queen-post frames are additionally stiffened with passing braces stretched between the inclined standing queen posts in every other segment. In the eastern roof slope, the inclined standing queen post frame appears only in a reduced form. It consists of one inclined standing queen post in the central axis, resting directly on the short joist, coped with a hip purlin connecting with longitudinal inclined standing queen post frames within the corner rafters.

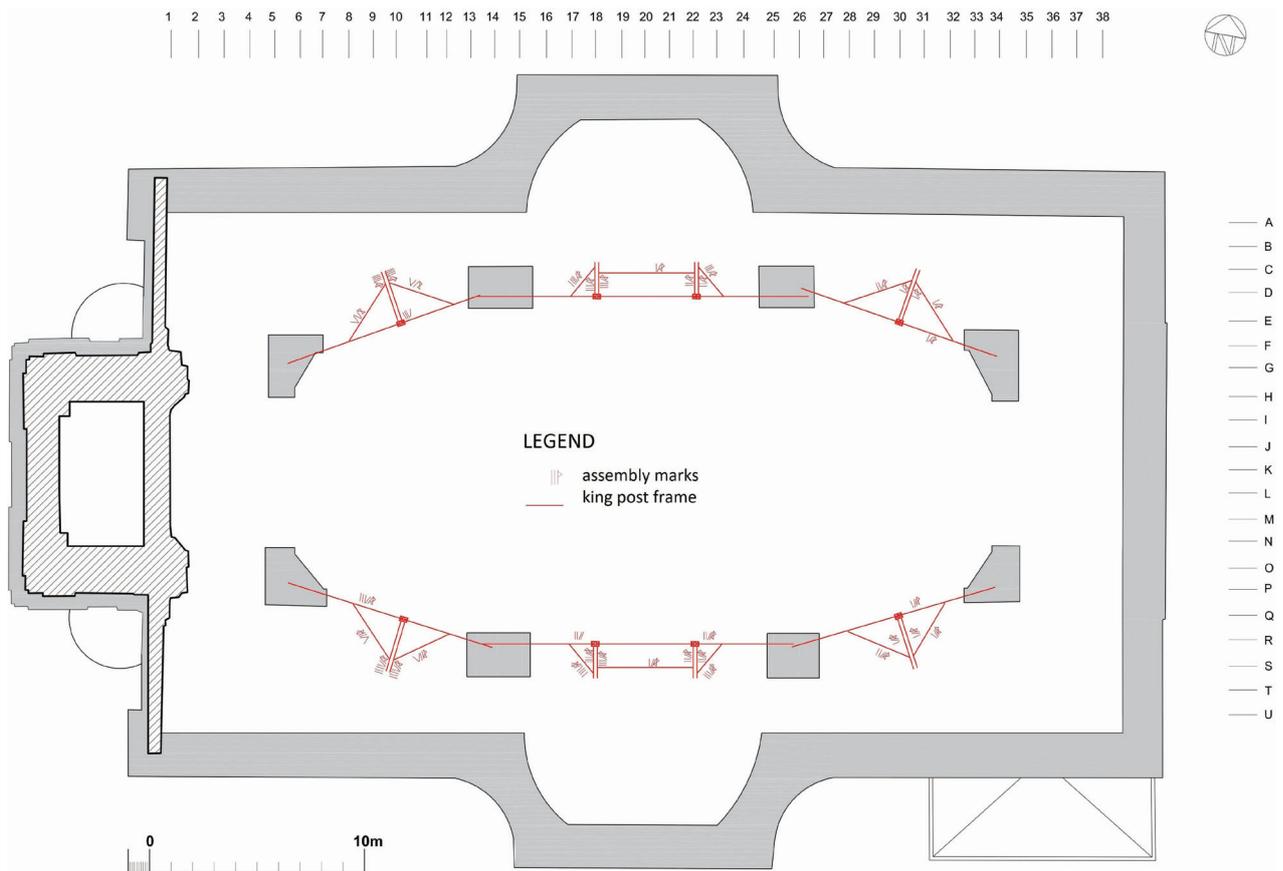
Fig. 6. Leszno, Church of the Holy Cross, roof structure, diagram, hanging king and queen post frames on the southern and northern sides of the elongated octagon (elaborated by U. Schaaf, M. Prarat)

Standing king post or queen post frames on the lower tier (Fig. 6) run on the southern and northern sides along the inner, elongated octagon from truss 5 to truss 34. The tie beam of the hanging queen-post frames is based on pillars, and some short tie beams are suspended from it. The queen post itself, from which the stay is suspended, is present in trusses: 10–18, 22, and 30. In the hanging king post frames, each king post is supported by two passing braces. On the other hand, in the hanging queen-post frames, there is a straining beam between them instead of passing braces.

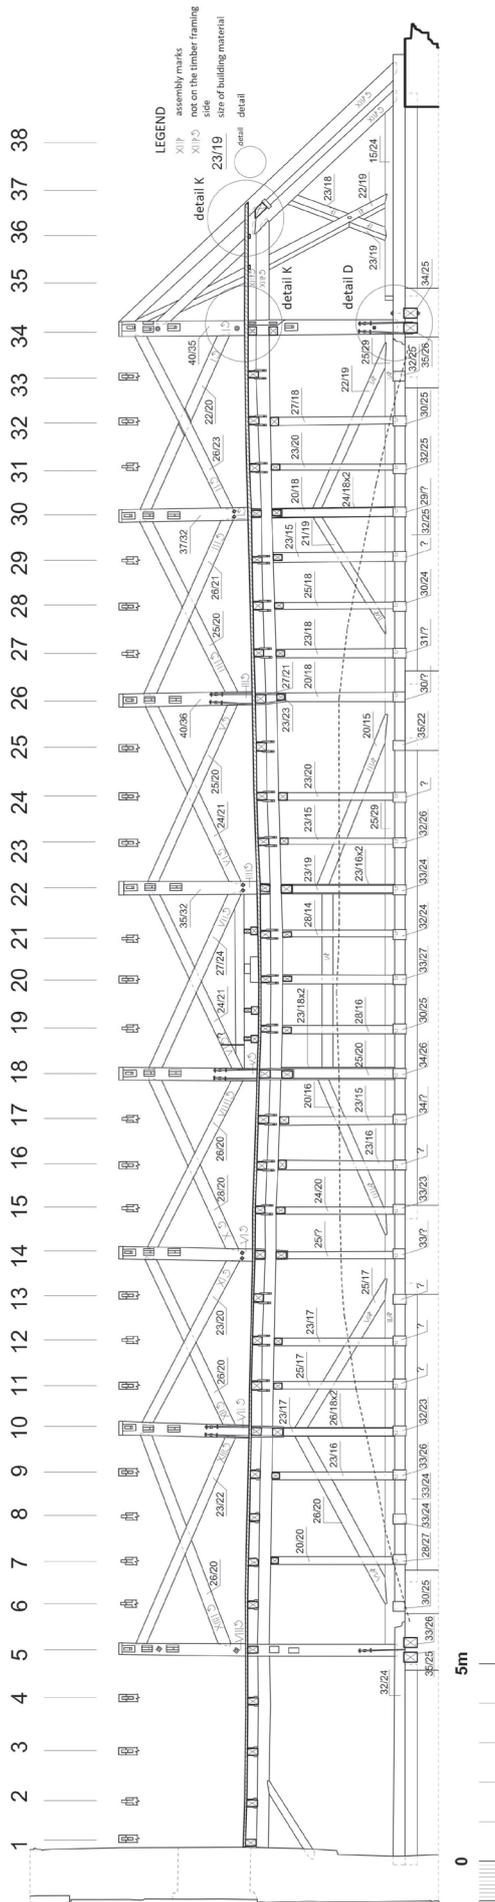
Fig. 7. Leszno, Church of the Holy Cross, roof structure, longitudinal cross-section (elaborated by U. Schaaf, M. Prarat)

The hanging king-post frame on the upper tier (Fig. 7) is built of king posts found in trusses: 5, 10, 14, 18, 22, 26, 30, 34 and intersecting passing braces between them. Collar beams, a longitudinal spandrel beam, and straining beams are hung on the king posts. In trusses 5 and 34, queen posts extend through both tiers. A binding beam is suspended from the queen posts on which short tie beams rest.

The king post is – apart from two pairs of passing braces – additionally supported by rafters; their connection has already been described above. The intersecting passing braces of the longitudinal stiffener of the hanging king post structure are connected with king posts only by means of a frontal angled notched joint without a tenon, and with each other, by means of a simple lap joint (see Fig. 7).

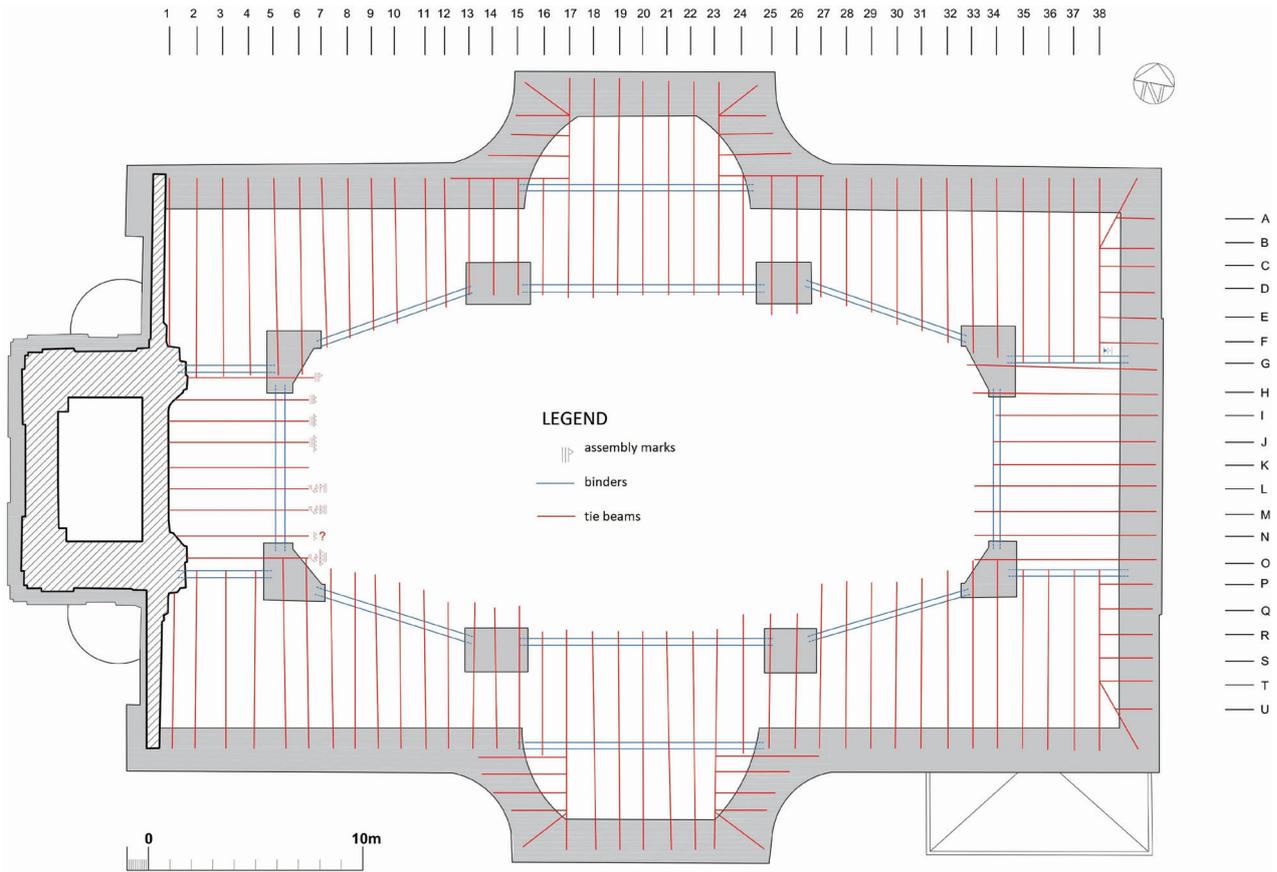
Fig. 8. Leszno, Church of the Holy Cross, roof structure, diagram, entablature diagram (elaborated by U. Schaaf, M. Prarat)

The east-west beams on the western side are not directly related to the roof structure. On the western side, they rest on the wall of the tower, and on the eastern side, on a double binding beam (Fig. 8).

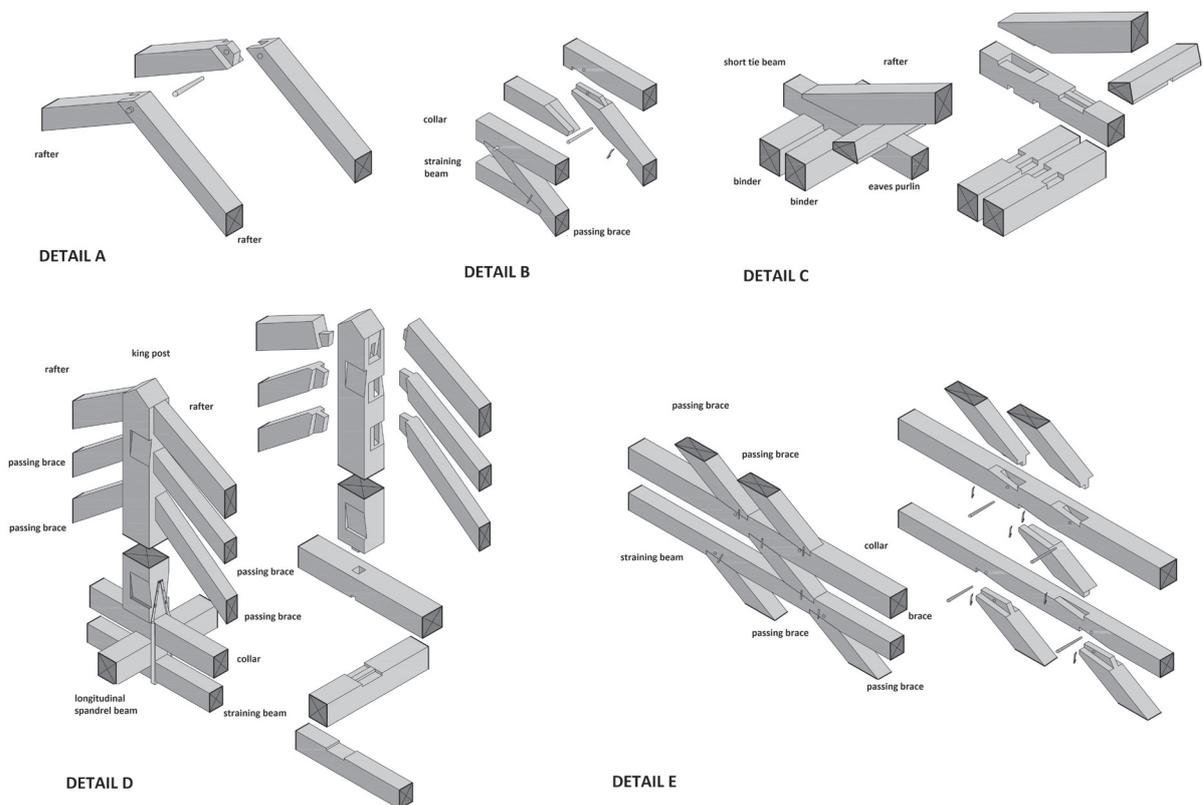
Fig. 9. Leszno, Church of the Holy Cross, roof structure, construction details (elaborated by U. Schaaf, M. Prarat)

paired common rafters, the rafters are connected with each other by means of a pegged scarf joint bridled with a full tenon (see Fig. 9, detail A) or a tease tenon. The last joint protects the tenon better against adverse weather conditions. Collar beams in these trusses connect to the rafters by a tenon with a front notch (see Fig. 10, detail L). The corner rafters are tenoned into diagonal short joists and connected to a queen post by means of a one-sided frontal angled notched joint. Jack rafters with diagonal cuts are butted to them.

In the inclined standing queen-post structure, eaves purlins are placed on the short tie beams by means of a central notch (see Fig. 9, detail C), while the inclined standing queen posts are tenoned both in the eaves purlin and in the roof purlin (see Fig. 10, detail L). The latter, in turn, connects with the collar beam by means of a side notch. The straining beam is connected to the inclined standing queen posts partially by means of a pegged tenon with a frontal angled notched joint, partially by a non-pegged tenon with a frontal angled notched joint (see Fig. 10, detail L) and partially only by a non-pegged tenon. The spandrel beams of the inclined standing queen-post frame connect to the inclined standing queen posts by a tenon, while the passing braces of the inclined standing queen-post frame connect to the roof inclined standing queen post by a frontal angled notched joint.

In the king post structure, the king post is present in trusses 10, 14, 18, 22 only within the upper tier. It is connected to the collar beam by a non-pegged tenon, and a longitudinal spandrel beam is suspended from it using a suitably bent flat bar, fastened with dogs and bolts (see Fig. 9, detail D). In the transverse direction, the king post is supported by passing braces, braces, and rafters. On the lower tier, each pair of passing braces extends from the short tie beams to the straining beam and connects to it by means of a pegged tenon with a frontal angled notched joint (see Fig. 9, detail E). In the extension of the passing braces, there is a pair of braces stretched between the straining beam and the collar beam; in order to connect these elements, a lap joint secured with a dog was used. The passing braces on the upper tier connect both with the collar beam and with the king post with a frontal angled notched joint. Owing to the larger cross-section of the king post, the ends of the passing brace are partially additionally embedded in the sockets cut in the king post (see Fig. 9, detail D).

In most of the principal rafter trusses and paired common rafters (exceptions are trusses: 2, 4, 6, 13, 25, 33) there is an additional pair of passing braces at the lower end, which connects at the lower end with sections of the tie beam and at the upper end, either with a straining beam or with a collar beam using a frontal angled notched joint (see Fig. 9, detail E). In the second case, the straining

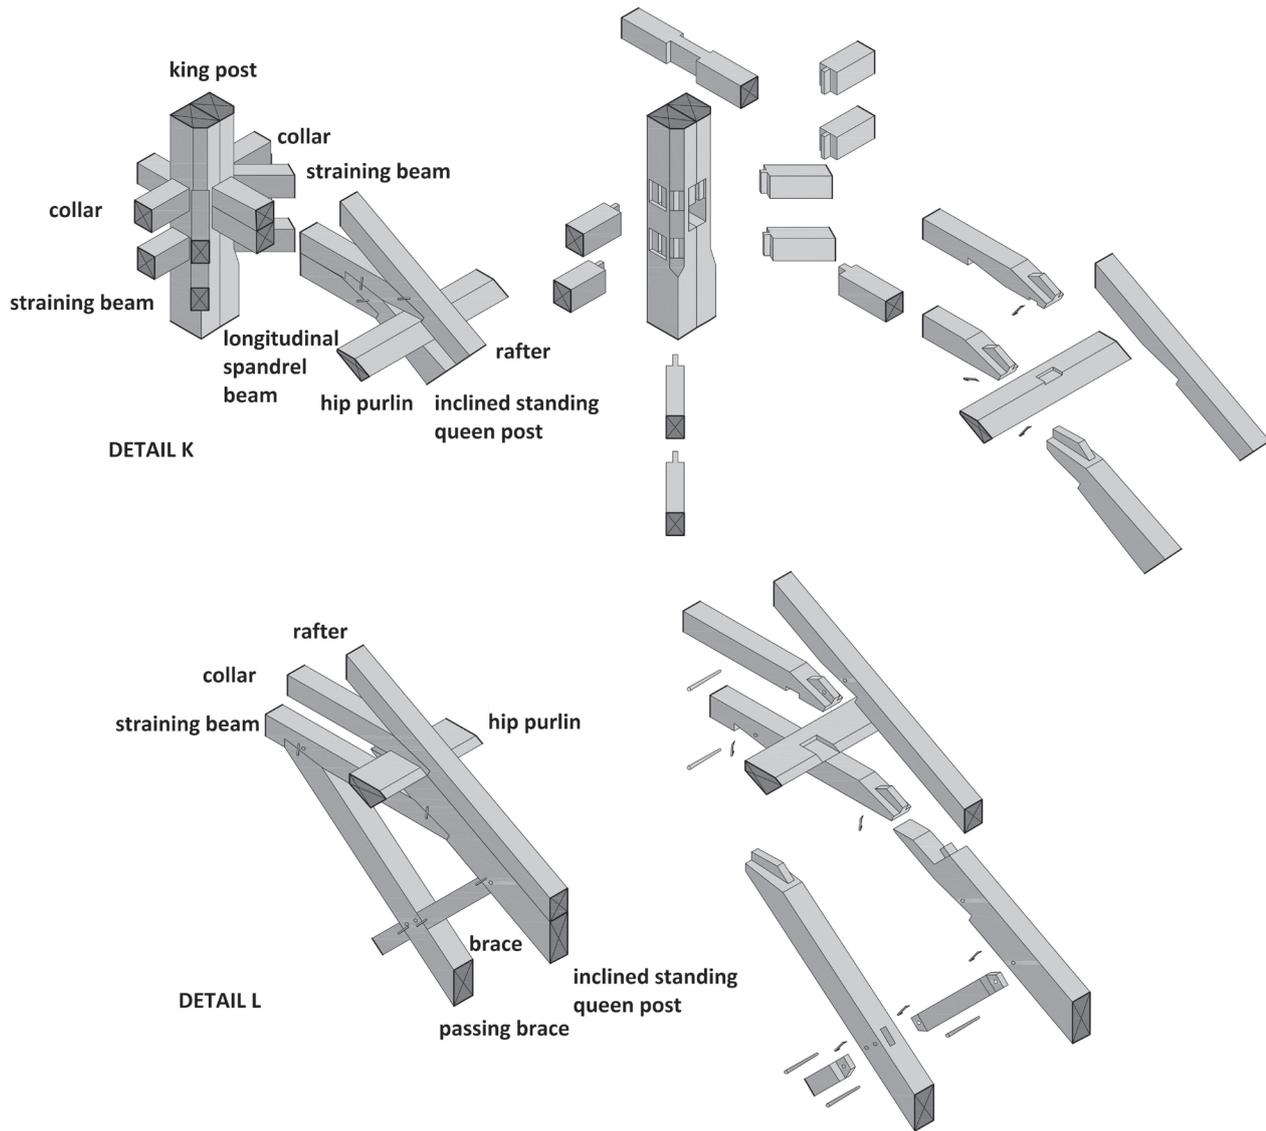
Fig. 10. Leszno, Church of the Holy Cross, roof structure, construction details (elaborated by U. Schaaf, M. Prarat)

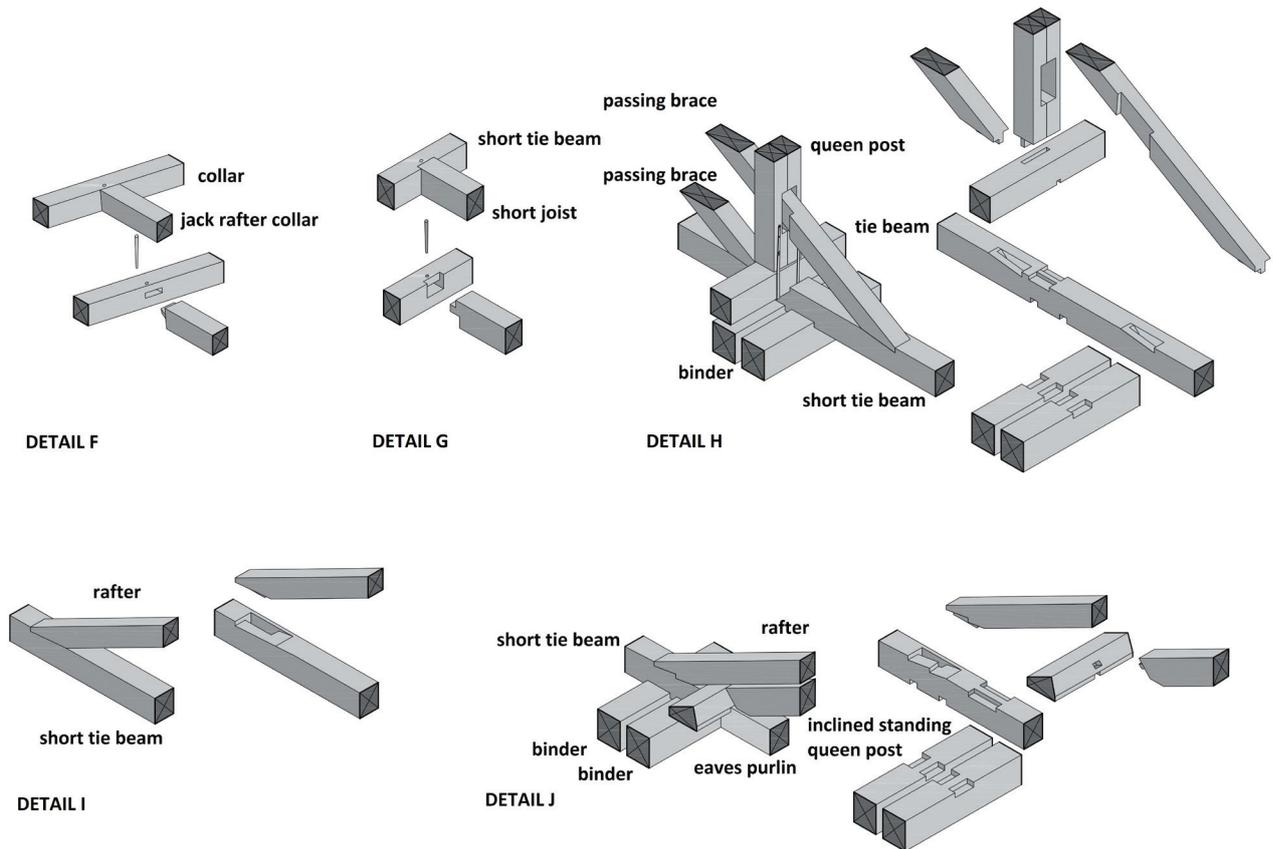
Fig. 11. Leszno, Church of the Holy Cross, roof structure, construction details (elaborated by U. Schaaf, M. Prarat)

Double binding beams rest directly on the pillars or the western and eastern walls of the church. Both the short tie beams and jack rafters are embedded in the lateral walls on the outside. From the inside, the short tie beams connect with double binding beams at different levels using the middle notch (see Fig. 11, details H and J) or, in the case of an internal binding beam, also partially in the side notch. This joint secures the short tie beams in their location. The short joists are connected to the sections of the tie beams at one level by means of a pegged tenon joint with a straight bolt, which makes a greater load of this joint possible in the vertical direction (see Fig. 11, detail G).

The rafters are connected with short tie beams or jack rafters by a non-pegged tenon joint in three variants: without a notch, with a single front notch, or with a double notch (see Fig. 11, details I and J). It was not necessary to secure this connection with a peg, and the notch permits it to be loaded more with compressive force. In the ridge, the rafters are connected in principal rafter trusses of the first variety with king posts using a non-pegged tease tenon, with the end of the entire rafters partially recessed into a socket cut in a king post with a larger cross-section (see Fig. 9, detail D). This is how the king post was effectively suspended. In the remaining principal rafter trusses and

A hanging king post in trusses 5 and 34 extends across both tiers. On the lower tier, it connects to the short tie beam by means of a tenon. One of the double binding beams is suspended from the king post by means of two flat bars, bent appropriately and fastened with dogs and bolts. Two sections of the tie beam were connected with short tie beams by means of a notch, and a pair of supporting passing braces were connected to both the tie beam sections and the king post using the frontal angled notched joint. The transverse, longitudinal, and diagonal spandrel and collar beams above are connected to the king post essentially by means of a tenon (Fig. 11, detail F). For this purpose, the queen post was given an appropriate hexago-

In the hanging king or queen post structure, along the inner octagon, the tie beams connect with the short tie beam using the frontal angled notched joint (Fig. 11, detail H). Some of these joints are additionally held together with bolts. The hanging queen post itself extends from the tie beam in which it is tenoned into the inclined standing queen post with a lap joint on the side of each section of the hanging queen post. A tie beam is suspended from the hanging queen post by means of two appropriately bent flat bars attached with dogs and a bolt. The hanging queen post is in turn supported by a pair of passing braces which are connected to the tie beam using a frontal angled notched joint, and to the hanging queen post by means of a tenon with a frontal angled notched joint or only by a frontal angled notched joint.

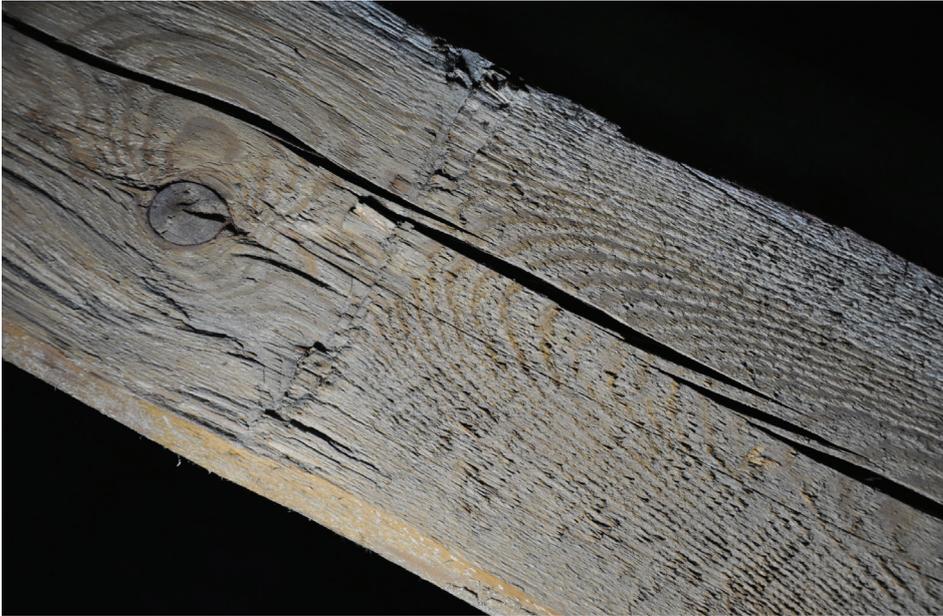
Fig. 12. Leszno,
Church of the Holy Cross,
roof structure, traces of ax
and saw processing
(photo by U. Schaaf, M. Prarat)

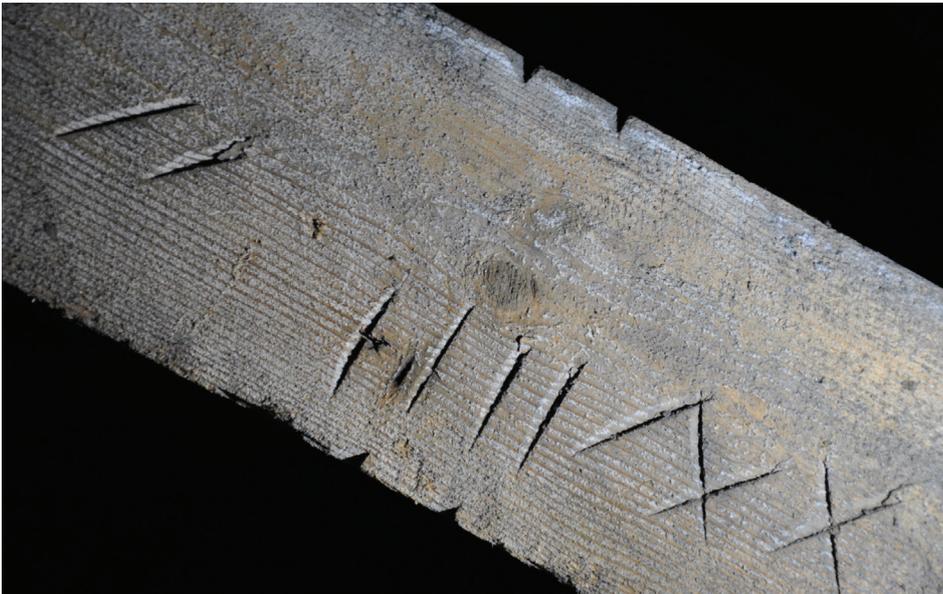
Fig. 13. Leszno,
Church of the Holy Cross,
roof structure, carpentry
assembly marks, Roman numeral
in conjunction with by-marks
in the form of diagonal cuts
and triangular cuts on the edges
(photo by U. Schaaf, M. Prarat)

Basically, Roman numerals were used to mark the structural elements during the timber framing process made with an ax and marks with a triangular shape made with a chisel and partially connected with the system of Roman numerals. Additionally, three types of by-marks were used: in the shape of oblique cuts made with an ax, triangular cuts at the corners of the truss structure elements made with

a chisel (Fig. 13), and marks of a triangular shape adjacent to a thin line made with a chisel and a stylus.

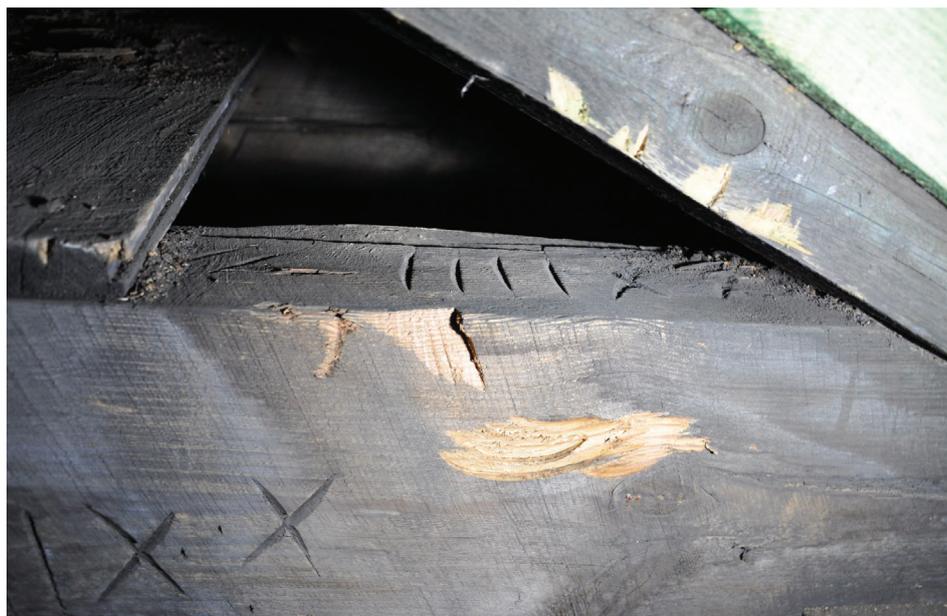
Fig. 14. Leszno, Church of the Holy Cross, roof structure, carpentry assembly marks on both sides of the timber framing (photo by U. Schaaf, M. Prarat)
