## *Architecture and building technology of the 16<sup>th</sup>-century half-timbered church in Byków*

An architectural survey of the former Evangelical church, now the Church of Our Lady of the Rosary, in Byków (Długoleka municipality, Wrocław district) was conducted in 2022. Its erection dates back to 1574. The church underwent significant expansion and reconstruction in the following centuries, which dramatically changed its form.

Based on these, the authors were able to determine that the original church was erected in a timber-frame construction and consisted of a nave and an elongated, trilateral closed choir on the east and a tower on the west. The corpus and choir were covered with gabled roofs with king post trusses. Much of this structure has been preserved in the present church structure.

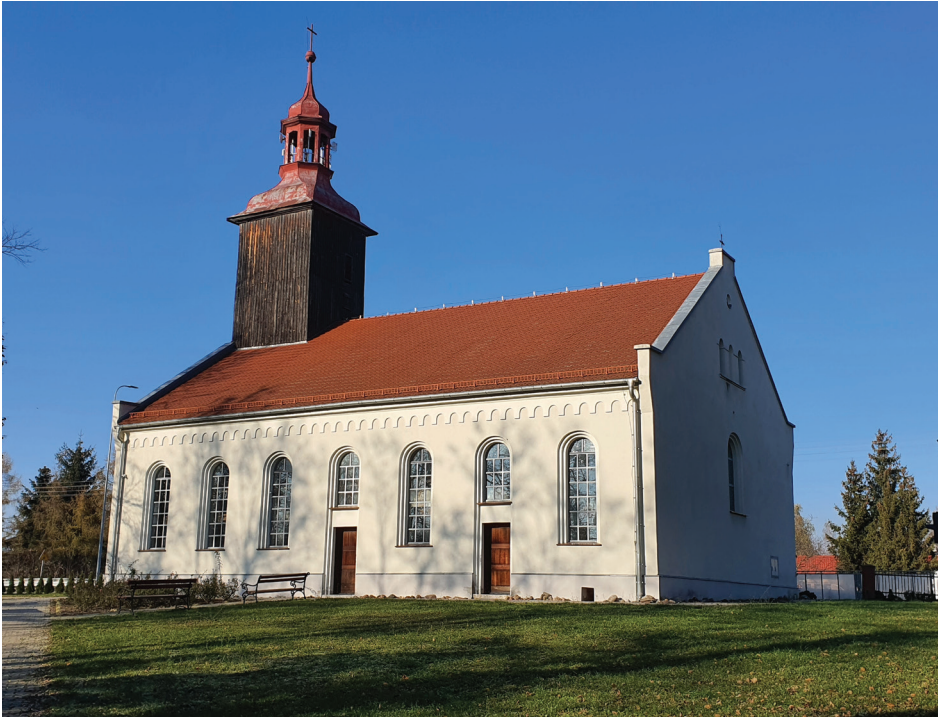
Fig. 1. Church of Our Lady of the Rosary in Byków, southern elevation, view towards the north-west (photo by M. Prarat, 2022)

truss. The narrower side aisles are separated by single rows of columns supporting richly decorated matronea, which in the choir section turn into former patrons' boxes; in the western part of the main nave, there is an organ matroneum. In 2009, the church was entered into the register of historical monuments<sup>1</sup> (Fig. 1).

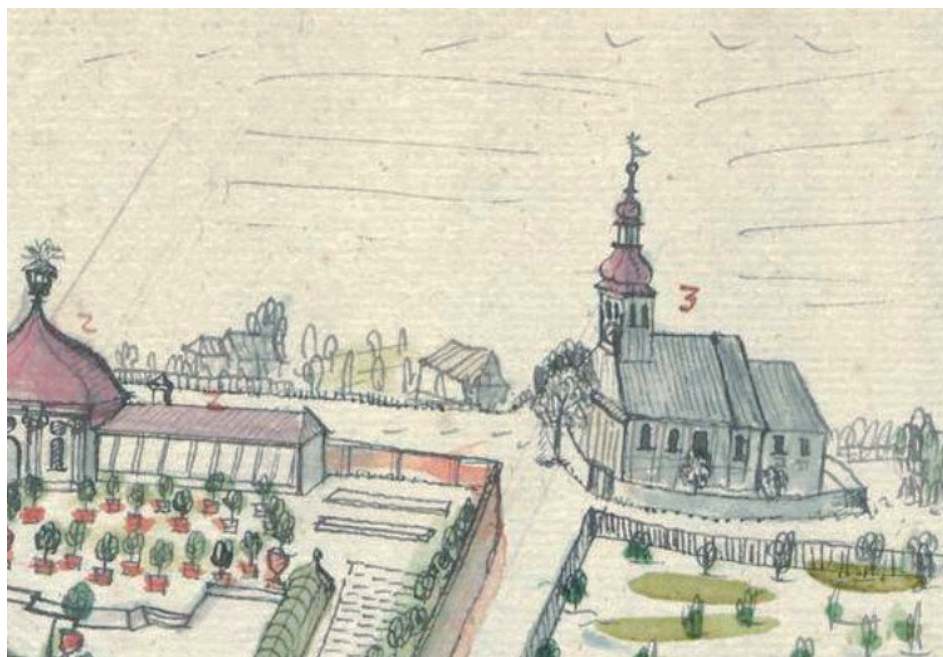
Fig. 2. Church of Our Lady of the Rosary in Byków depicted in a fragment of a drawing by Friedrich Werner from a publication published in the mid-18<sup>th</sup> century (source: Werner 1754)

structure (Brzezicki et al. 2006; Donath et al. 2012). The church was captured by Friedrich Bernhard Werner (1754) in a drawing showing the palace with Baron Haugwitz's garden of 1754) (Fig. 2). The 19<sup>th</sup>-century works are mentioned in the Files of the Conservator of Monuments of the Province of Lower Silesia (Archiwum Państwowe... ref. no. 1172) – the following were enumerated: replacing the half-timbered construction of the walls with bricks and changing/reconstructing the roof<sup>4</sup>. The authors make the reservation, however, that the research in question did not include a full archival search. The history of the church and the parish is presented in more detail in *Dzieje gminy Długoleka* [History of the Commune of Długoleka] by Zbigniew Fras (1998), although the information contained in the publication does not contribute anything new to the subject of the construction history of the church.

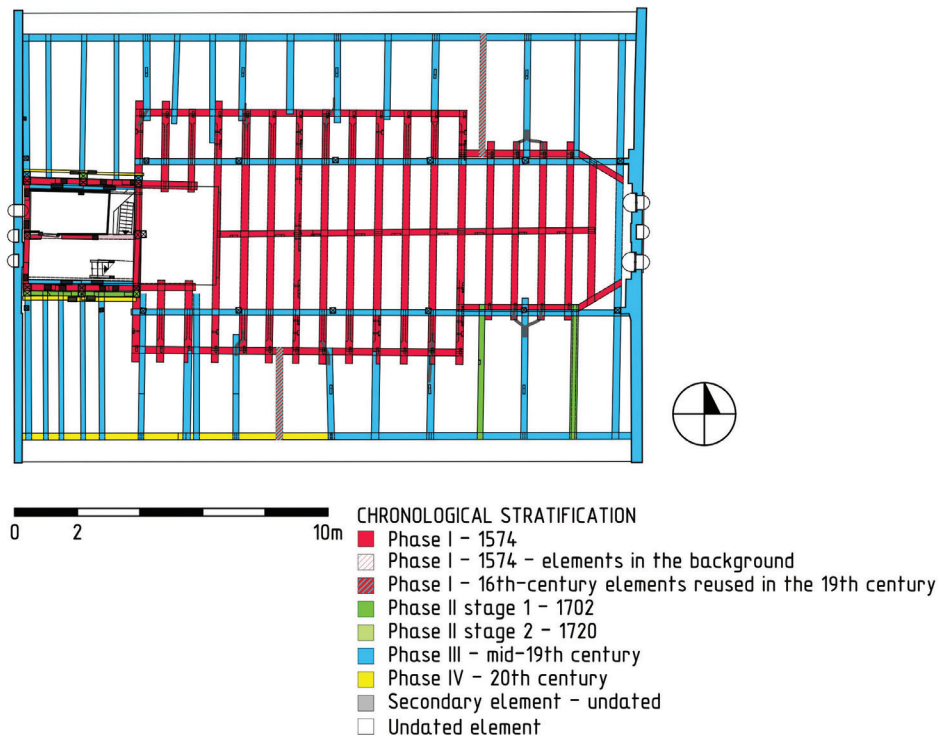
Fig. 3. Church of Our Lady of the Rosary in Byków, chronological stratification of the church, projection at the level of the entablature (elaborated by M. Kumorowicz-Brzeska, U. Schaaf, M. Prarat, D. Jagiełło)

The building history of the church in the 2<sup>nd</sup> half of the 19<sup>th</sup> century and in the 20<sup>th</sup> century is not rich. Shortly after the renovation, in 1858, the church was damaged by lightning. Four years later, the archives noted the need to replace the roof covering on the north side, which was to take place a year later (Archiwum Państwowe... ref. no. 1172). Therefore, the last phase is related to the period of 20<sup>th</sup>-century repairs and additions, mainly observed in the area of the structure and tower<sup>8</sup>. It seems that those activities were carried out rather ad hoc, never having a clear impact on the form or structural arrangement of the preserved church structures. In 1945, the church was taken over by Catholics and the Evangelical parish was liquidated. Currently, it serves as a branch church of the Roman Catholic parish of St. Michael the Archangel in Długołęka (Fig. 3).

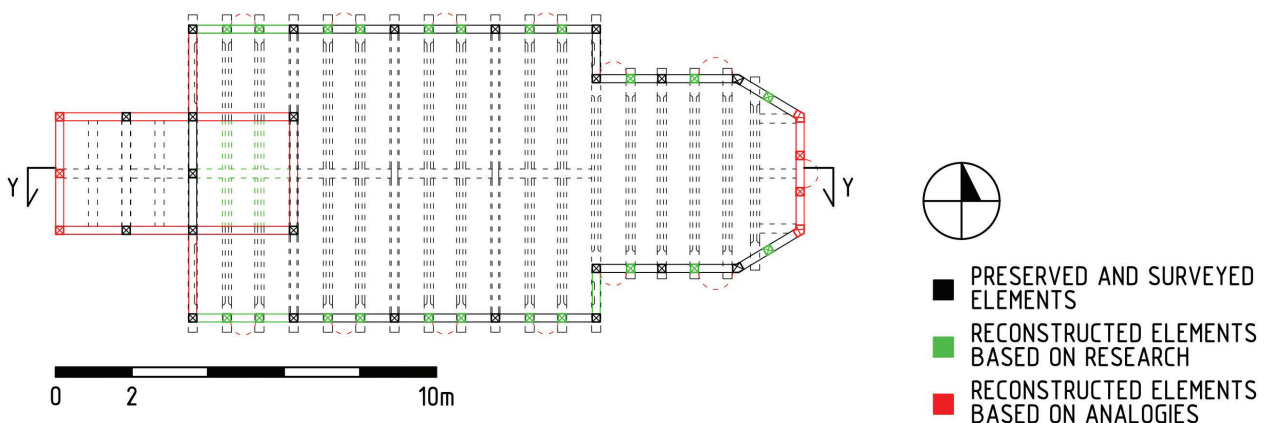
Fig. 4. Church of Our Lady of the Rosary in Byków, reconstruction of the original form of the church (16<sup>th</sup> century), ground floor plan at window level (elaborated by M. Kumorowicz-Brzeska, U. Schaaf, M. Prarat, D. Jagiełło)

**The nave and choir** were built as a half-timbered construction: it consisted of posts and studs running from the ground plate, through the entire height of the, to the up-

per plate, between which four rows of rails were stretched, creating a regular lattice with square panels. Additional stiffening was provided by braces and passing braces (Fig. 4).

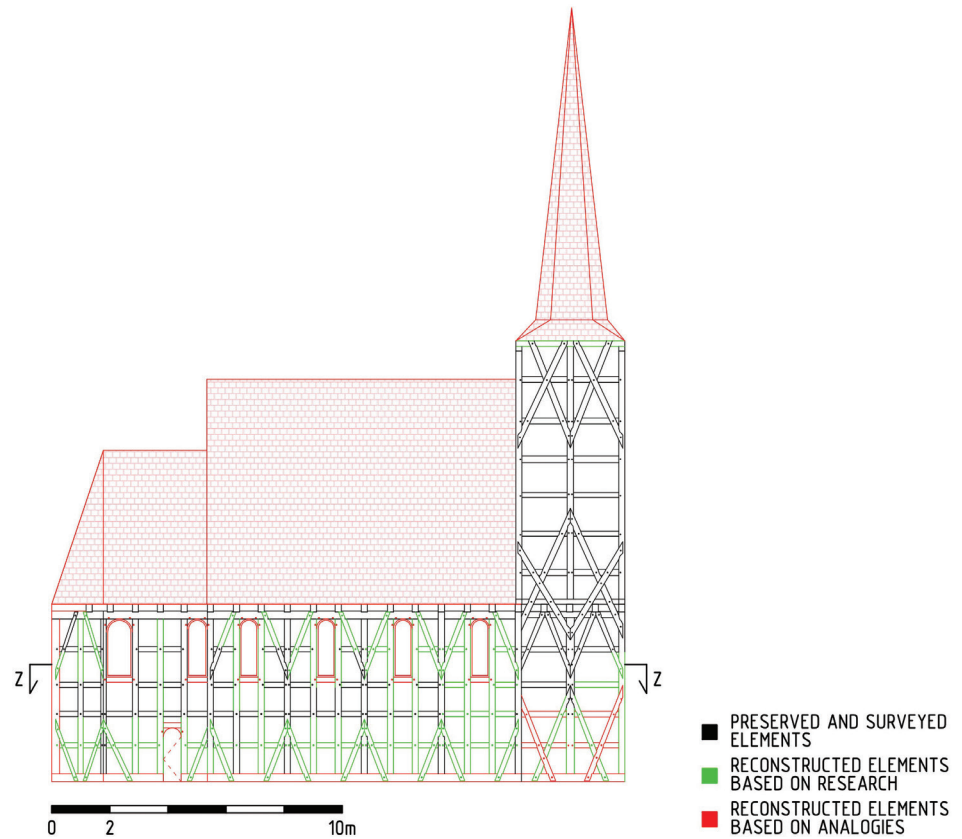
Fig. 5. Church of Our Lady of the Rosary in Byków, reconstruction of the original form of the church (16<sup>th</sup> century), northern elevation (elaborated by M. Kumorowicz-Brzeska, U. Schaaf, M. Prarat, D. Jagiełło)

(ground plate–rail 1–main post), and in the upper part, inclined outwards (main post–rail 4–upper plate)<sup>13</sup>. The reconstruction of the original layout was possible thanks to the preserved large sections of walls – timber-clad and constituting internal wall bonds in the nave body. On the basis of the known analogous solutions of similar dating<sup>14</sup>, it can be assumed that in the central field of each bay there were single window openings, closed at the top in segments, with a height slightly lower than the height of two frame fields<sup>15</sup> (Fig. 5).

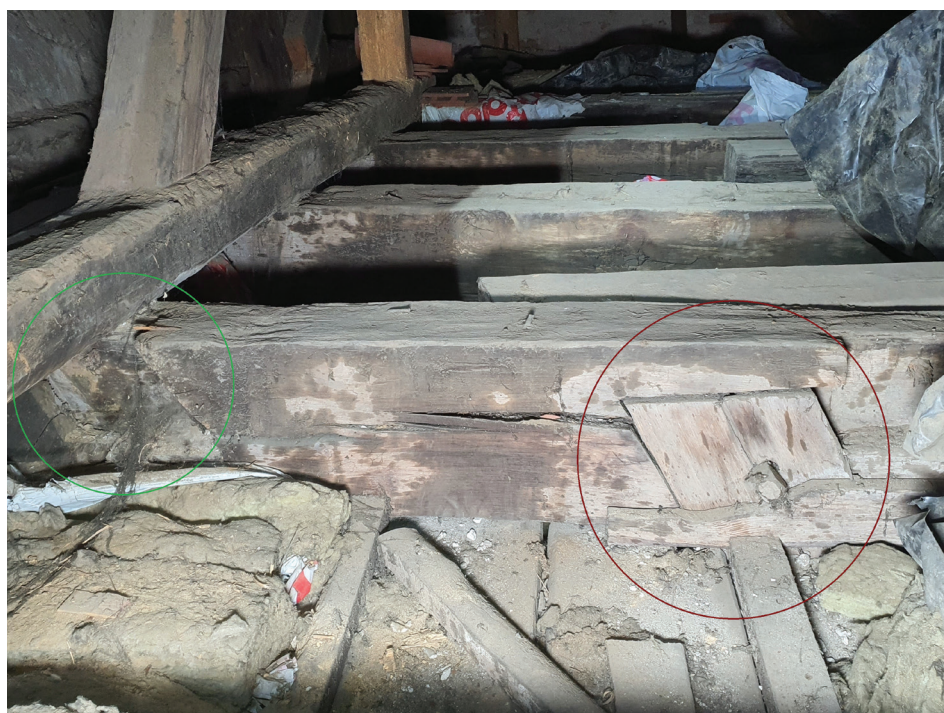
Fig. 7. Church of Our Lady of the Rosary in Byków, the end of the brace connecting with the entablature of the body (red) and the empty mortise after the lap joint of the king strut frame (green) (photo by M. Prarat, 2022)

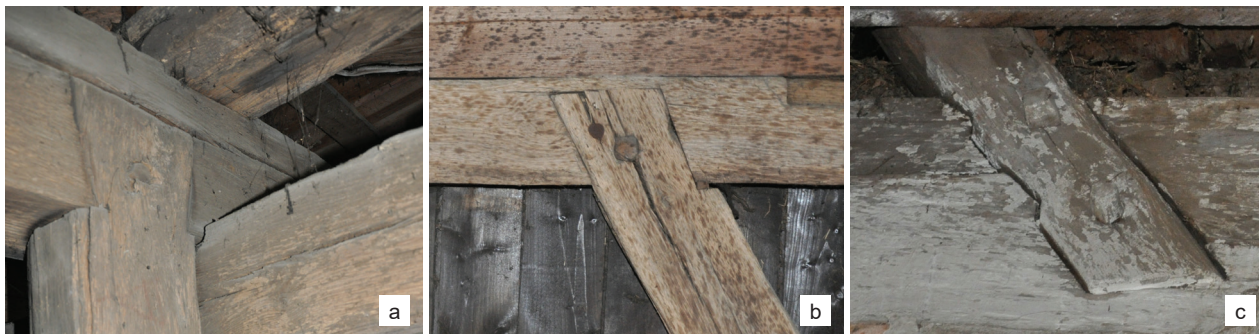
Fig. 9. Church of Our Lady of the Rosary in Byków, list of carpentry joints – lap joints:  
a) double dovetail lap joint-shaped, b) single dovetail lap joint-shaped, c) double-notched (photo by U. Schaaf, 2022)

each other, and in several varieties – division according to shape, mostly pegged joints. A straight lap joint was used to connect, among others, the ground plates of the longitudinal and transverse frames (tower) or, less frequently, a passing brace with a rail to which the tower is attached<sup>29</sup>. The notched lap joint was used for connecting passing braces with posts (body and tower<sup>30</sup>), passing braces with an upper plate (tower) or braces/passing braces with tie beams (joint in the beam on the side without the chamfer). An alternative connection for the passing braces with the main post or upper plate (nave and tower) is a single dovetail lap joint, which is also found, among others, when connecting short posts with the rails of the central bonds of the tower (Fig. 9). Crossing lap joints were used, for example, to connect rails with the stud of the bonding of the oblique walls of the choir (perpendicular elements) or passing braces that pass through the jetty bressumer or the upper plate of the lower storey (tower). The more commonly used variant is the notched lap – a connection of a passing brace and a rail (body and tower) or scissor passing braces (tower<sup>31</sup>). Where St Andrew's crosses intersect on the rail, double lap joints were used as in the passing braces of the upper stiffening of the northern frame of the tower.
