**Dorota Janisio-Pawłowska\***

## *The directions of evolution of church architecture in the background of the cultural landscape of seaside area of Western Pomerania*

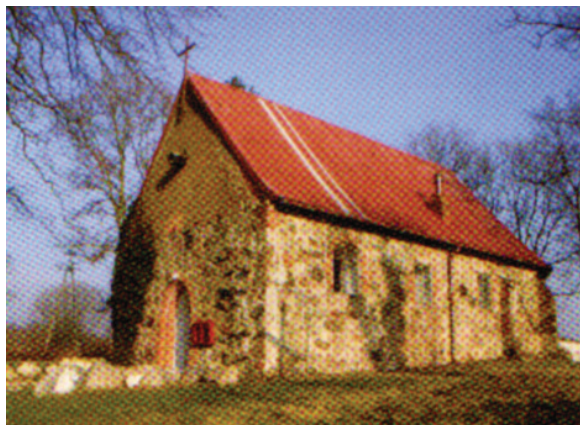
Fig. 1. Górkki Pomorskie, Romanesque-Gothic village church from the beginning of the 15<sup>th</sup> century. Source [1]

forms with several naves on the plan of the Latin cross or as basilicas. The ecclesiastical buildings were constructed with granite which is popular in that area in the form of blocks or carefully cut quarters which was the basic building material; this is why that kind of architecture is commonly called the “granite architecture”, however, it was gradually replaced by bricks (Fig. 1). The next art currents

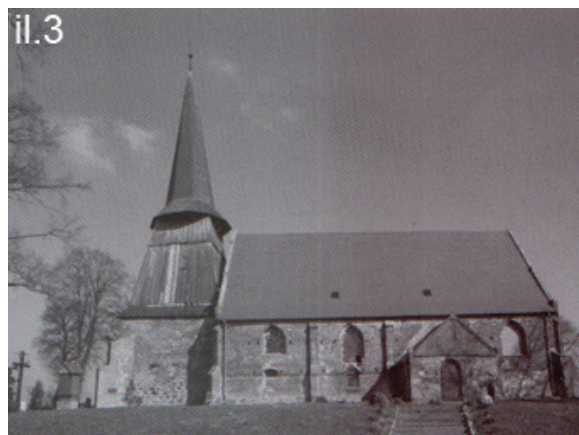
Fig. 3. Cerkwica, village church built after 1400 with an annexed tower. Source: [1]

At the close of the Middle Ages, the new church buildings appeared only sporadically. Most work in the area of sacred architecture included remodelings and annexing towers, porches, and sacristies to the existing buildings as for instance in the village church in Cerkwica (Fig. 3).

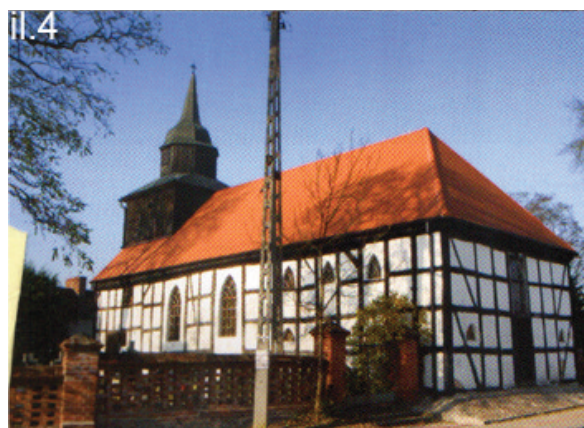
Fig. 4. Świerzno, village church in the timber frame structure from 1681. Source: [1]

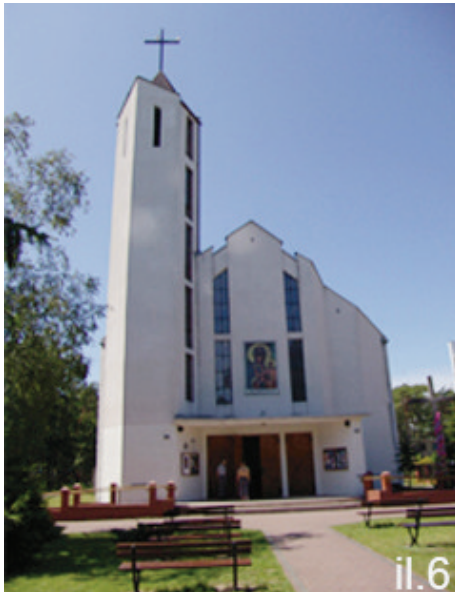
il. 6

Fig. 6. Międzywodzie, parish church from 1993, proj. by Walenty Zaborowski (photo by D. Janisio-Pawłowska, 2011)

The parish church in Międzywodzie (Fig. 6) built in the 1990s has a simplified conservative form; its main body is designed on a rectangular plan with east-west orientation. It is a hall church with a separated presbytery covered by a double-pitched steep roof and with a tower added on the left side by the entrance portal. The temple's windows, mostly filled with stained glass, are located in the main and side entrance portals. The parish church in Rewal (Fig. 7), built in 1976–1978, resembles a boat in its visual form, whereas its main body in its oval section

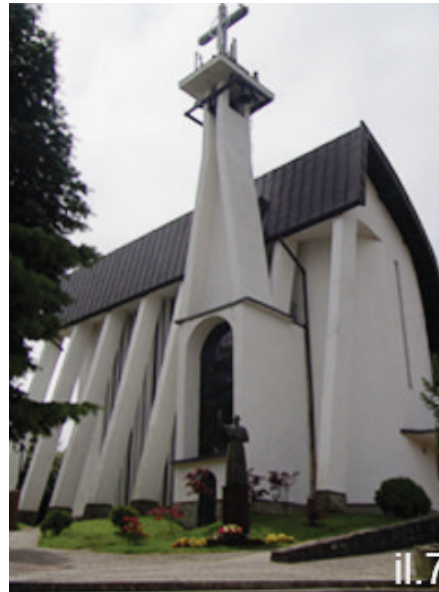
il. 7

Fig. 7. Rewal, parish church from 1970., proj. by Zbigniew Zaborowski (photo by D. Janisio-Pawłowska, 2011)

resembles a heart and it is a single space irregular design with an amphitheatrical choir; the whole structure is covered by an irregular double-pitched roof, it has a tower added from the north and its north wall has stained-glass windows. The church in Niechorze (Fig. 8), in construction since 2000, is a single space building on an irregular plan with a separated presbytery, covered by a steep roof with a false tower; the whole structure is a result of free expression on Gothic. The parish church in Pobierowo built in 1984–1986 (Fig. 9) has a single space form on a rectangular plan with an elevated presbytery inside; the church was connected with residential quarters and there is a tower adjacent to the main body of the building; the whole structure is covered by a steep double-pitched roof declining toward the presbytery. That example of a sacred space demonstrates an attempt at achieving ideal. Some of the new churches show repetitive patterns like the one

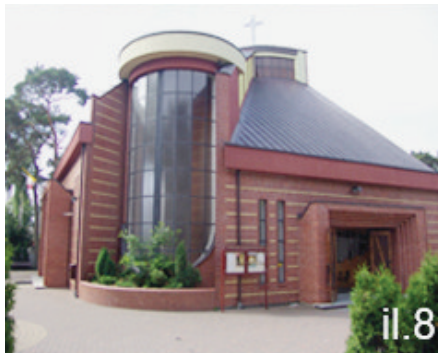
il. 8

Fig. 8. Niechorze, church in construction since 2000, proj. by Halina Rutyna (photo by D. Janisio-Pawłowska, 2011)

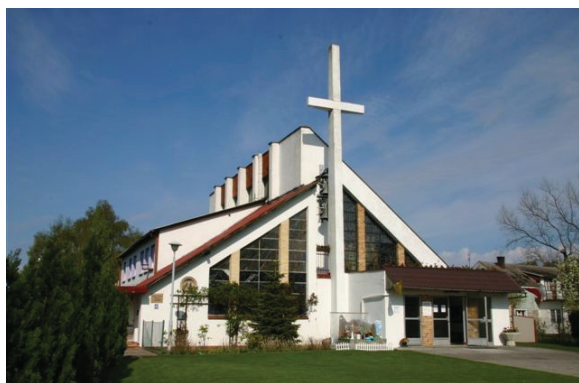
Fig. 10. Dziwnówek, parish church from ca. 1990., proj. by Jerzy Okniński (photo by D. Janisio-Pawłowska, 2011)

in Dziwnówek (Fig. 10) built around 1990 which is a replica of the existing church designed by A. Szymski and M. Wołoszyn in the 1970s in Dębno Lubuskie. The parish church in Dziwnów (Fig. 11), built in 1973–1977, is another example. It is based on a rectangular plan with the choir in the south part. The church has an east-west orientation, with the tower in its central part of west portal. The whole structure has a simple modernist form where the cross is the only indicator of the building's religious purpose. The church in Pogorzelica (Fig. 12) from around 1995 is one of many examples of unsuccessful combination of historical styles. Other examples include the filial church built in Czaplín Wielki (Fig. 13) around 1995 whose form is anti-Neo-Romanesque or the parish church in Łukęcin (Fig. 14) that has been in the process of construction since 2001. The latter is also an example of unsuccessful return to the tradition of timber-frame architecture. The churches

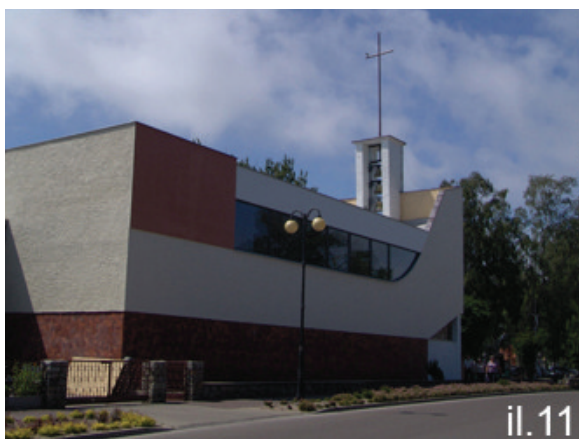
il. 11

Fig. 11. Dziwnów, parish church from 1973–1977, proj. by Otton Odon (photo by D. Janisio-Pawłowska, 2011)
