Bartłomiej Gloger*

Nonsuch – zaginiony pałac Henryka VIII

Nonsuch – Henry VIII's lost palace

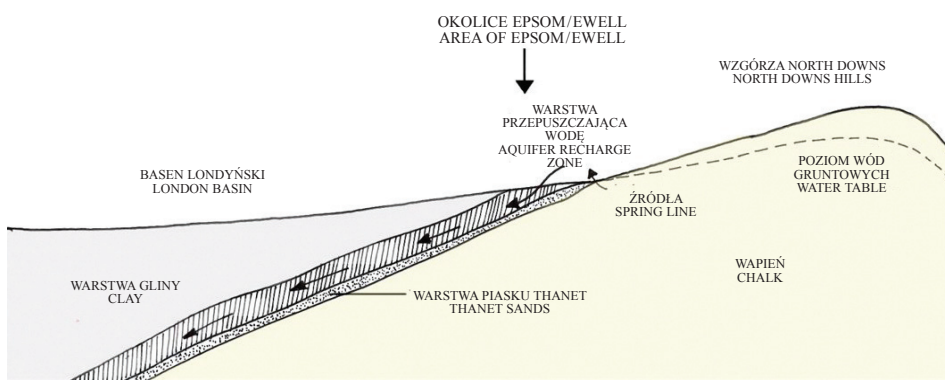
Il. 1. Uproszczony schemat warstw geologicznych (rys. B. Gloger)

Fig. 1. Simplified diagram of geological strata (drawn by B. Gloger)

the creation of numerous natural springs (Fig. 1). The characteristics of the entire region are a good microclimate, scenic beauty and a profusion of springs (admired since the Roman times). The hills are intersected with many river valleys and are of outstanding natural beauty, which attracted humans to build their settlements here. The traces of the first settlers in this area date back as far as prehistoric times [1], [3].

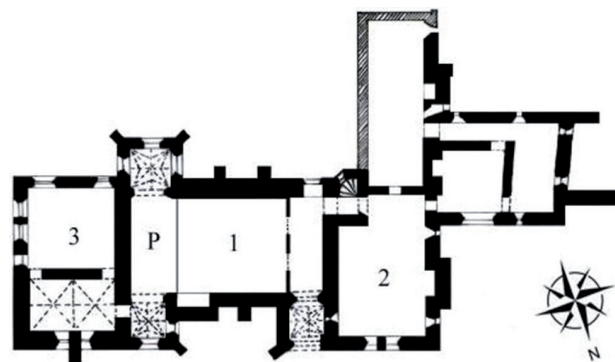
Il. 2. Plan Great Chalfield Manor w Wiltshire (rys. B. Gloger).
1. Hall. 2. Kuchnia i pomieszczenia pomocnicze. 3. Salon. P. Podium
Fig. 2. Great Chalfield Manor in Wiltshire (drawn by B. Gloger).
1. Hall. 2. Kitchen and ancillary rooms. 3. Parlour. P. Dais

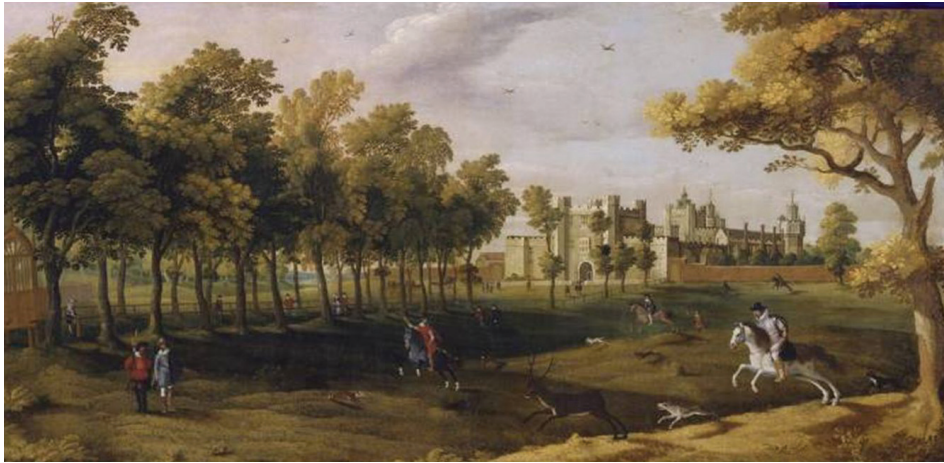
Il. 4. Widok na północną fasadę Nonsuch, XVII w., nieznaną artystą (©The Fitzwilliam Museum, Cambridge)

Fig. 4. North view of Nonsuch, 17th century, unknown artist (©The Fitzwilliam Museum, Cambridge)

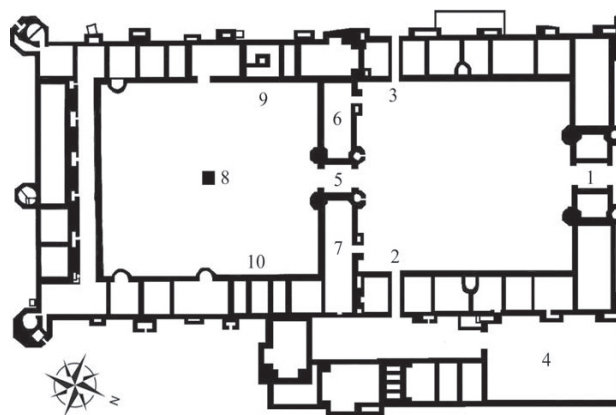
Il. 5. Plan Nonsuch zrekonstruowany na podstawie badań archeologicznych (rys. B. Gloger).

1. Brama wjazdowa. 2. Przejście do tzw. budynków ogrodnika. 4. Podwórze kuchni. 5. Wewnętrzna brama.
6. Prawdopodobnie spiżarnia. 7. Piwnica na wino. 8. Fontanna.
9. Prawdopodobnie wejście do apartamentów króla.
10. Prawdopodobnie wejście do apartamentów królowej

Fig. 5. Nonsuch Plan reconstructed based on archaeological research (drawn by B. Gloger).

1. The gatehouse. 2. Passage to the kitchen.
3. Passage to the gardener's lodge. 4. Kitchen's courtyard.
5. Inner gate. 6. Probable pantry location. 7. Wine cellar.
8. Fountain. 9. Probable entrance to the King's apartment's.
10. Probable entrance to the Queen's apartment's

The appearance of the north facade was no different to the buildings erected in this period in the widely popular Gothic style. The inventory written in 1650 describes the central tower of the gatehouse as 17.5 metres wide and three storeys high. It is known that the ground floor contained two rooms that were probably used by the porter. Unfortunately there is insufficient information relating to the functions of the rooms on the upper floors as the historic sources remain silent [3]. A view of the first courtyard opened up as the visitor passed through the gate that was *the most beautiful in its size and appearance and that rose high above the battlemented stone walls on either side* [8, p. 34] as described by the rector of Cheam, Anthony Watson [14], (Fig. 5).

Anthony Watson – otwierał się widok na pierwszy z dziedzińców (il. 5).

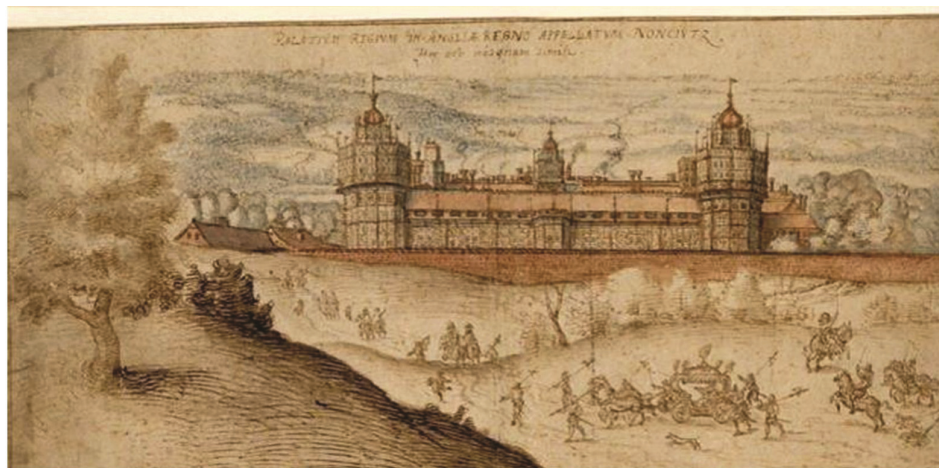
Il. 6. Południowa fasada Nonsuch,
Joris Hoefnagel, akwarela 1572 r.
(© The Trustees of
the British Museum)

Fig. 6. South facade of Nonsuch,
Joris Hoefnagel, aquarel 1572
(© The Trustees of
the British Museum)

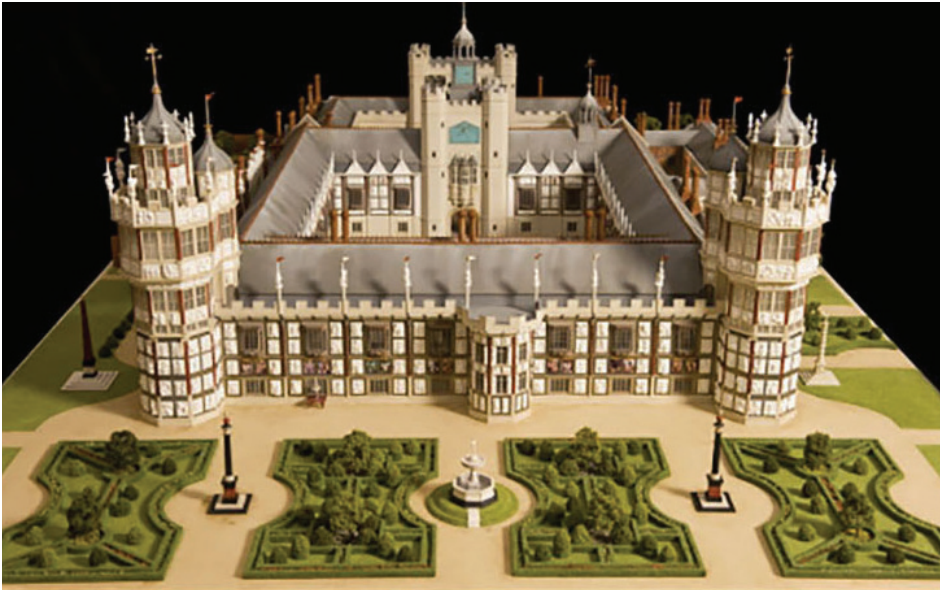
Il. 7. Makieta Nonsuch wykonana na podstawie badań archeologicznych (fot. Bournemouth News & Picture Service)

Fig. 7. Nonsuch model based on archeological research (photo by Bournemouth News & Picture Service)

The King's private garden was maintained in the French style with symmetrical flowerbeds that were designed to create floral patterns called "knots" (Fig. 7). The centre of the garden was occupied by a fountain of Venus, which was located on a shallow hill and surrounded by other statues. The planting arrangement not only included roses, daffodils and lilies but as well ivy and different species of fruit trees specially imported from France. The main attraction was the maze with high hedge walls and a complex plan that disoriented visitors. The entire garden was divided into several sections and the so-called *wilderness* was one of them. The theatrical forest was designed to appear wild with trees overgrown with ivy and a multitude of ferns and shrubs creating a mysterious ambiance. The grove and statue dedicated to the mythological goddess

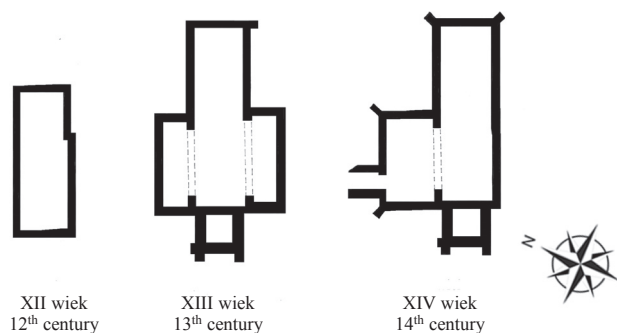
Il. 8. Schemat planu kościoła Marii Dziewicy w Cuddington (rys. B. Gloger)

Fig. 8. Schematic plan of the Virgin Mary church in Cuddington (drawn by B. Gloger)

The single nave church with the adjacent chancel that once stood in Cuddington was the only structure fully excavated on site. It was concluded that it was demolished first as the palace had to be located in the exact position to ensure the water supply by gravity from the spring in the hillside. As mentioned previously the salvaged stone material was used to build the foundations of the inner courtyard, which stood on this part of the site. The surrounding graves in the vicinity of the church were left intact during necessary works in 1538 unless the foundations or other trenches had to run through the area were they were located.

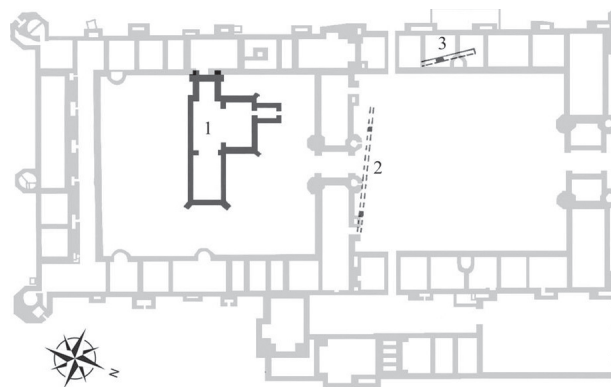
Il. 9. Pozostałości po osadzie Cuddington odkryte podczas wykopalisk (rys. B. Gloger). 1. Kościół. 2. Prawdopodobnie ściana graniczna cmentarza. 3. Ściana stodoły

Fig. 9. Remains of Cuddington settlement discovered during excavations (drawn by B. Gloger). 1. The existing church. 2. The probable churchyard wall. 3. The wall of the barn

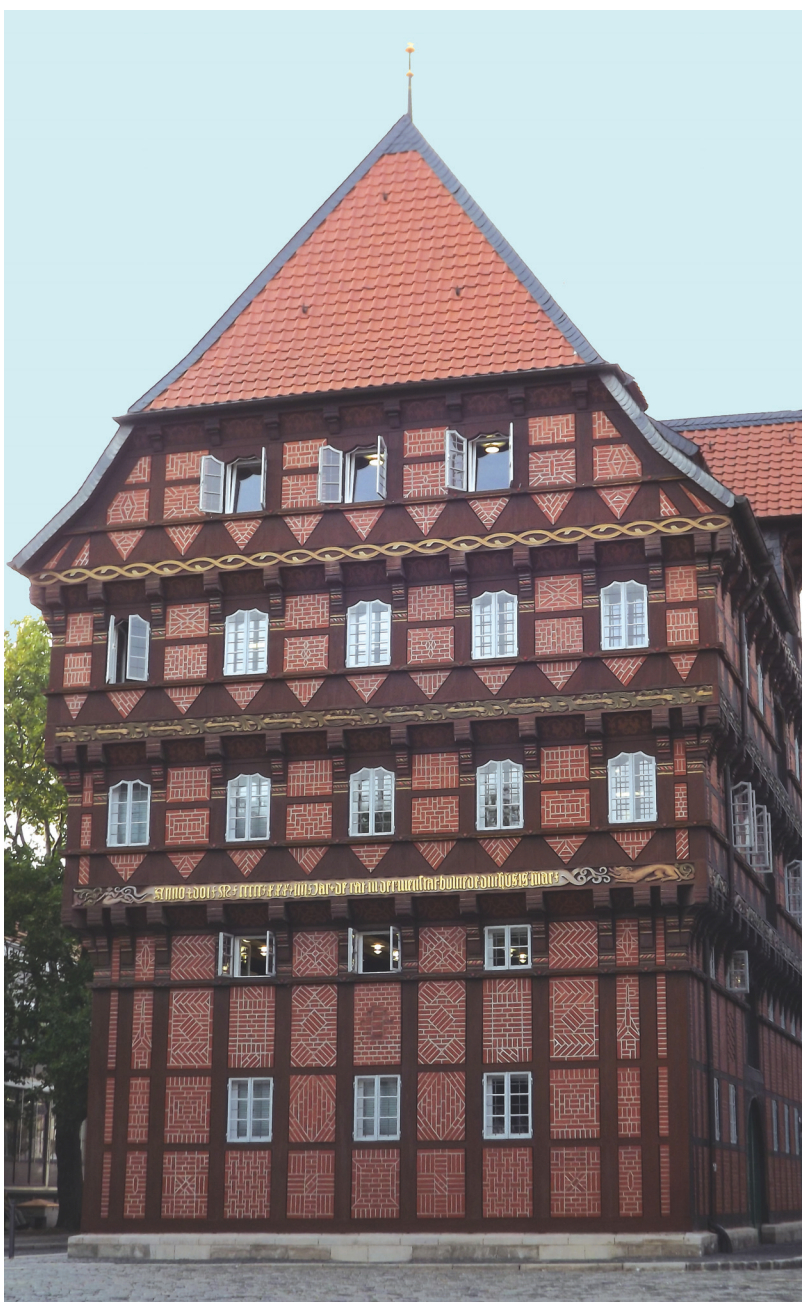
Dom Wagi w Braunschweig
z ozdobnymi wypełnieniami fachów
przez zastosowanie zmiennego wążku cegły
(fot. D. Kowalska)

Alte Waage (Old Weight House)
in Braunschweig with decorative brick nog-
gin panels of mixed patterns brickwork
(photo by D. Kowalska)
