## *Interdisciplinary research as a form of monument protection and preparation for the investment process on the example of the former Gdańsk Shipyard complex*

#### *Architectural and conservation research of the U-Boat Hall (89 A)*

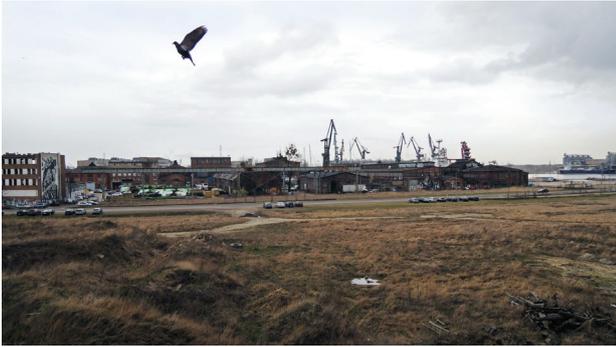
Fig. 1. View of a fragment of the area of the former Gdańsk Shipyard in 2019. Until the beginning of the 21<sup>st</sup> century, the area in the foreground of the photo was filled with shipyard halls constituting one of the main production lines of hull construction. Currently (2022), investment works related to the construction of multi-family buildings are underway there (photo by A. Orchowska-Smolińska)

The transformation process of the Gdańsk shipyard area initiated this way was associated with the emergence of plans to convert the oldest part of the shipyard into a new district of Gdańsk, i.e. connecting the post-shipyard area with urban tissue (Fig. 1). It is worth mentioning here the unique documentation of the Shipyard's heritage by Michał Szlaga, which began to be created in 1999. The artist undertook a several-year-long project of photographic recording of changes in the cultural resources of the shipyard areas undergoing the first transformations. The publication of the results of the documentation work took place in 2013 in the form of a richly illustrated album with numerous descriptions [19]. Two industrial heritage researchers, Dr. Waldemar Affeld from the Gdańsk University of Technology and Professor Jacek Dominiczak from the Academy of Fine Arts, played an important role in the project in the context of reading the meanings of shipyard remains.

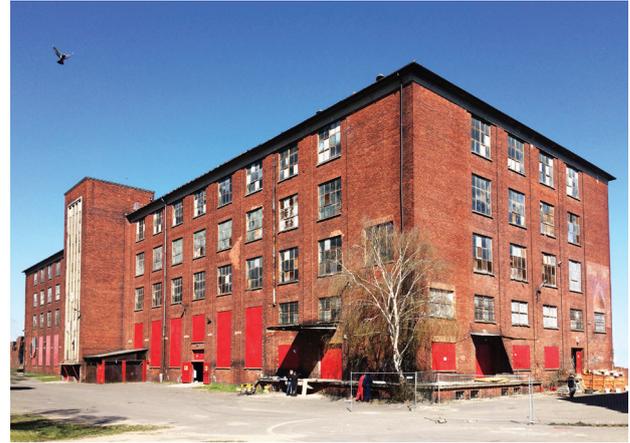
Fig. 5. The body of the Main Warehouse (89A), so-called the U-Boat Hall, in the view from the south-east, 2019 (before the start of conservation works) (photo by A. Orchowska-Smolińska)

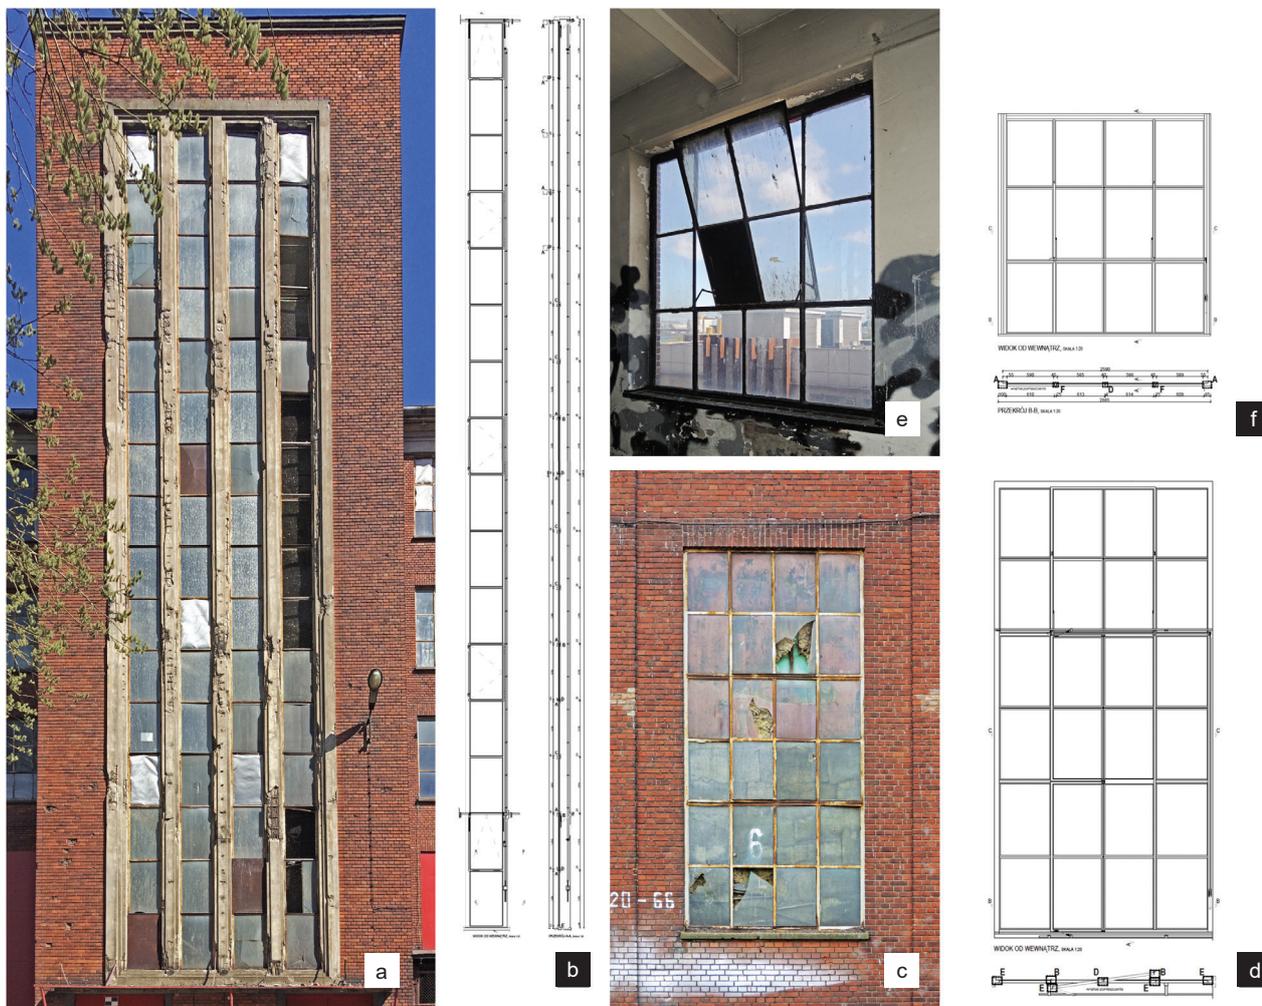
Fig. 9. Variety of metal windows covered by the detailed examination of the Main Warehouse (89A), so-called the U-Boat Hall. All industrial windows were of a type so-called “complex” windows, made of steel, rolled elements, of the standing or lying type, with fixed or tiltable sections, 2018–2019: a, b) staircase avant-corps (TYPE 4 window) in the southern elevation – a sixteen-row, single-section window, dimensions: width 95 cm, height 2081 cm; five single-deck opening wings, c, d) ground floor (TYPE 2 window) – a six-row, four-section window, dimensions: 260 cm, height 551 cm; three four-quarters wings in the central part with hinged openings, e, f) window of upper floors (TYPE 1 window) – a three-row, four-section window, dimensions: width 268 cm, height 287 cm; four-quarters vertically tilting section that opens vertically (source: [22])

dustrial window fittings. Industrial windows were a cheap solution, if only because of their considerable number (nearly 200 windows outside and another ca. 100 pieces inside) (Fig. 9). The steel rails were fitted with windows made of reinforced plain, white glass with a dense mesh.

In the exterior view, large window panels show a division with thin lines of profiles. During use the profiles corroded, and the glazing often cracked and broke. The as-is, then, was a mosaic of multi-coloured glass panes with different types of reinforcement mesh. Determining the original
